2010 43QGP Allegro Bus

4/18/2011

4 – FYI – WINDOW AWNING MOUNTING. Every time I wash the coach a few of the pop rivets used to mount the window awning brackets would snag the cloth or sponge and tear a hole in it or pull it out of my hand requiring me to climb down to retrieve the item from the floor. Deciding enough was enough I got my battery powered drill out installed a small sanding drum in order to grind away any left over protruding pin left over from the pop rivet installation. In most cases any left over pin protruded about 1/8 inch in a few cases even 3/16 of an inch. Not all pop rivets left pins protruding but enough of them did to warrant the above action.

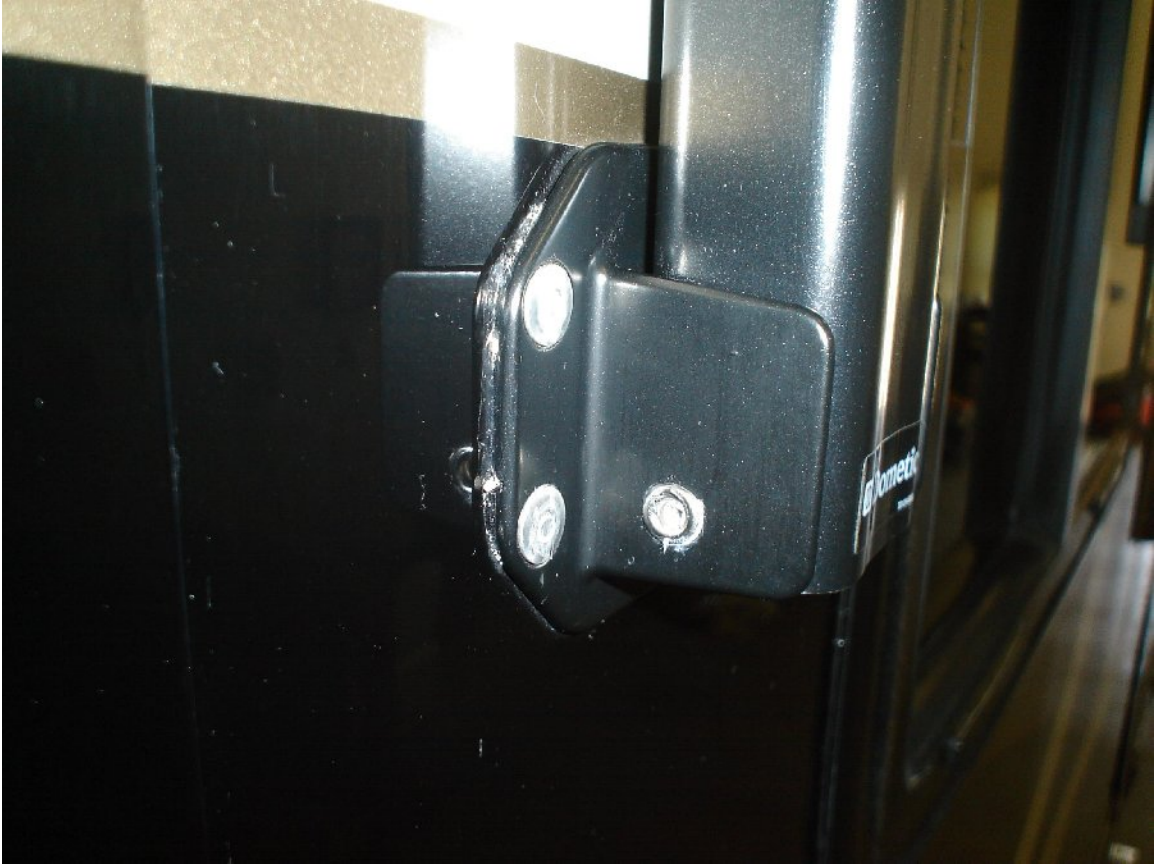
I noticed a few of the pop rivets actually pulled the whole pin through the rivet without leaving a portion of the pin in the hole to plug the center hole. In those few cases that hole would be an entry point for water intrusion into the fiberglass wall panel. Again a small amount of clear silicone sealant was pumped into those open holes.

After sanding the pin flush with the pop rivet surface, a dab of clear silicone sealant was added over the pin hole for protection against any possible water entry around the pop rivets pin.

After sanding and sealing every pop rivet pin which needed sanding, attention was focused on applying silicone sealant over the head of every pop rivet.
