2010 43QGP Allegro Bus

6/5/2011

10 – FYI – GALLEY SINK DRAIN LEAK. We were fortunate in actually being at Red Bay when the galley sink drain pipe sprung a leak. First indication of the problem was when Cathey had finished washing a few breakfast dishes drained the sink and the bottom of a foot got wet. I think we got lucky because the coach was low on the driver side just enough to have the water flow out from under the slide and not back toward the wall. Daniel Newcomb in Bay 4 took the complete area apart in order to find the leaking pipe. It turned out the flexible PVC conduit used by Tiffin for the moving part of the drain had become crimped just enough to split the conduit on both sides of the crimp.

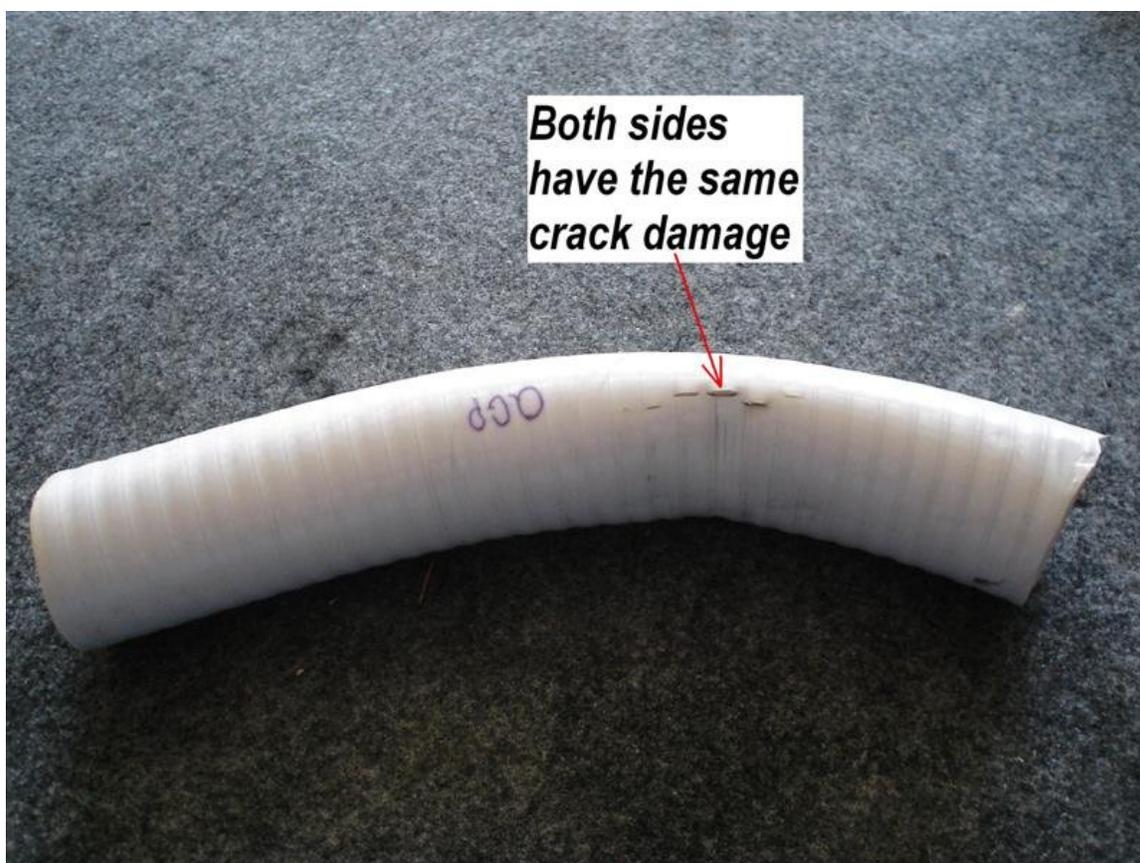
The above conduit is made to flex but it is not made to flex to the extent or as many times as will be required when used in a galley slide.

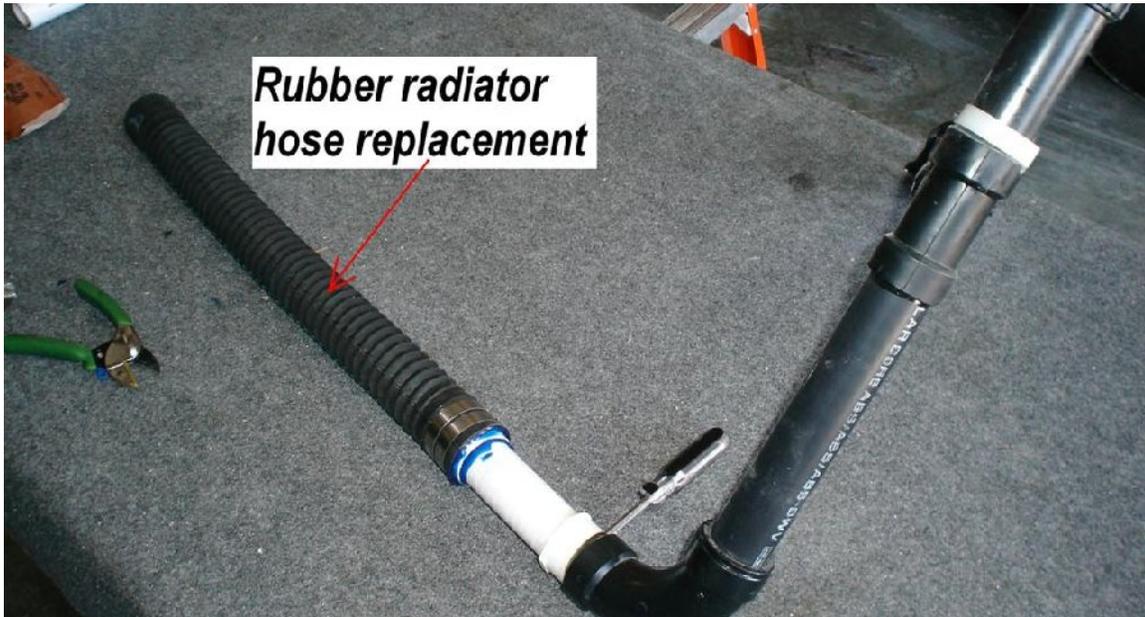
Disassembly and reassembly takes time in our case a couple of hours to remove and reinstall other components which were in the way.
