## 2010 43QGP Allegro Bus

11/7/2011

**31B – FYI - COACH-STEP RV STEPS.** This file is a continuation of the problems with the Lippert Component Company's "Coach Step" RV steps. After experiencing intermittent step operation Tiffin was called. I explained the problem, after explaining what I was seeing Tiffin shipped a new step motor to me. After installing the step motor the steps would not completely retract they would come close to closing but just not the last one inch without assistance.

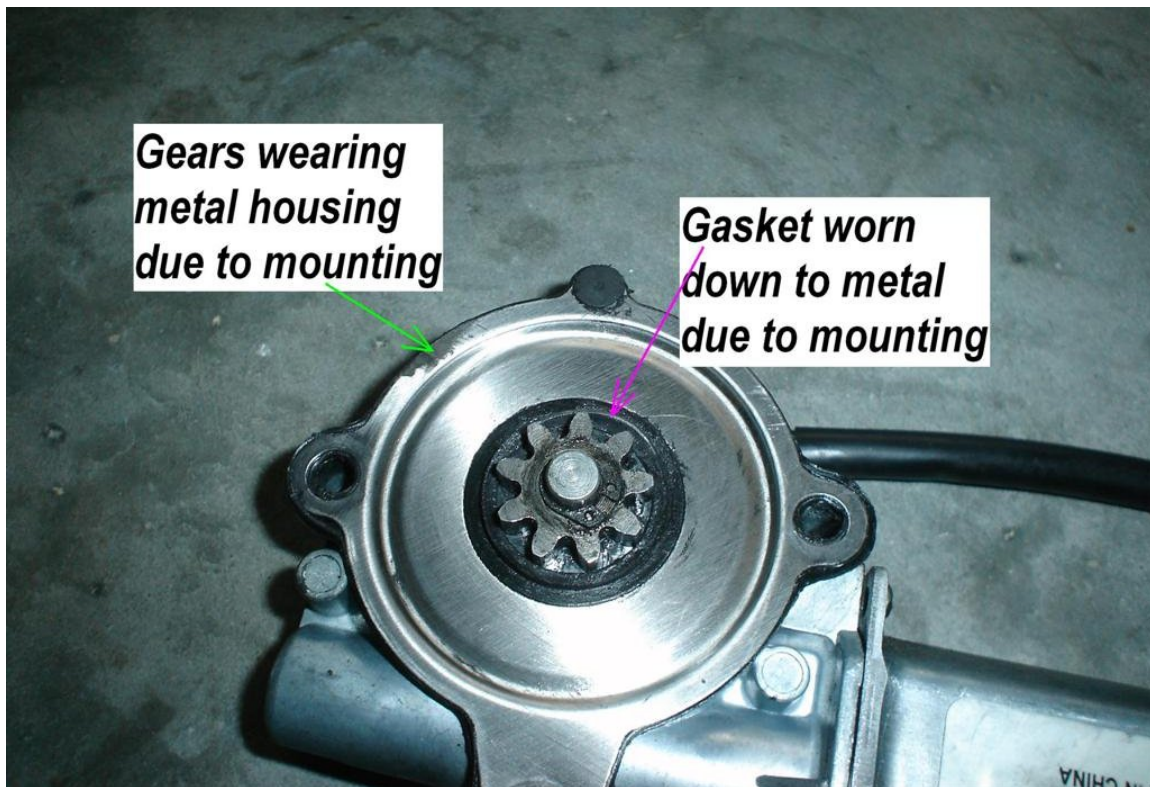
I thought the problem might be related to the motors gearbox and step gear as they were rubbing again each other during operation which was causing some wear on the gearbox and gasket.

The worn portion of the gearbox and the gasket can be seen in the above picture. I thought this might be causing enough drag to stop the motor from completely retracting producing just enough resistance to tell the motors controller to stop due to the increased current load.

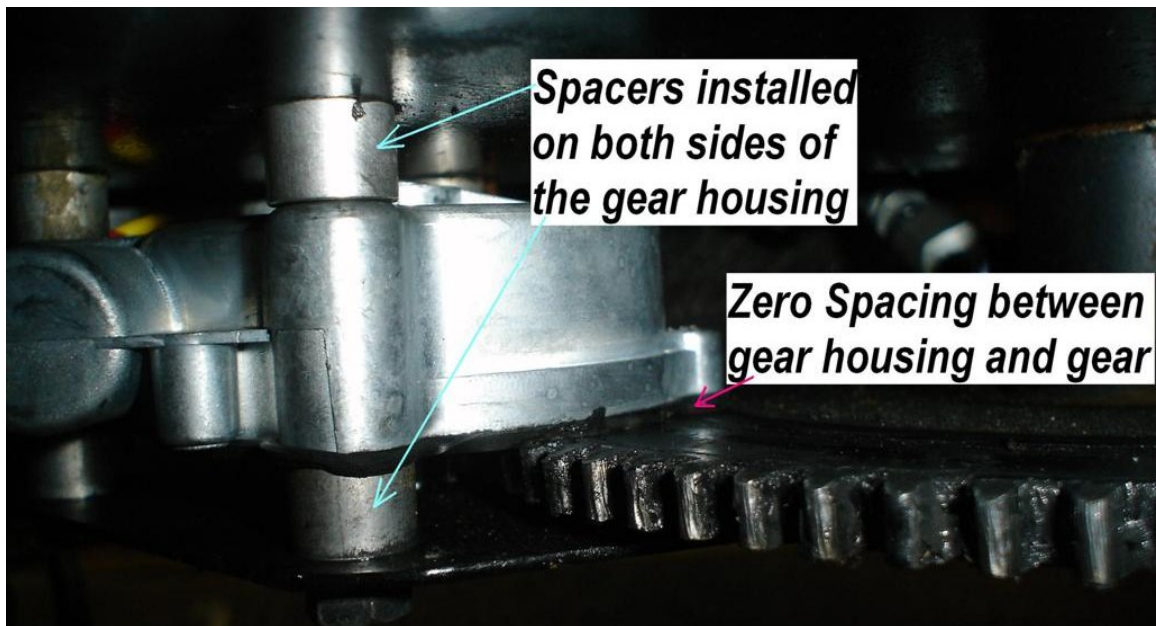
As seen in the above picture there is NO spacing between the housing and gear which is causing some damage to the gearbox.
