## 2010 43QGP Allegro Bus

**31D – FYI - COACH-STEP RV STEPS.** This file is a continuation of the problems found with the Lippert Component Company's "Coach Step" RV steps. A problem found quite often is the “Stutter Sound“ or in some cases also known as the “Machine Gun Sound” when the steps are retracted or extended and do not lock in either position, rather they just ratchet or stutter. Below is a partially disassembled new step motor, the gear box cover and the “C” clip on the nine tooth gear were removed to expose the internal gearing.

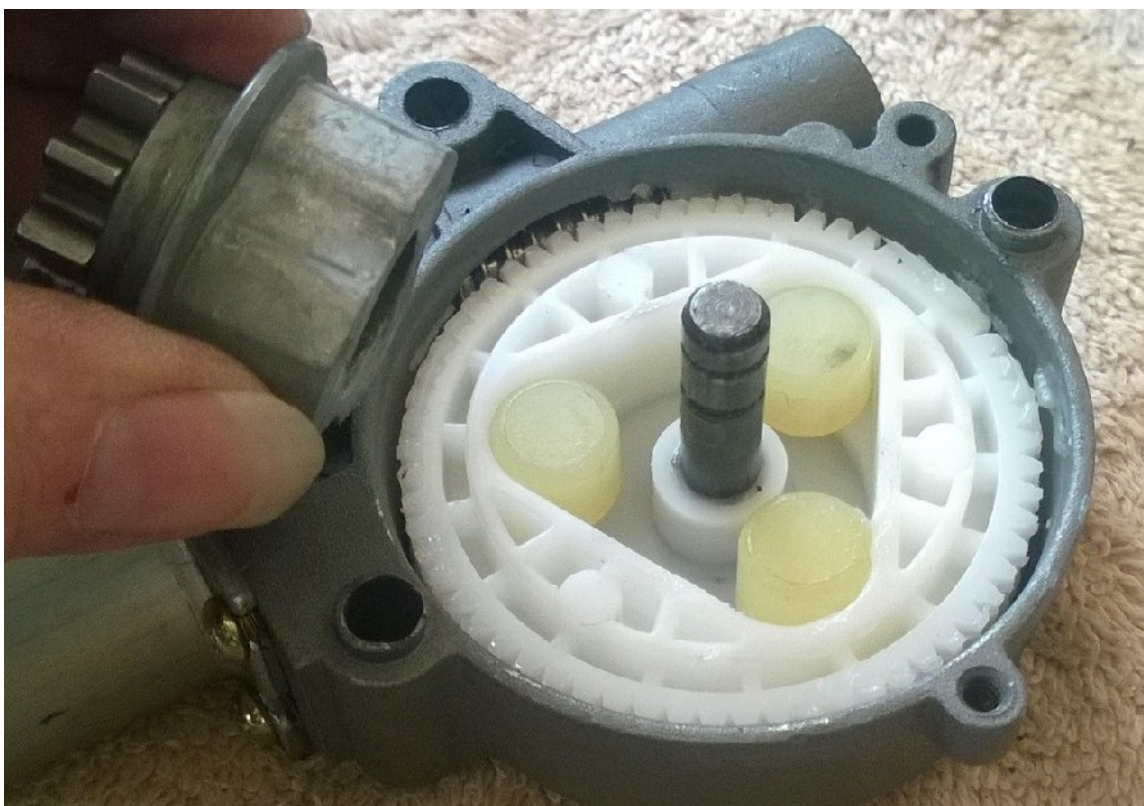
The slightly yellow round nylon “PLUGS” as I’ll call them for lack of a better term are part of the gear train. The gear shown in my hand slips over the shaft and aligns with the three plugs. In this motor the plugs are the **DESIGNED** weak link in the motor. These plugs are designed to be sacrificed before other damage occurs to the motor. So the next time you go to extend or retract your coach steps and you hear the Stutter Sound or the Machine Gun sound think about getting your step motor replaced or repaired

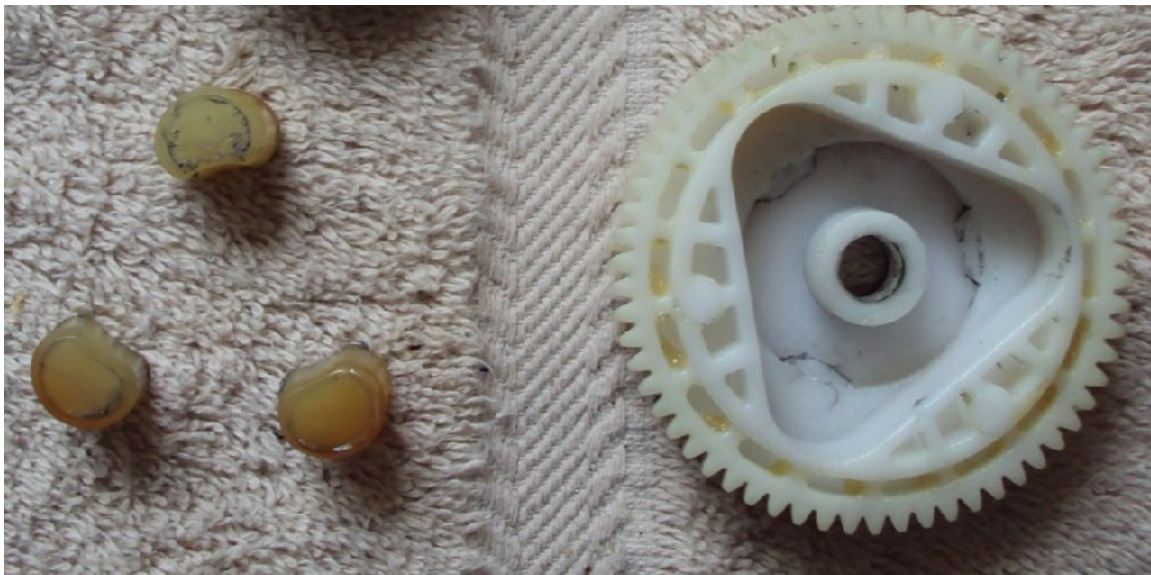
SOON because that sound is the ONLY warning you will get before the steps STOP partially extending or retracting. If you have an old step motor you MAY be able to cannibalize parts from the old step motor to repair the mounted step motor before the steps lock partially extended or retracted when you want them to be the opposite of what they are. You can also purchase a repair kit with three nylon plugs, the kit is manufactured by Dorman # 74410, at most automotive parts houses for about \$ 8.00 plus tax. Stepping onto a **PARTIALLY EXTENDED** or **RETRACTED STEP** is **EXTREMELY DANGEROUS**. The drive train of the step mechanism was not designed to bear the load of a person's weight while the steps are partially extended or retracted they will and have broken when stepped on. Below is a photo of an old step motor with its distorted nylon plugs.

Looking at the two photos it is easy to see a large difference in the SHAPE of the plugs in the two photos. Look at the distorted side of the old step motor PLUGS compared to the new step motors PLUGS. What occurs **EACH** time the step changes from extended to retracted OR retracted to extended the side of the aluminum three tooth gear in my hand squeezes the three plugs until the step controller senses a spike in current, when that spike is sensed the controller turns OFF the voltage to the step motor. Each and every time the steps change from open to closed or closed to open this squeezing process takes place UNTIL the nylon plugs become so distorted the three tooth gear slips past the plugs and you hear the Stutter or Machine Gun sound, that sound is your warning the coaches steps are going to **STOP** operating as they were designed.

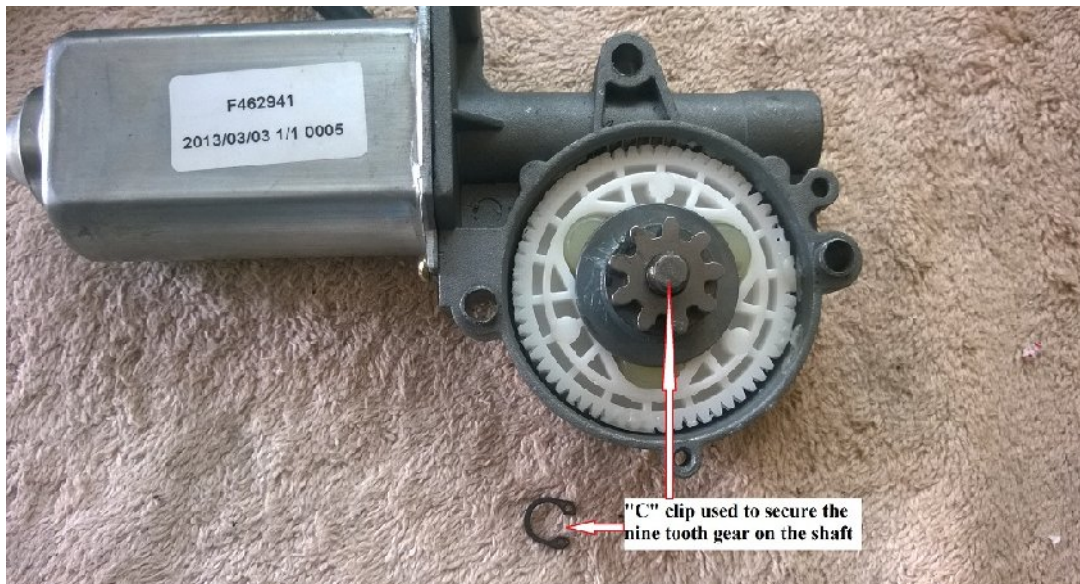
As seen above the motors cover can be removed from the gearbox however to remove the nine tooth to three tooth gear (seen in my hand) requires the removal of the "C" clip from the shaft.

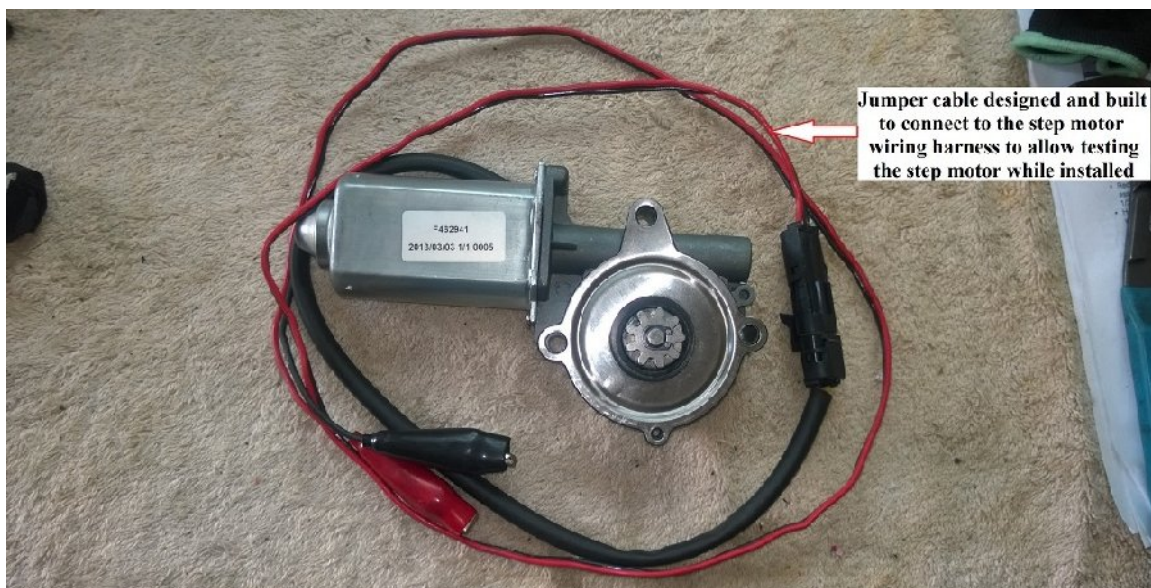
Over the years there have been times when the steps acted up leaving me to wonder what the exact problem was. In an effort to eliminate the step motor as the cause the pigtail harness shown below was built. With a pigtail like this the step motor can be disconnected from the step controller, the pigtail can be connected to the step motor wiring harness, the alligator clips on the pigtail can be connected to the generators positive and negative 12 volt connections on the back side of the generator. This test will quickly show if the step motor is the problem or if the problem is located elsewhere.
