2010 43QGP Allegro Bus

11/30/2011

34 – FYI - TIFFIN'S GALLEY SLIDE REPAIR. Recently we noticed paint had been rubbed off of the frame around the galley slide on the end near the kitchen sink. First we found the rubber gasket had moved from where it had originally been stuck on the slide that allowed the paint to paint contact which rubbed the paint off of the slide frame mounted in the coach sidewall. After the rubber gasket was moved back to where it belonged we found the reason behind the damage, the slide frame attached to the coach side wall had become separated by about 1/4 of an inch from the side wall. This 1/4 inch was bare metal, the tech decided the only way to keep the two pieces together was to install five 1/8" pop rivets in the frame in order to clamp the slide frame to the coach's sidewall.

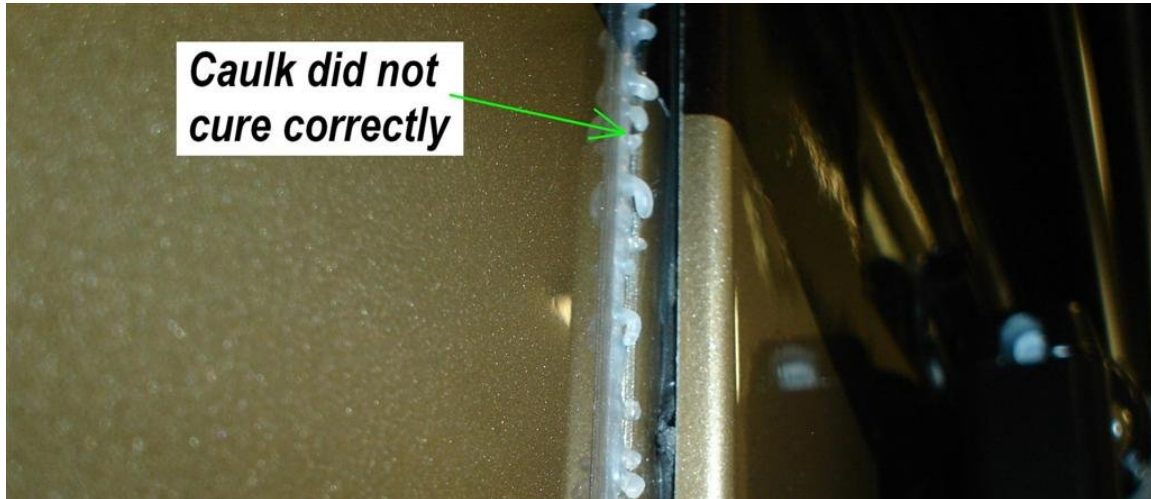
caulk around the frame appeared to have bubbled up. After checking it turned out the caulk was not bubbling but where the frame had been moving side to side allowed the caulk to not be able to cure properly allowing bubbles to occur before the caulk cured after the bubbles had formed.

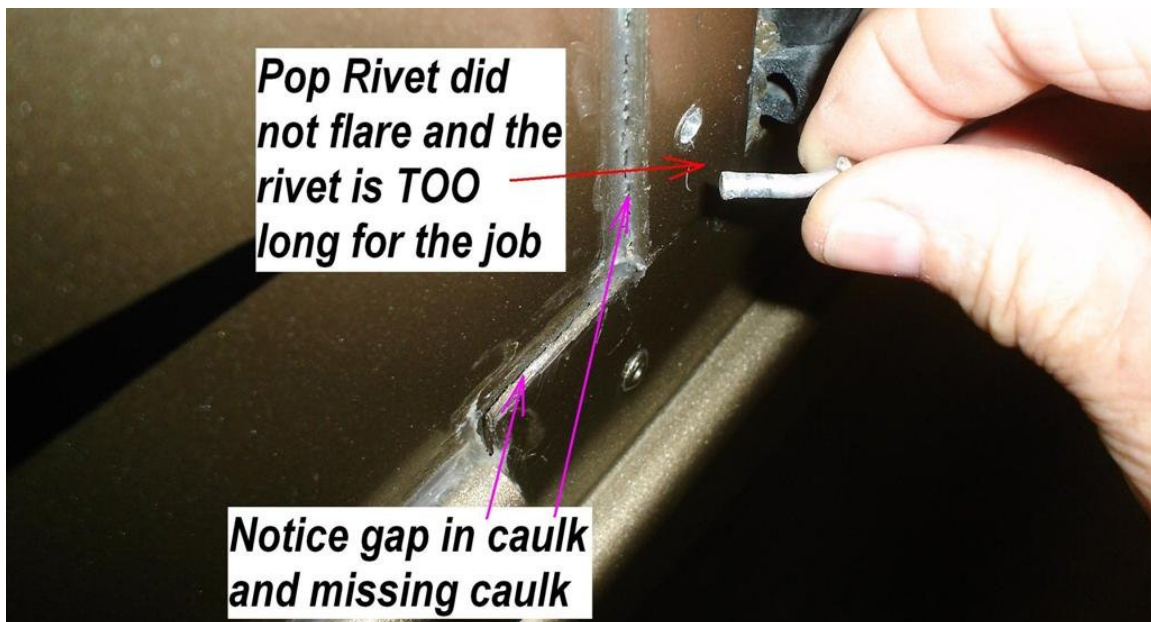
I also noticed the pop rivets were not tight against the sidewall frame which allowed the frame to move slightly side to side just as it had before but to a lesser extent now then before installing the pop rivets. Upon closer inspection the lower pop rivet had not popped/flared the end of the rivet which is necessary for holding the two pieces of material together but was just sitting loose in the hole, the rivet was removed using just my fingers.
