## 2010 43QGP Allegro Bus

2/21/2012

**41 – FYI - TIFFIN CHASSIS BARE METAL.** We have owned two Tiffin coaches both coaches were shipped with more bare chassis metal then I thought was possible. It appears when the chassis painter is painting the chassis if the metal cannot be seen from a standing position it does not get painted. I lost count how many cans of spray paint have been used on the chassis metal of our two coaches. While working on another modification more bare metal was found which had not been painted on the firewall.

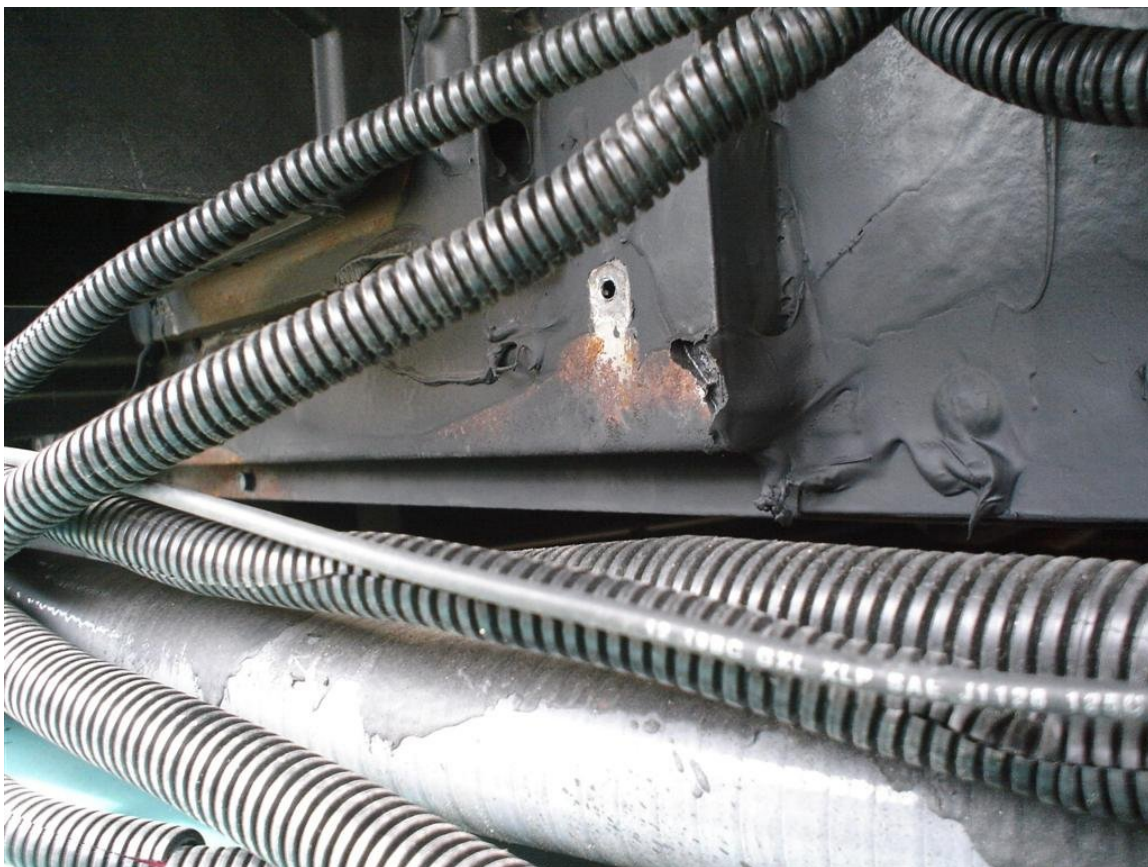
I understand some wiring is installed in the welding shop prior to the chassis being painted. But you can see in the above firewall photograph MOST of this wiring had been installed BEFORE the chassis had been undercoated or painted. The lower section of the firewall just above the generator had not been painted from side to side, also the bottom of the firewall had not been

painted either. Painting both firewall sections (face and bottom) POST production was not easy.
