2010 43QGP Allegro Bus

61 – FYI – RV STEP MAINTENANCE – GROUNDS (COACH STEP).

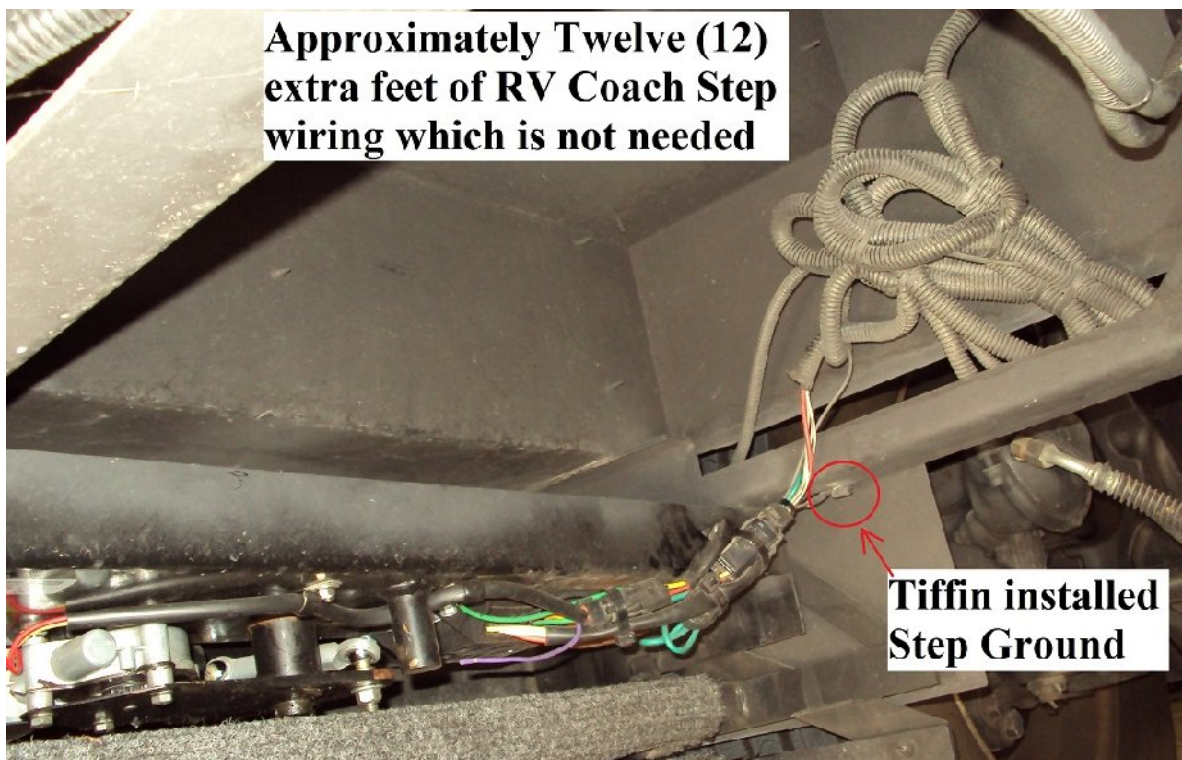
While checking on an intermittent RV step operation it was determined the most likely cause was going to be the method Tiffin used for grounding the RV steps electrical system. As noted in the below photo Tiffin made this wiring harness at least 12 feet longer than necessary. The split loom was removed to make sure the wiring was intact without splices or damage before continuing. Tiffin used the best wiring and insulation for this project as a result I decided not to remove the excess wiring which had been my initial plan, a plan which would have resulted in splicing the wiring.

After checking the step mechanism, magnetic reed switch, and wiring the ONLY problem found was the method of making the ground. Tiffin installed a steel bolt with one galvanized washer in an oversized hole, the reed switch and step mechanism grounds were both connected to this bolt. That might have been okay **IF** Tiffin had taken the time to clean the paint and primer from the step's steel assembly before making the ground connection.

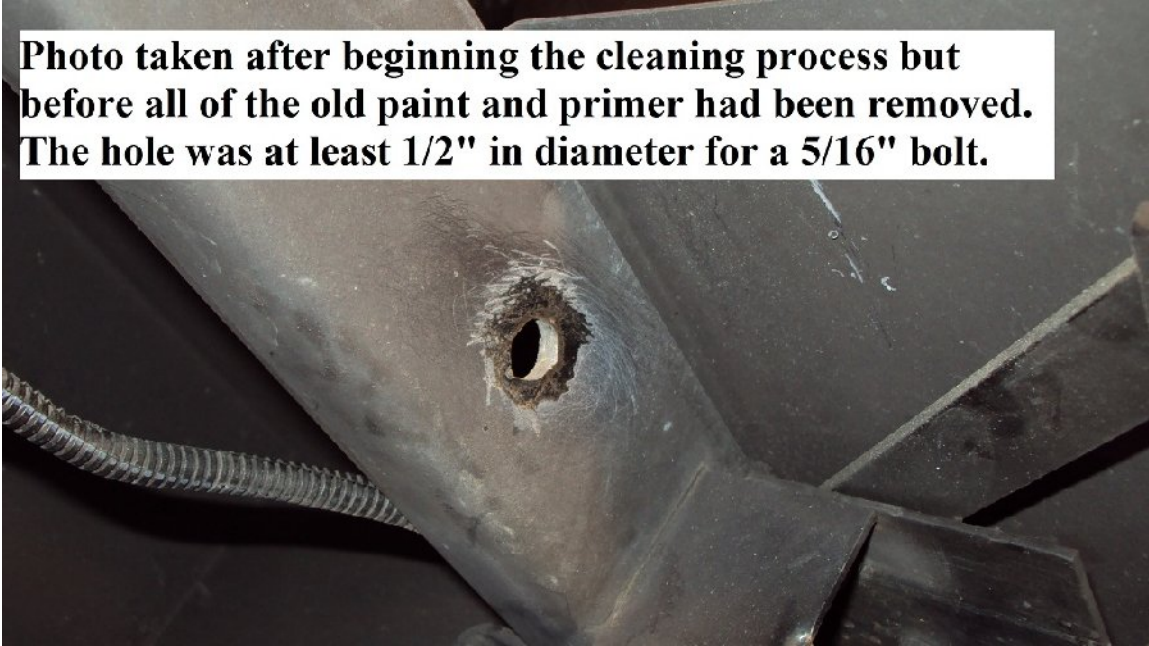
Photo taken after beginning the cleaning process but before all of the old paint and primer had been removed. The hole was at least 1/2" in diameter for a 5/16" bolt.

After removing the old ground hardware the steel around the ground connection was cleaned of all paint and primer before the metal was sanded in order to provide a clean surface for the new ground connection.

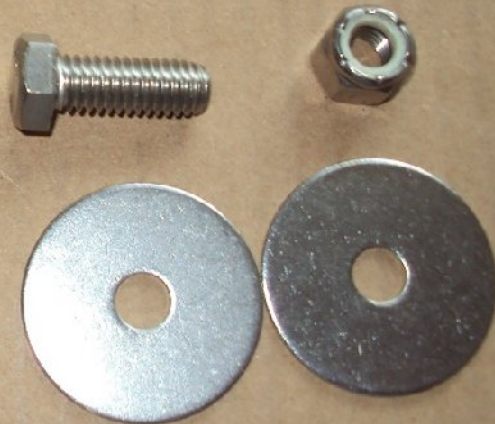
New Stainless Steel fender washers, bolt and nylock nut for grounding the RV steps

At this point a decision was made to install stainless steel hardware to prevent any future corrosion or rust causing a grounding problem.

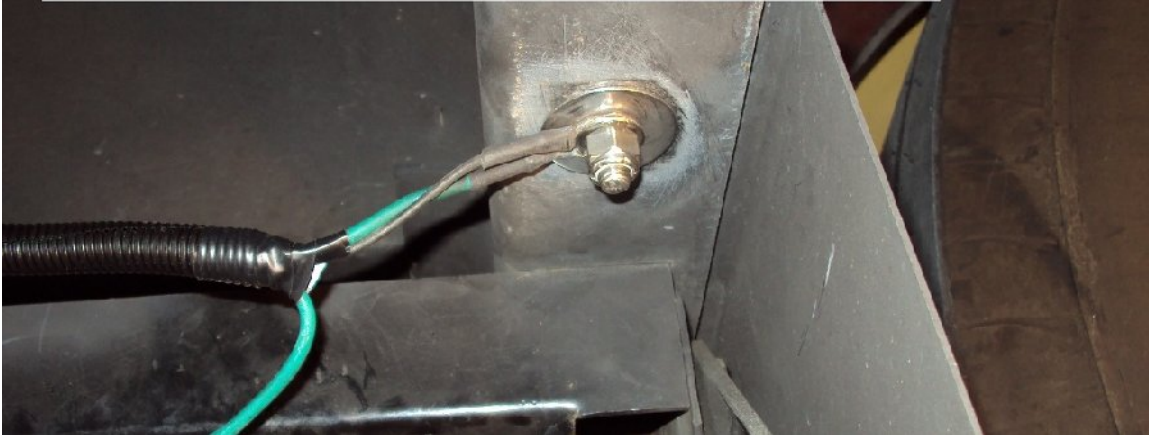
Old ground hardware removed, paint and primer removed from the RV steps steel structure then new stainless steel hardware installed

As you see in the above photo the new ground connection has clean steel under the washers. After the hardware was installed and tightened the hardware was sprayed top and bottom with a coat of Battery Terminal Protector to prevent road salts or rust from reducing the effectiveness of the NEW ground connection.

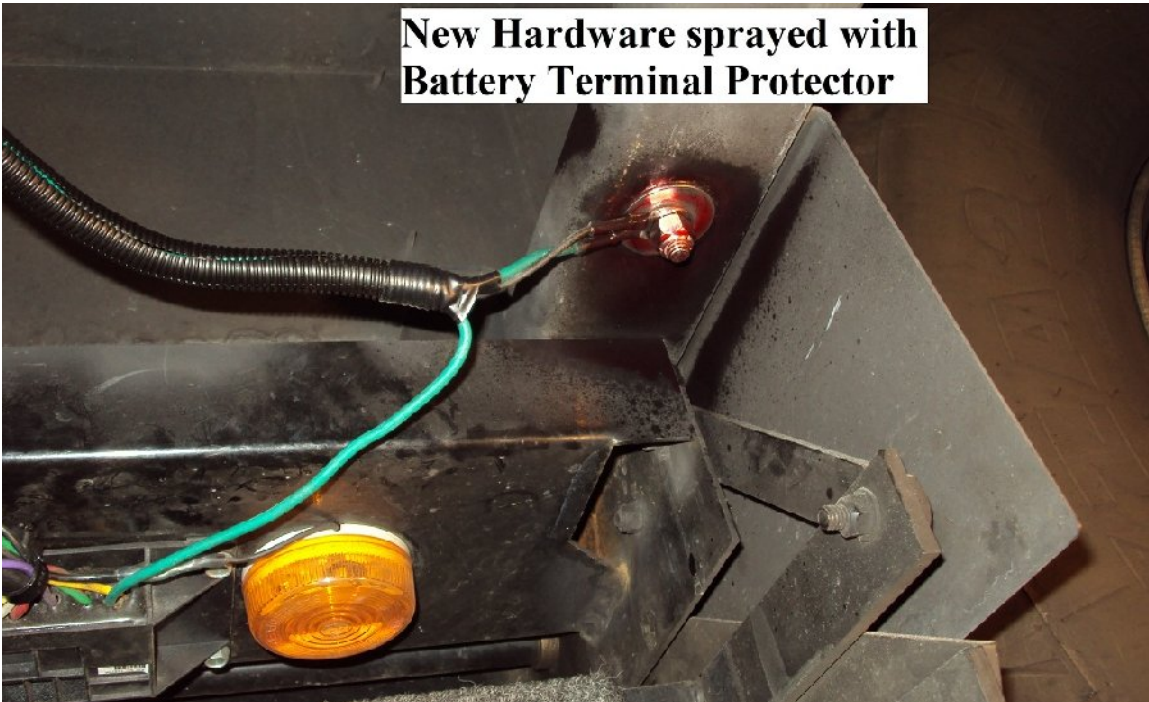
New Hardware sprayed with Battery Terminal Protector
