2010 43QGP Allegro Bus

62 – FYI – POWERGLIDE WELDED SUPPORT BRACE. Our 2010 Powerglide chassis has a welded support brace located near the rear of the engine on the driver side. When we purchased the coach the weld was broken on the left end of the brace, since that time Tiffin has re-welded the brace twice once on the right end and a second time on the left end, as of today the weld has broken for the fourth time. I decided it was time for me to make a modification to this brace which should stand the test of time.

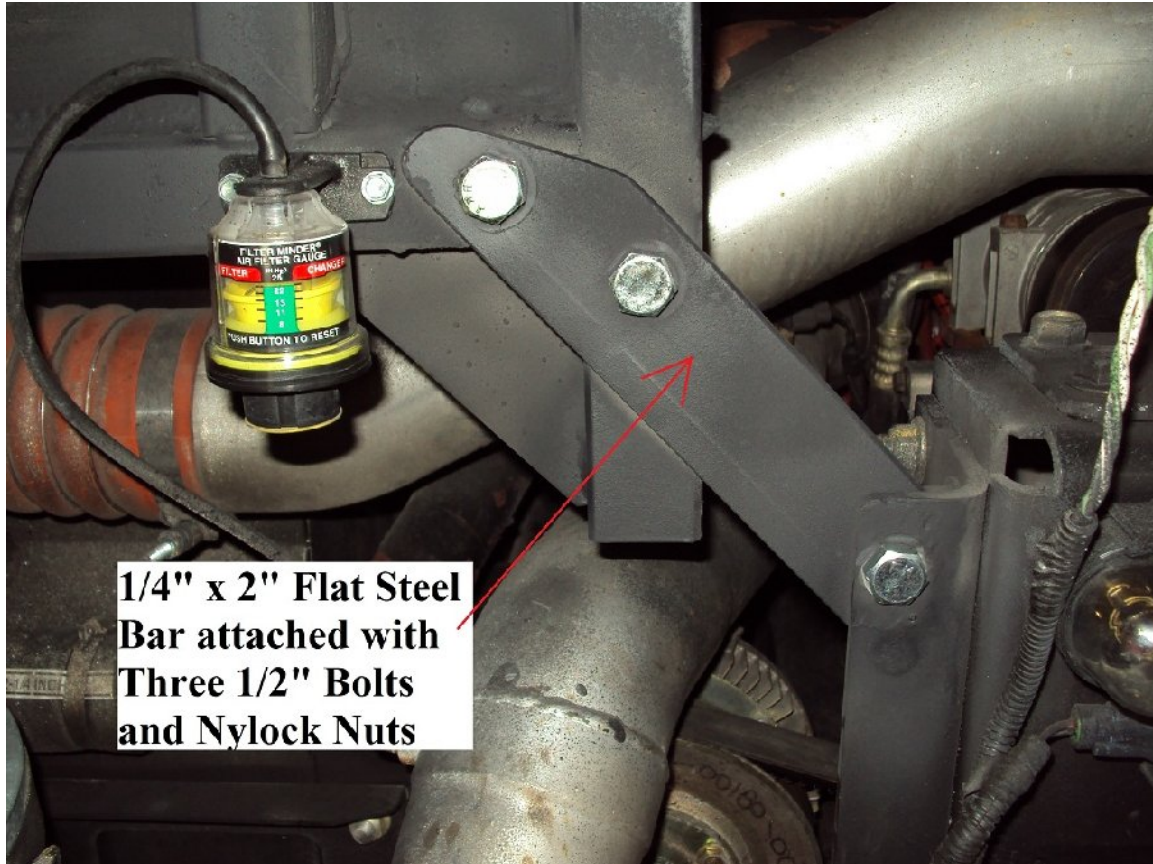
**1/4" x 2" Flat Steel
Bar attached with
Three 1/2" Bolts
and Nylock Nuts**

Removed the existing metal angle using an angle grinder, cleaned the metal surface to remove the welded material from the adjacent box steel and steel angle. Two 1/2" holes were drilled for installing bolts thru two locations on the box steel a third 1/2" hole was drilled in the coolant reservoir side brace. A piece of 1/4" thick by 2" wide steel flat bar was used to bridge the gap where the Tiffin installed support brace had been welded.

The above modification should stand the test of time.
Looked at the 2013 Powerglide chassis' last week, Tiffin is continuing to weld the coolant reservoir side brace's as they did on our 2010 coach.
