## 2010 43QGP Allegro Bus

11/20/2012

**63 – FYI – NEW FIBERGLASS ROOFTOP CRACKS.** Well our coach made eight months between having the fiberglass roof radius rails replaced before the fiberglass developed more cracks. The top of our coach is usually checked on a weekly basis so if the cracks were there last week I did not notice them and I was looking for them.

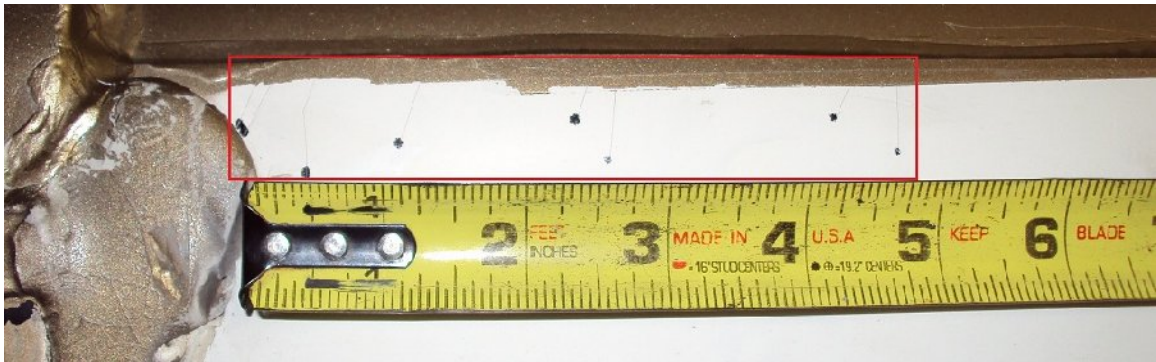
Driver Side Rear 1,

We believe those wooden wedges started the damage to our roof, or started the gel coat cracks which the change in weather has caused to deepen and lengthen. The cracks are **ALL** near one of the following, the Front Cap (DS – 1 crack) (PS – 11 cracks), Rear Cap (DS – 8 cracks) (PS – 3 cracks) Vent stack (DS – 4 cracks) Awning Attachment Cover (PS – 1 crack).

What is obvious in almost every photograph? Almost ALL of the cracks are near the caps (front and rear), vent stack or the awning cover, the same places where the most wedges were driven to allow Victor and George more room to slide the new aluminum radius under the fiberglass caps. In order to maneuver both ends of the metal under the front and rear caps, the metal was first pushed in one direction twice the distance needed, this allows the opposite end of the metal to be pushed under the opposite ends cap. After both ends are under the caps the whole piece of metal is driven back to center the new metal radius under the front and rear caps.
