## 2010 43QGP Allegro Bus

### 74 – FYI – REPLACING TEFLON BLOCK ON BEDROOM SLIDE.

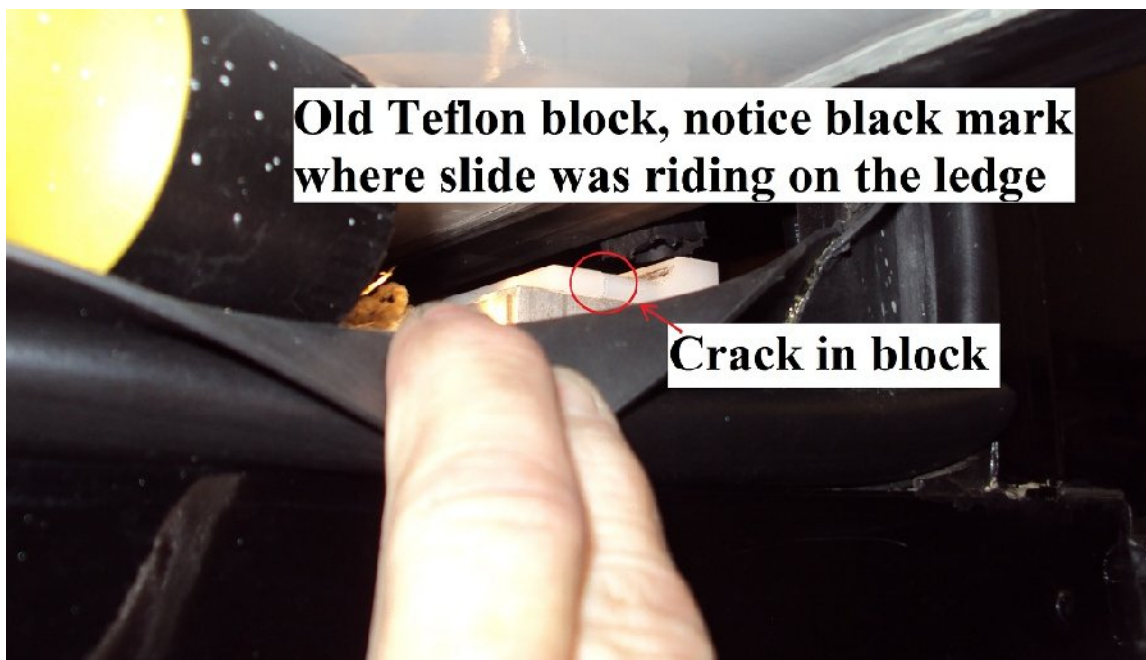
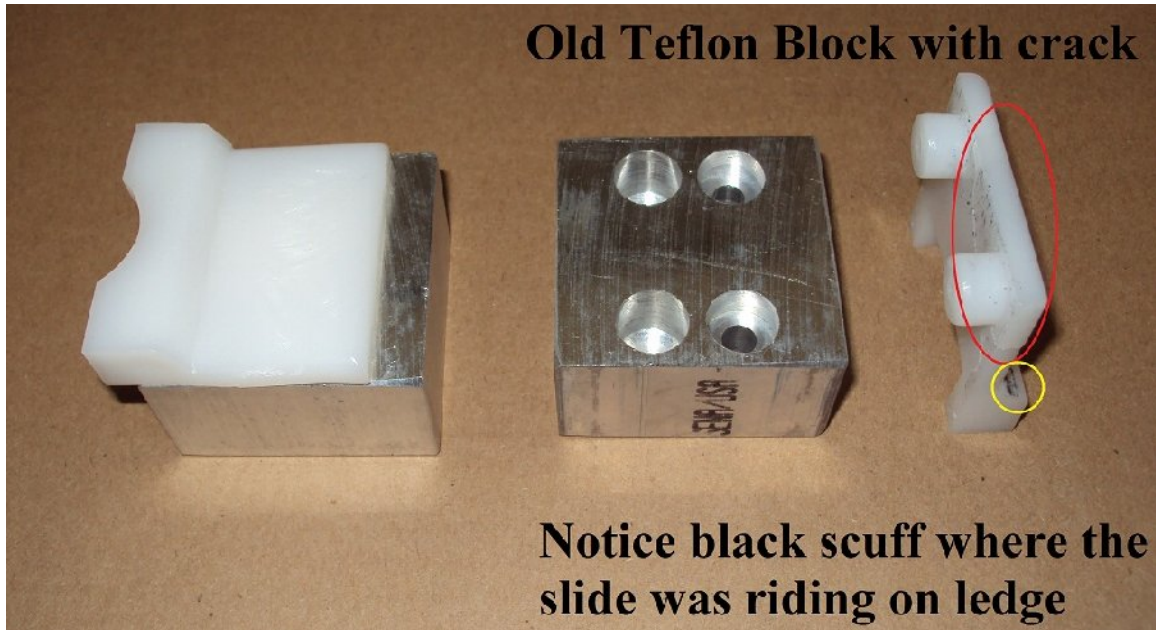
While spending leisure time in Red Bay last year I noticed both of the Teflon blocks on the passenger side bedroom slide were cracked. The problem was brought to the attention of Terry and Tony our techs in bay 33. During construction the aluminum blocks are permanently installed for two purposes, one to keep the slide centered, two to allow the slide to slip over the blocks Teflon insert. The problem with our blocks they were installed almost a ½ inch too close together. The Teflon blocks have a flat slide portion for the slide to slip over and at the same time have a beveled edge to an outside ledge to keep the slide centered as it is extended and retracted. With the blocks installed too close together the weight of the bedroom slide was being supported on the small ledge rather than on the wider portion of the two Teflon blocks. Over time the Teflon ledge on both blocks had broken. Terry and Tony moved the rear most aluminum block a ½ inch to increase the spacing between the two blocks. A couple of days ago I found one of those Teflon blocks had cracked. As this current problem was a previous Tiffin repair Tiffin was e-mailed stating the problem and information on last year's repair. Today a package was received from Tiffin containing the new Teflon blocks which will be used to replace the broken block.

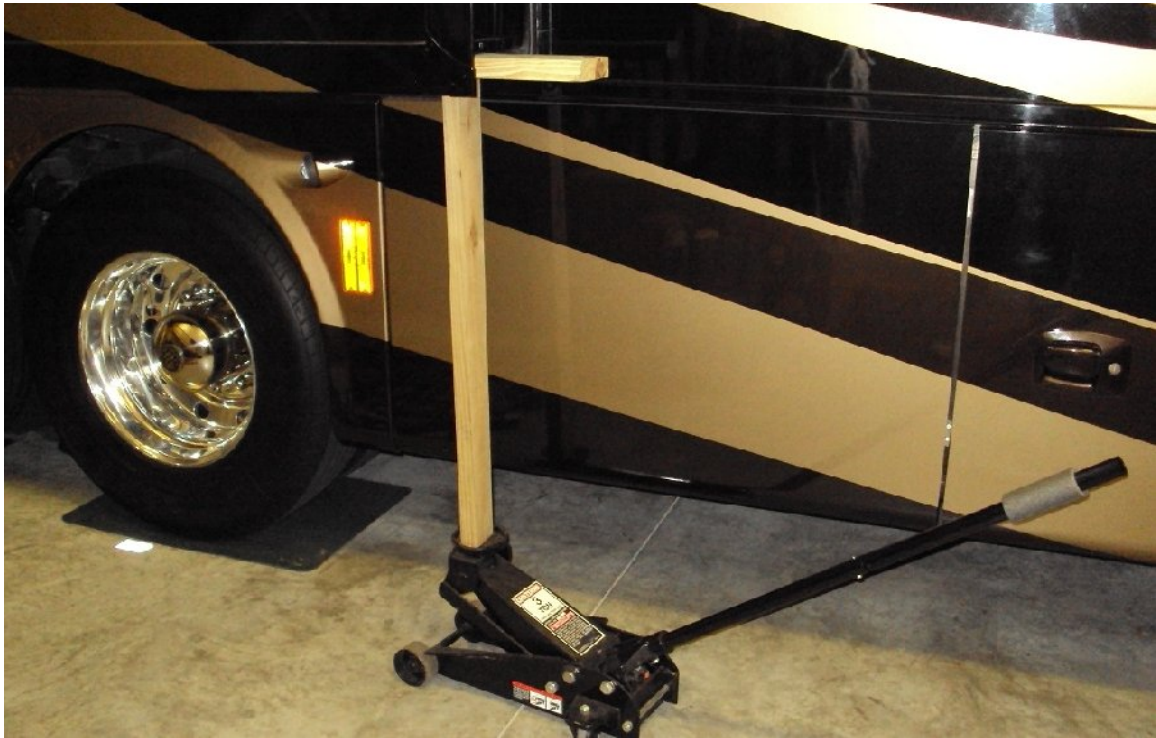
After inserting the block it's just a matter of slowly lowering the jack while making sure the slide is centered between the outside ledges on the Teflon blocks before completely lowering the slide. Based on the black scuff on the broken block there may be a need to move this aluminum block to the right another  $\frac{1}{4}$  inch, to prevent damaging another Teflon block, time will tell.

Replacing the broken block does not require many tools or a lot of effort. Two boards and a jack were used to lift the slide a couple of inches allowing the Teflon block to be removed and the new Teflon block to be inserted.
