2010 43QGP Allegro Bus

8/10/2013

92 - FYI – DRIVER'S SIDE SLIDE GASKET. A little over one year into ownership our coach driver's side slide gasket was pulling loose at the top of the slide, the metal teeth had rusted, than broken releasing the gaskets grip on the trim. Fortunately at that time we were already in Red Bay for other warranty repairs, so the gasket was replaced with a new gasket this one with a longer sweep as the original gasket sweep was not touching the top of the slide. Now we roll forward almost another two years to find the same problem occurring for the second time.

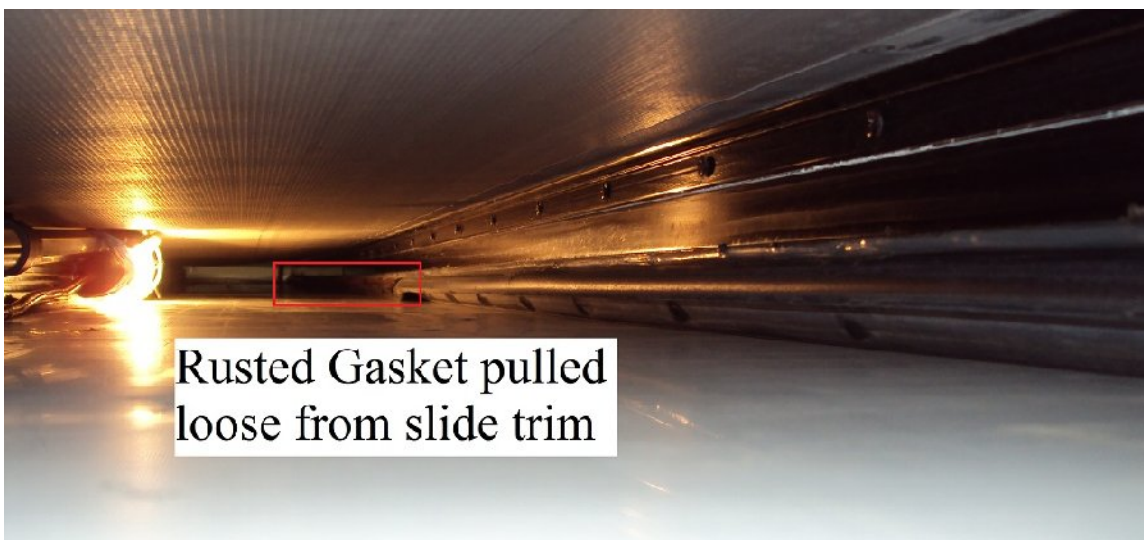
As seen in the above photo the metal teeth in the second slide gasket did no better than the original slide gasket.

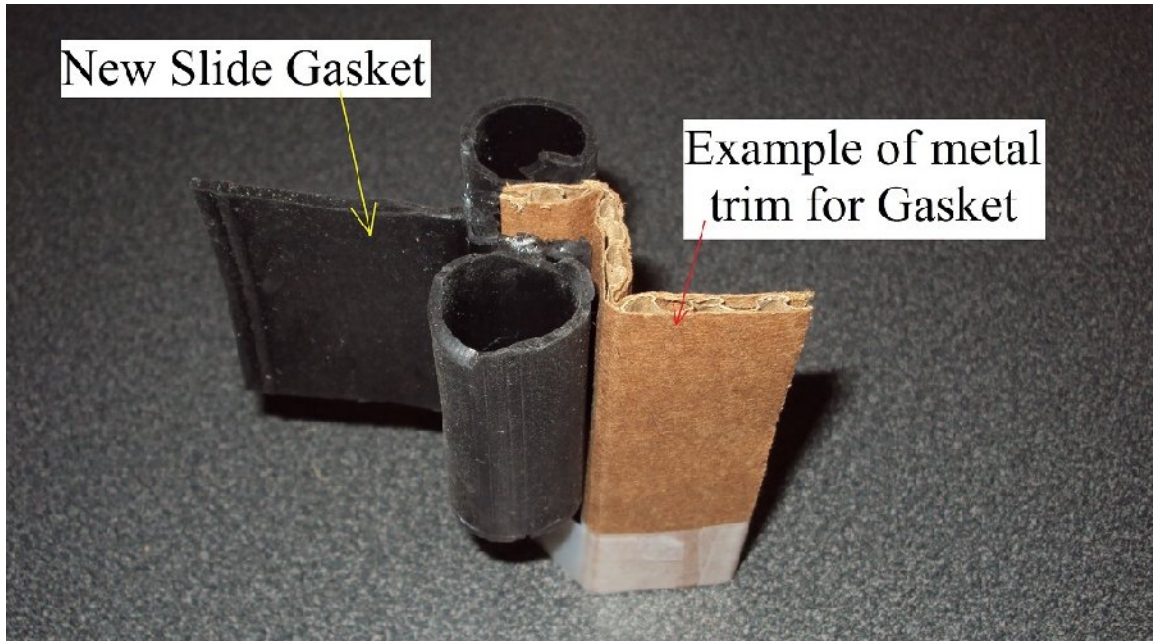
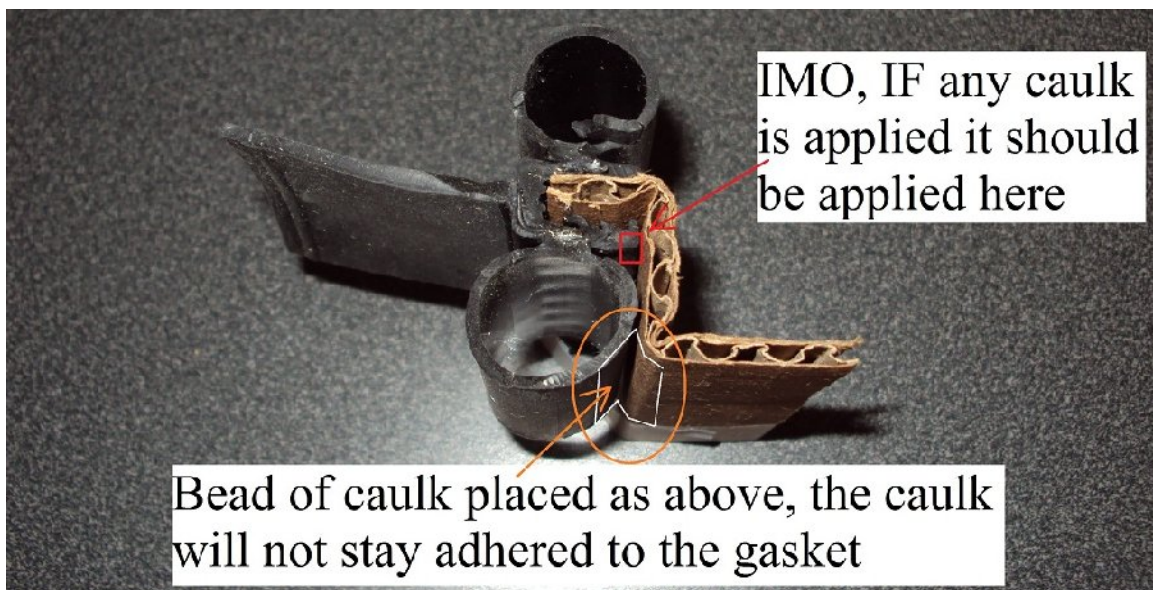
The below photo is an example I put together to better explain the new gasket and its mounting. For ease of explanation a piece of cardboard was used in place of the metal trim mounted to the coach sidewall around three sides of the slide opening. The new gasket has two places where the gaskets metal is exposed those places are at each end of the gasket as the metal is fully enclosed at all other points.

The dealer's workers installed silicone caulk inside the white area in the above photo the gasket material does not allow bonding between the caulk and gasket to occur. When the gasket was depressed or flexed the caulk

pulled away from the gasket. Where the caulk was smeared over the brown paint the caulk bonded really well requiring four hours to remove the caulk from the metal trim and the gasket.

IMO, the new fully encapsulated metal grip in the new gasket DOES NOT REQUIRE caulking to prevent the metal teeth from rusting.

IF caulking is desired I suggest it be installed where the red box is show in the above photo and where the white box is shown in the below photo, both locations are the same, I just pulled the bubble back to better show where to apply the caulk in the below photo. Again I do not believe it is necessary to caulk the gasket as it is messy and hard to work with.

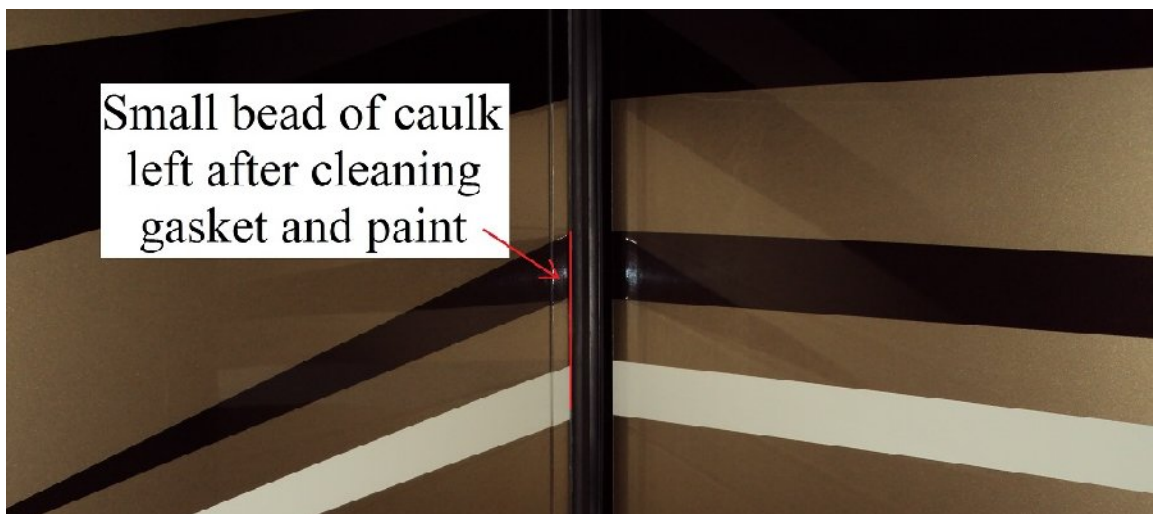
After cleaning up the dealers mess on the new gasket and sidewall trim a small bead of caulking was left in place.
