2010 43QGP Allegro Bus

111 - FYI – REPAIRING THE DRIVER’S FRONT SLIDE RETRACT STOP BOLT.

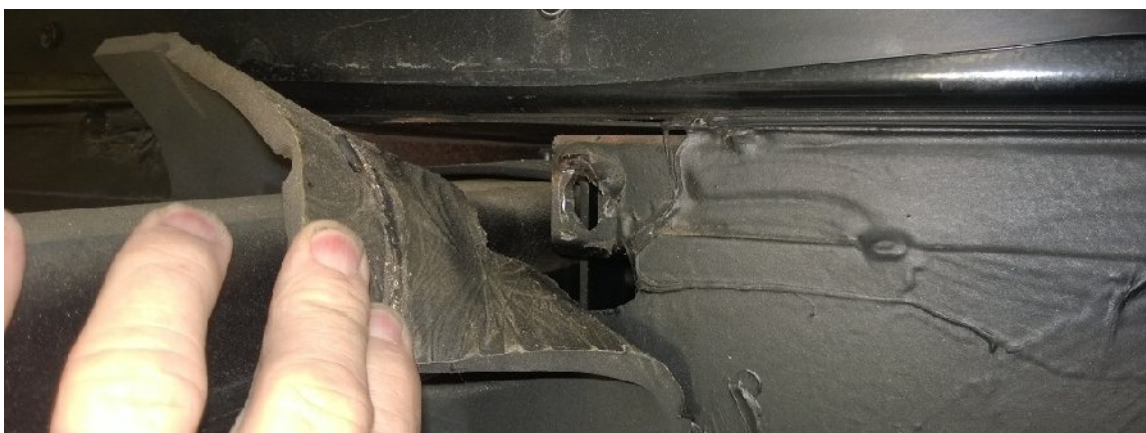
I found that bolt, one nut and part of the tack welded nut lying on the ledge under the slide mechanism.

As you can see in the above photo, the nut tack welded to the slide frame fractured allowing the bolt and one nut to fall out of the hole, finally resting on the ledge under the slide mechanism.

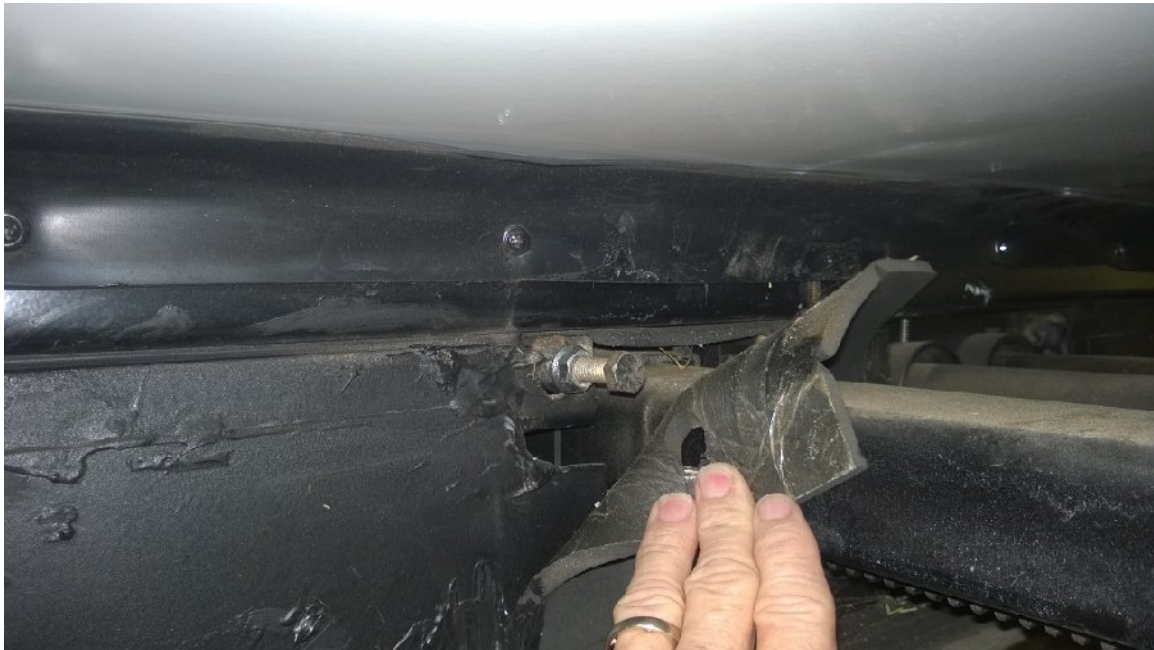
The following photo shows the aft D/S Slide Retract Stop Bolt as it came from the factory.
