## 2010 43QGP Allegro Bus

2/4//2015

**118 - FYI – OTD AWNING MOTOR SHAFT REPAIR.** While putting the finishing touches on the installation of the OTD (Over The Door) awning LED lighting project, I experienced a near and close encounter with the OTD awning motor shaft breaking, when that happens the awning explosively deploys. If I had been in front of the awning rather than to the side I would have been HIT by the awning cover when the shaft broke and possibly knocked off the ladder onto the concrete floor. During 35 years of construction I've been on a ladder one second and on the floor the next second, TWICE.

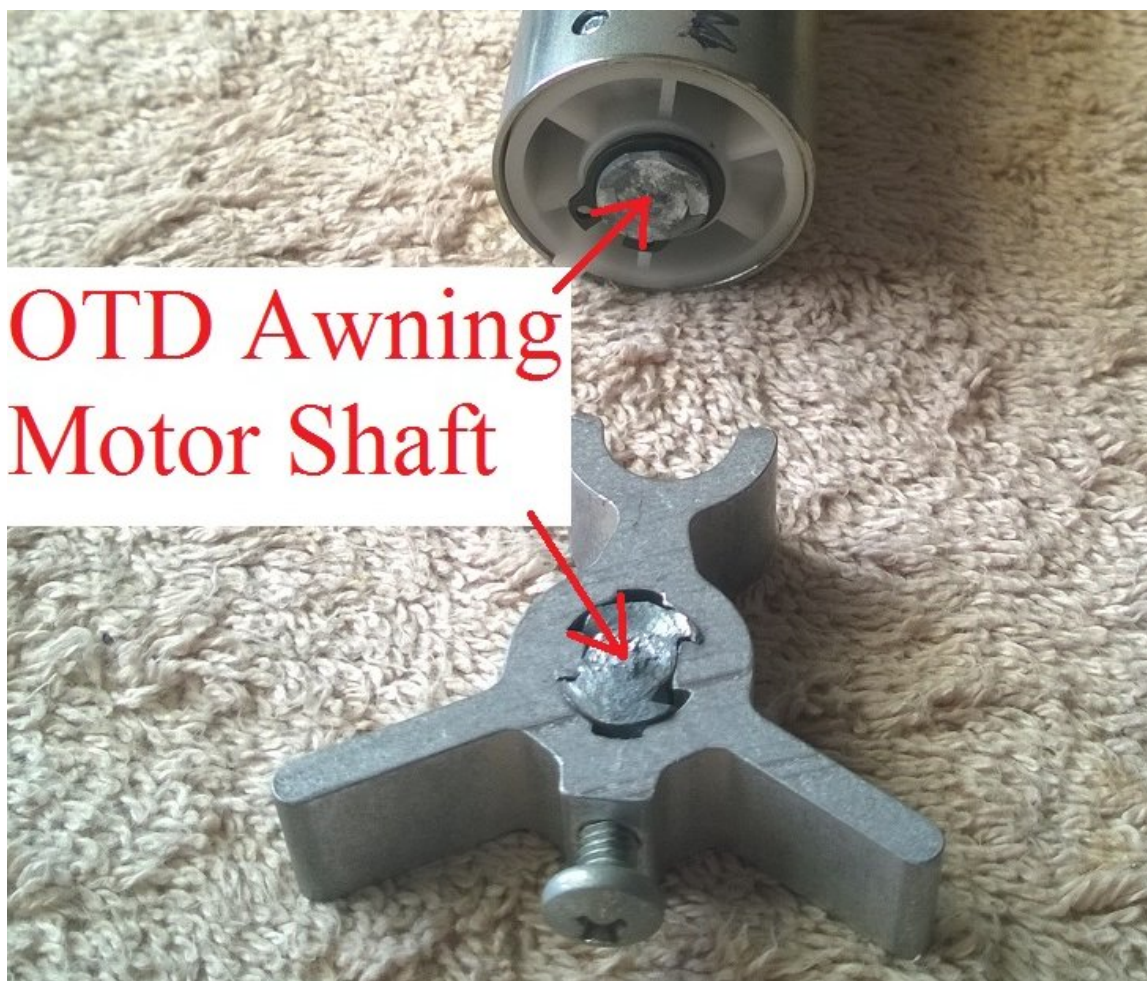
As seen below the awning shaft was wrung in half, IMO, this is another Tiffin failure to properly adjust the awning open and close stop settings.

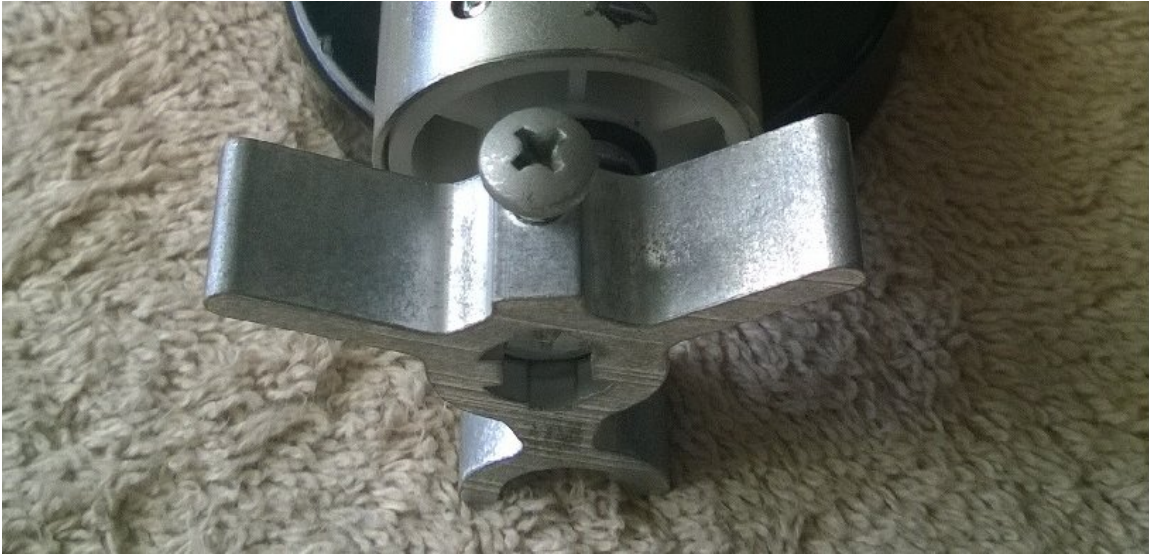
The below photo shows the way the motor shaft looks when it is not damaged. The Philips head set screw keeps the Jumping Jack in place, my term for the aluminum figure which appears to be a Jumping Jack with a Phillips screw head.

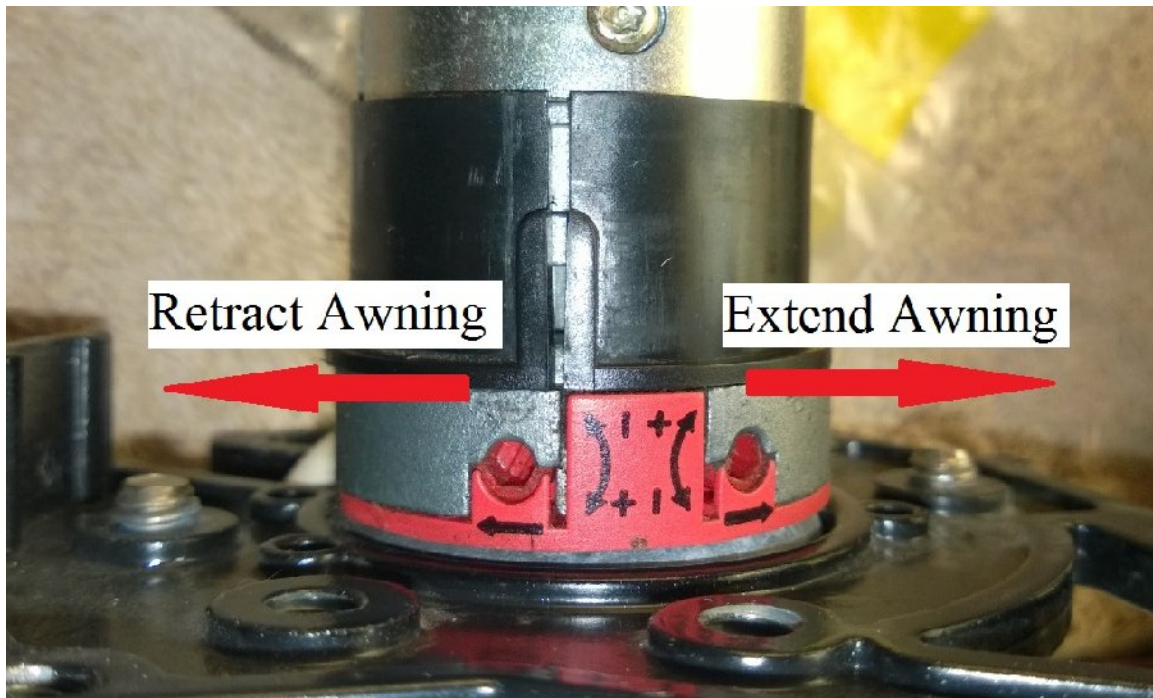
Now on to the part of this file that make me very unhappy with SOME Tiffin's employees. The awning motor STOP limits can be adjusted to prevent this type of damage from occurring.

Part of this is my fault I should have known Tiffin did not properly set the motor STOP LIMITS after the same thing occurred to our 2007 Phaeton's OTD awning motor.

After the repair the **RETRACT** awning **STOP** setting required turning **SEVEN FULL REVOLUTIONS** in the – direction before the motor would **STOP** where it needed to **STOP** without being stalled to a **STOP**. Each time the awning motor retracted and **STALLED** to a **STOP** contributed toward the wringing apart of the awning motor shaft.

While on the ladder I decided to adjust the **EXTEND** motor **STOP** setting because the awning fabric would unwind too far when the awning **EXTENDED** to Tiffin's set awning motor **STOP** point. To properly set the **EXTEND STOP** point required turning the set screw **THREE FULL REVOLUTIONS** in the – direction.
