## 2010 43QGP Allegro Bus

## 8/24/2015

## 124 - FYI – REMOVAL OF ALUMINAM FOIL LINER INSIDE THE SUPPLY CHAMBER OF THE COLEMAN AC/HP UNIT. After four plus years the rear unit began shredding small pieces of thin aluminum foil. We were 10 weeks into our 13.5 week trip so the unit was turned off until repairs could be made when we returned home. The photo below shows the foil torn in half and loose inside the supply side of the rear unit.

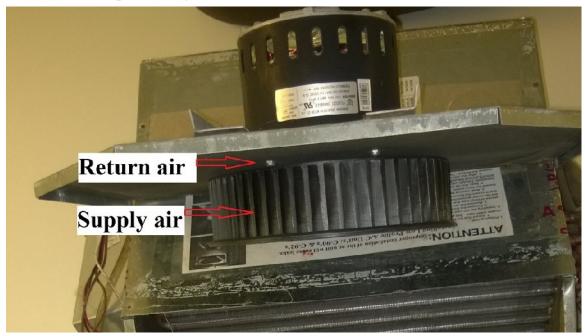
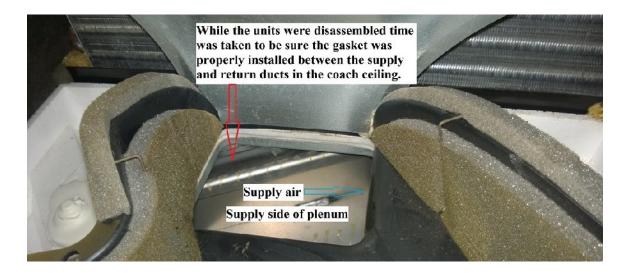
Below is the squirrel cage blower used to circulate air flow inside the coach.

apart the fan blades were all there were no cracks or signs

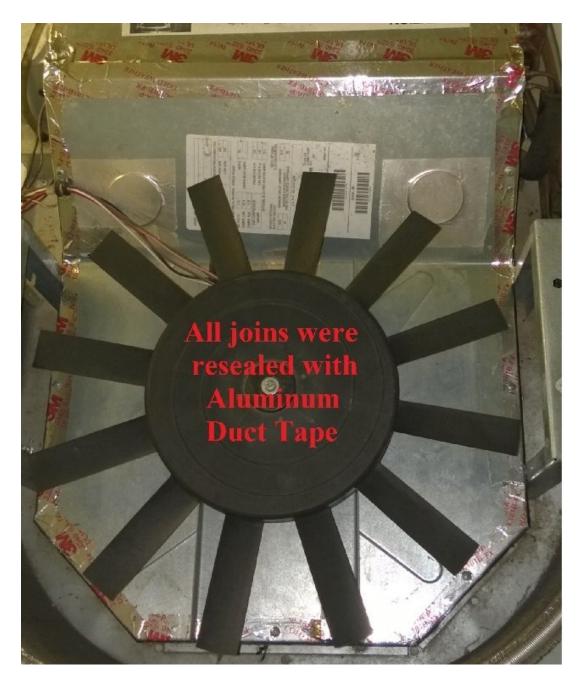
Each AC/HP plenum is ceiling foam, separated air chambers, the left **RETURN** duct running coach while the right **SUPPLY** duct running the coach.

installed inside the coaches diagonally to provide two chamber shown in **pink** is the on the driver's side of the chamber shown in **blue** is the down the passenger side of
