2010 43QGP Allegro Bus

125 - FYI – REPLACED THE ENGINE ALTERNATOR FOR THE SECOND TIME.

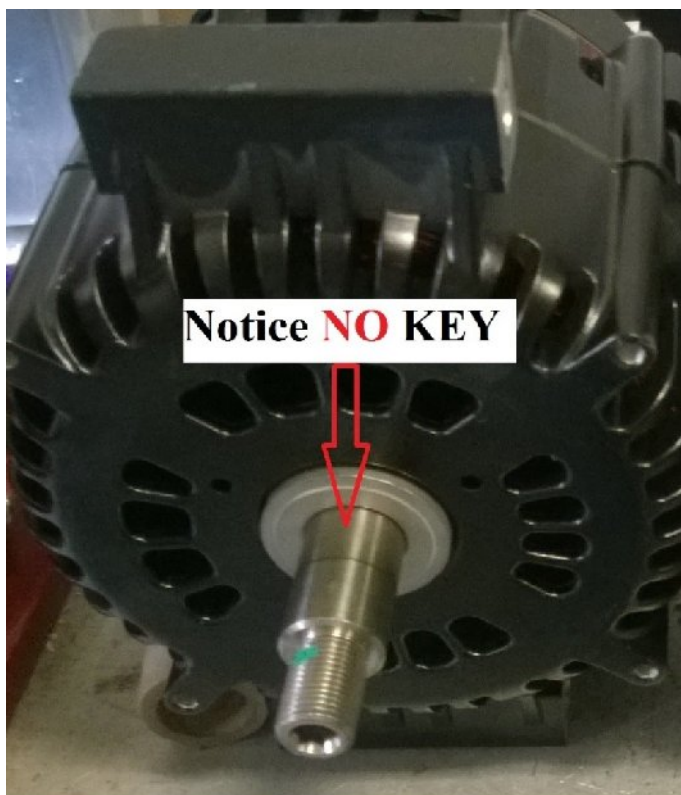
The standard 170 amp alternator Tiffin was installing in the Allegro Bus until mid-year 2014 is shown to the left, notice the key in the shaft's keyway. The new 210 amp alternator DOES NOT have a key or keyway in the shaft.

there was no keyway and no taper to the shaft. I was told he would check and call me back. A few minutes later Nathan did call back with the message the Powerglide production manager told him Tiffin was installing the alternator without any keyway, just to make sure the nut is tight on the shaft.

The shaft on the new alternator has a hex key 8MM slot to hold the shaft while tightening the nut. After my conversation an executive decision was made to use the same impact driver to install the 15/16" nut as was used to remove the nut from the old alternator. While holding the pulley in one hand the impact driver was held in the other hand to tighten the nut. Using this method the pulley is squeezed against a

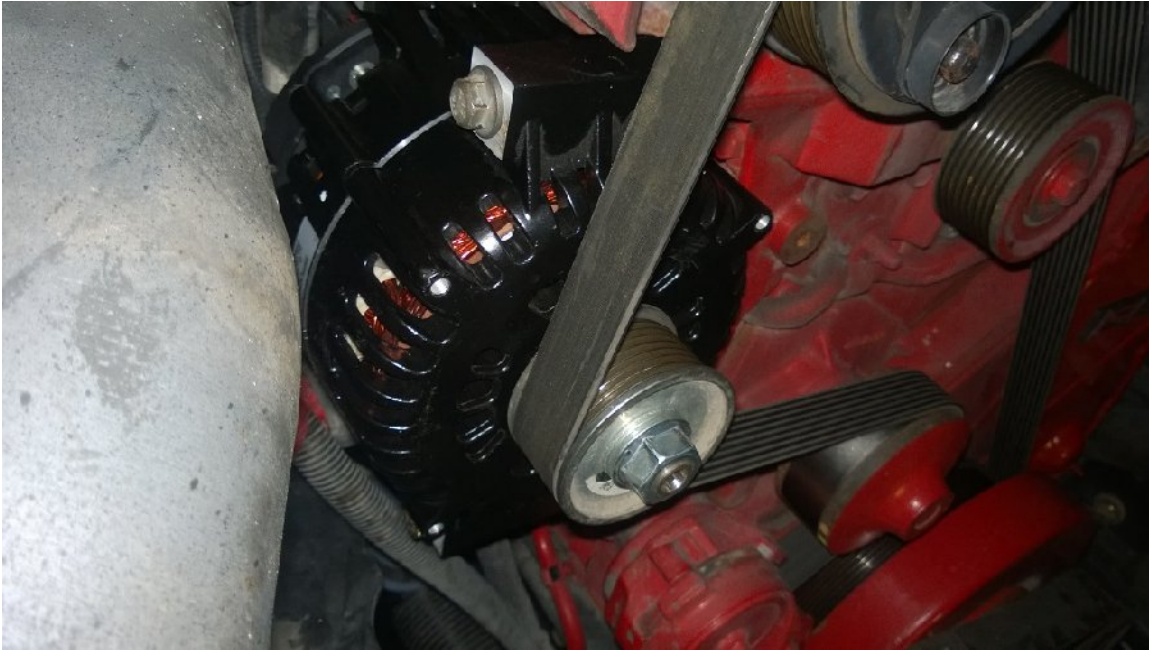
collar on the shaft by the torque applied to the nut using the impact driver. As shown below the tension on the pulley nut is the reason the alternator is able to supply charging voltage to the chassis batteries and the house batteries thru the Waytek Auxiliary battery Switch (ABS-200) which was installed to replace the White Rodgers "Charging Solenoid" on our coach.

Today 9/8/2015, just received a return e-mail from Gary Harris. I had sent an e-mail to him over the weekend asking about the keyway. His response was most heavy equipment alternators do not have a keyway on the shaft instead the nut is torqued in this case to 102 N-m or 75 Ft. Lbs. based two pages of Alternator specifications attachments to his e-mail reply.
