## 2010 43QGP Allegro Bus

**128 - FYI – DREADED CUMMINS WARRANTY SERVICE.** After being on the road for 8 weeks we were driving thru Louisville in construction traffic and torrential rain, when we heard a BING from the dash instrumentation and an Amber “Check Engine Light” was illuminated. At that point we were in construction traffic as we were driving between two parallel lines of New Jersey concrete barriers with NO place to pull over. Over the next few minutes the “Check Engine Light” would go out only to come back on a little while later with the BING. Finally able to pull off the road, the fault code was checked which turned out to be **SPN 3361, FMI 5**, The code told me there is a problem in the DEF system. The following is a Quote from the manual.

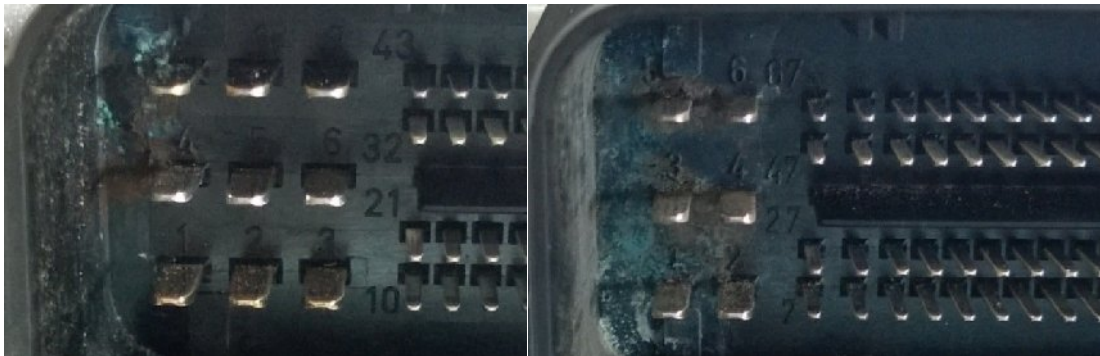
10:00 AM, two hours after speaking to the tech I took the following photos.

It was obvious to me SEVEN of the larger pins had either rust and/or corrosion on them. Cummins spent the rest of the day looking for and purchasing a pin removal tool because the shop did not have the tool. I made a point of telling them if they could not work on the problem there was no point in the coach sitting in the bay with the meter running. They

10:45, with the pin removal tool in hand the coach was moved into a bay to begin working on removing the rusted and corroded pins.

12:30, Lunch over I asked the tech what was the status, he replied he was making good progress with removing the seven (7) corroded pins.

13:15, Tech came into customer lounge to tell us the DEF repairs had been completed. After testing, no fault codes were found, the DEF pump was delivering pressure over 100 PSI, the coach was parked outside ready to be test driven.

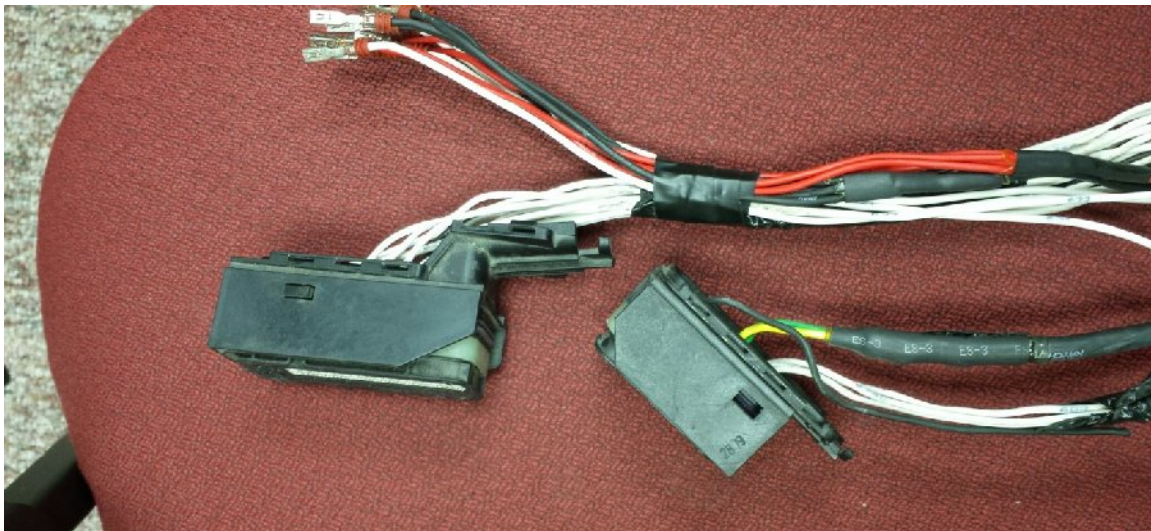
While on the phone with Gary Harris, Gary e-mailed photos of the four connectors to James and to my phone. We chose two connectors to be shipped by UPS next day air, they are shown below. Gary Harris explained the tech needed to be aggressive when pulling on the wire with the pin extraction tool in place. Gary pointed out he had extracted the pins from the harness shown in the photo below.

A conference call was made to Gary Harris, everyone was listening and involved in the discussion. Gary stated he could over-night a couple of DEF controller pigtails that had been salvaged from two damaged chassis harnesses. That would supply both a 53 pin and 86 pin connector and pigtail wires for Cummins to use if needed.

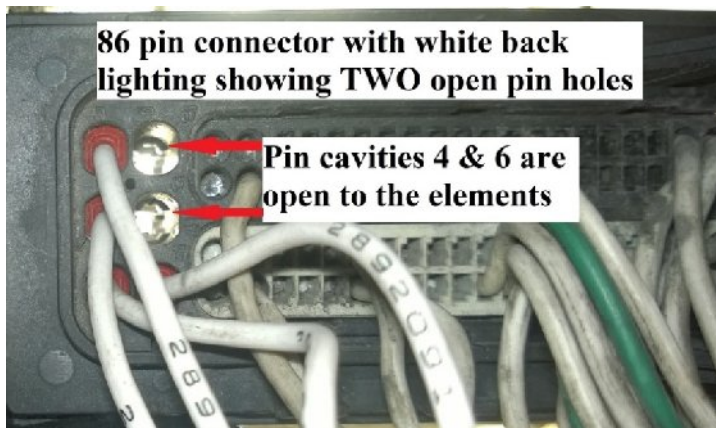
The photo on the left shows two **UNSEALED** pin cavities, this connector was mounted on the right side of the controller with the larger pins to the bottom, any moisture or water entering the connector will affect the voltage and ground pins preventing proper operation of the DEF system.

moisture from entering the connectors. After purchasing cavity plugs from a local truck dealer the open wire cavities were plugged.

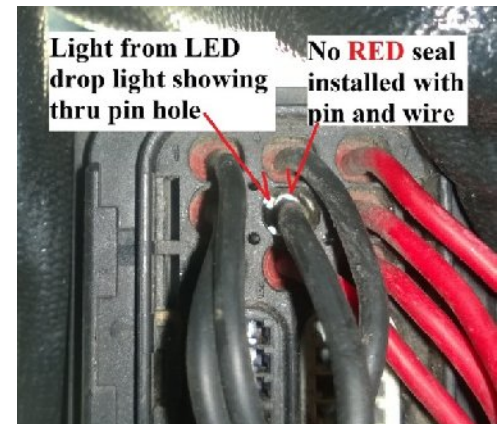
The photo to the right above, while the pin is inserted in the hole the **RED** cavity wire seal is missing. With a shop light back lighting the connector light shines thru any connectors where the cavity seal is missing.

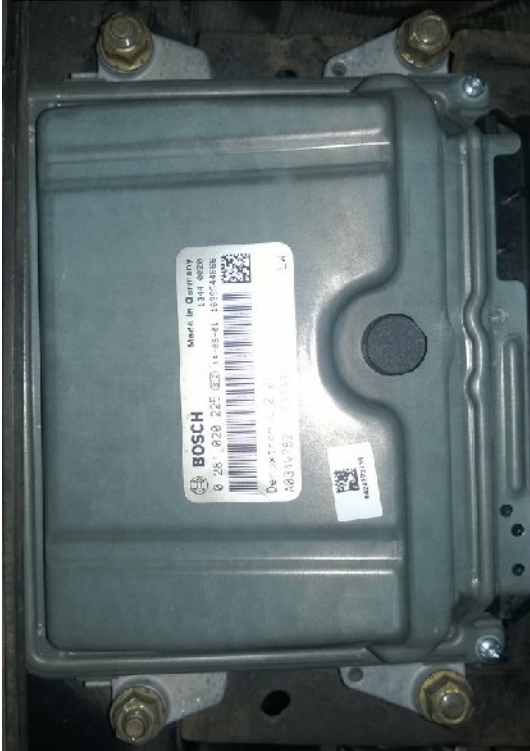
When voltage is affected, the pump does not operate as designed. When the tech installed the new DEF controller he mounted the controller tilted slightly counterclockwise, with a counterclockwise tilt water getting in thru

New controller mounted with connectors tilted to the left which allowed water to enter the open pin holes and remain inside the connector

the open pin holes ran into the lower portion of both connectors where the voltage, ground and pump control pins are located.

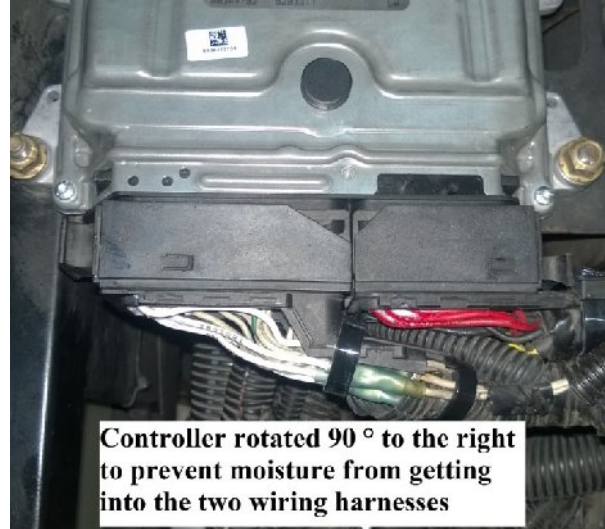
Controller rotated 90 ° to the right to prevent moisture from getting into the two wiring harnesses

As seen above right I remounted the DEF controller with its two connectors on the bottom of the DEF controller this position should prevent any
