## 2010 43QGP Allegro Bus

**133 - FYI – COOLANT LEVEL SENSOR.** During a recent slide open operation a “Check Engine Light” was displayed on the dash. Using dash instrumentation the fault code was checked displaying a, SPN 111 FMI 18 code.

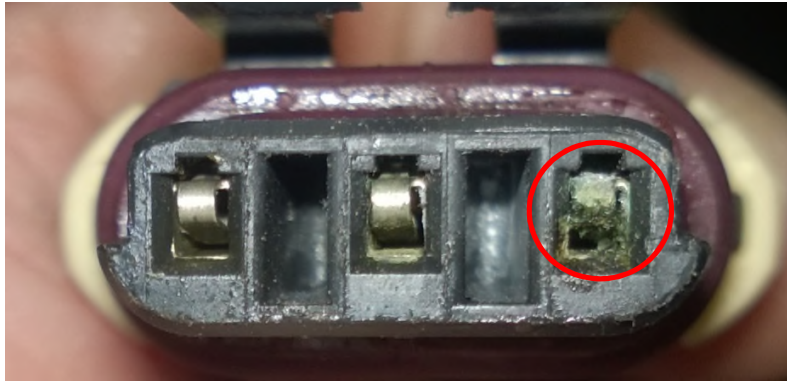
After disconnecting the coolant level sensor harness from the coolant sensor the problem was easily seen, both sensor and harness have a corroded pin. Both sensor pin and harness socket were cleaned however it was quickly apparent cleaning them would not provide a permanent solution. Nathan Davidson in the Tiffin Motorhomes Powerglide shop was contacted. Nathan provided me with the Coolant Level Sensor part number. Nathan then put me in contact with the parts department so the part could be ordered and shipped.

The sensor part number is **31643** cost of the part is \$ 55.96 with shipped adding another \$ 17.71 for a total of \$ 73.68. An additional \$ 0.01 was added to the cost, adding the penny provided a line item so Tiffin could supply me with a few socket pins and a new female harness connector to replace the damaged parts on the connector harness.

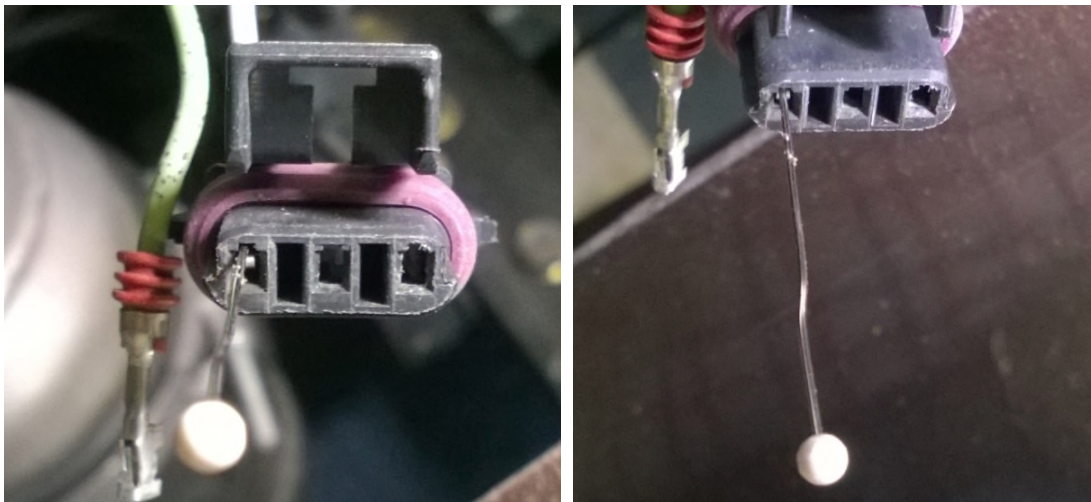
As seen above the wire with the socket was pushed **INTO** the harness from the back side then the pin was inserted above the pin on the front side where the locking tab is pushed down when the pin is inserted disabling the locking function. After the pin lock is disabled the wire along with the pin/socket was pulled out the back of the connector.

As it turned out the pins supplied with the new coolant sensor were not the exact same pins used with the OEM harness, the small difference caused a few problems until the new socket was modified by bending over one protruding tab on the new socket. When that modification was made the new socket and wire could be slid into the back of the new connector.

As shown one of the two tabs required bending over flat before the connector will allow pin insertion. The locking "T" tab prevents the pin/socket from backing out of the connector. To allow removal the wire and pin have to be pushed **into** the connector then the quilting pin is inserted above the "T" which pushes down and unlocks the tab allowing the pin/socket to be removed from the back side of connector. The wiring seals were damaged during pin replacement, since I did not have new wiring seals silicone
