2010 43QGP Allegro Bus

2/15/2011

THIRD coach modification was to **ELIMINATE ANY SAGGING OF THE TANK BAY FLOOR**. Our coach was assembled in late January 2010, **BEFORE** Tiffin admitted to having a tank flooring problem there for our tank bay floor had been built the same way as everyone else's except maybe the 2011 model year coaches.

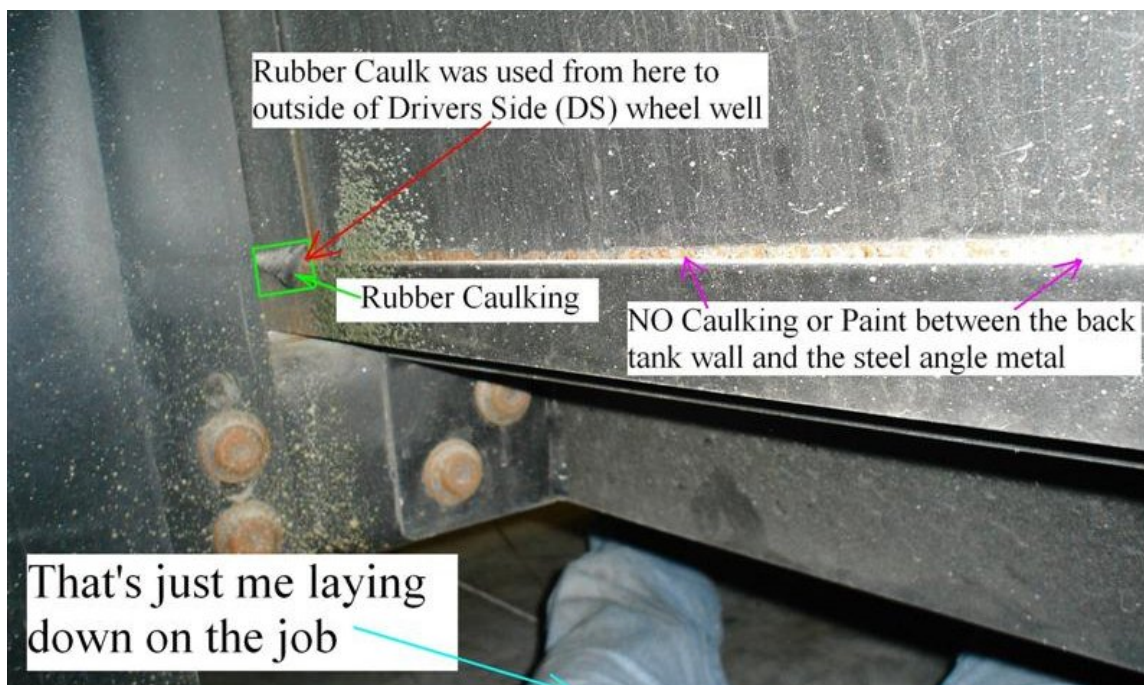
After climbing under the coach and checking ALL of the problem areas I had found under our previous 2007 Phaeton, it looks to me like Tiffin had tried to eliminate at least a couple of the previous floor issues. The forward part of both rear wheel wells where the rear tank bay wall is located had been sealed at the angle with a rubber caulking. However the portion of the rear tank bay wall **BETWEEN** both wheel wells did not have any caulking.

In hopes of eliminating any possible damage to the tank bay floor as a result of water from the roadway being allowed to seep between the rear tank bay wall and the metal angle I removed all of the under coat overspray, rust and any other debris in the seam prior to sealing the seam with a 50 year paintable silicone caulk. After the caulk had dried I painted over the caulk. Tiffin had also modified how they mounted the forward portion of the wheel

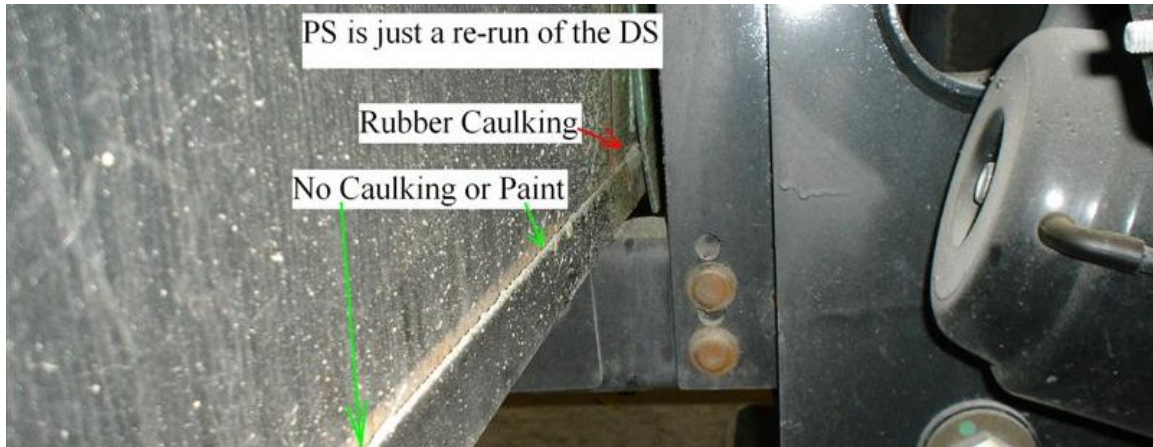
well plastic liner on my 2010 coach the liner was extended below the floor level this along with the addition of the rubber caulk should prevent water from entering the tank bay by way of the rear tank bay wall and metal angle. Below is a picture of the same driver's side problem also on the passenger side. The wheel liner can be seen extending below the metal angle.

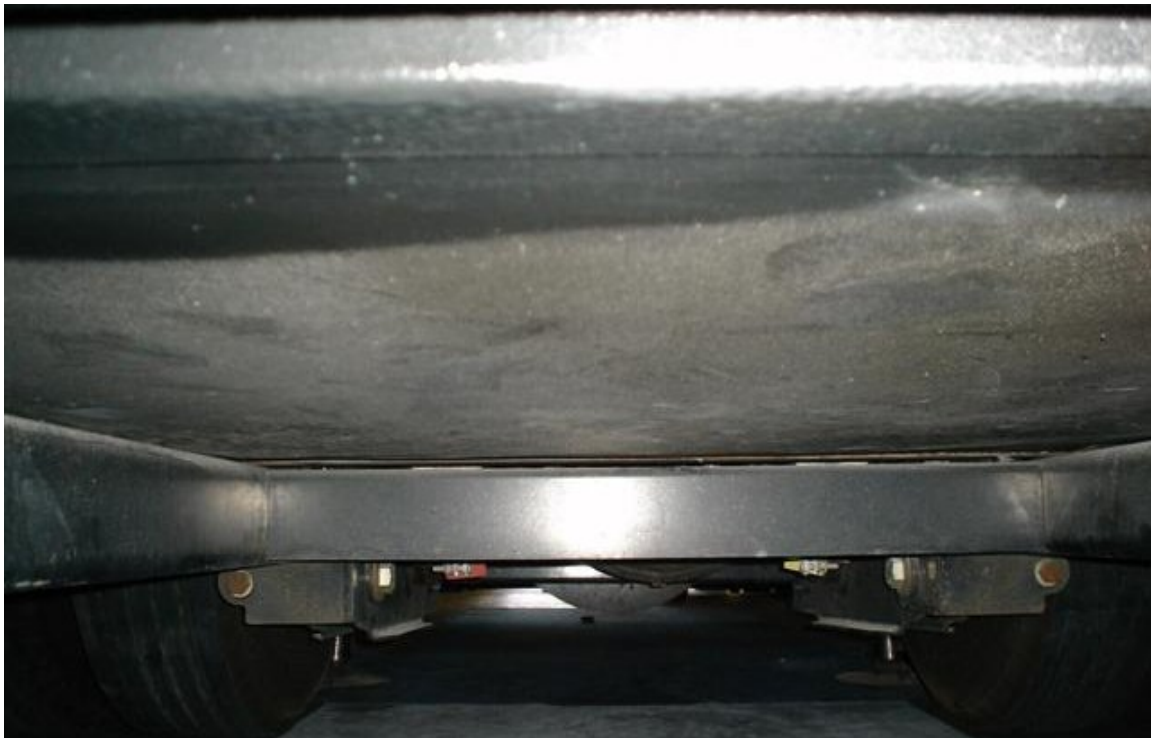
On our 2010 Powerglide chassis, Tiffin was still not installing any additional support under the tank bay floor. The perimeter of the tank bay is still using the same 1/8" by 1 1/4" steel angle metal with the only other support coming from the tank floor lying on top of both bottom chassis frame rails.
