## 2010 43QGP Allegro Bus

4/23/2011

**SEVENTEENTH - coach modification RAISING THE GENERATORS EXHAUST PIPE.** Our coach's generator exhaust pipe was mounted lower than any other component on the underside of our coach. I feared any debris on the road surface would or could damage or knock the exhaust pipe from its mounting which would cause under body damage to the coach. Soon after purchasing the coach, an exhaust manifold bolt was found missing, leaving the exhaust tail pipe with one bolt which was also loose to retain the exhaust piping to the generator. A new stainless steel bolt with lock washer was installed the loose second bolt was also removed and replaced with a second stainless steel bolt with lock washer.

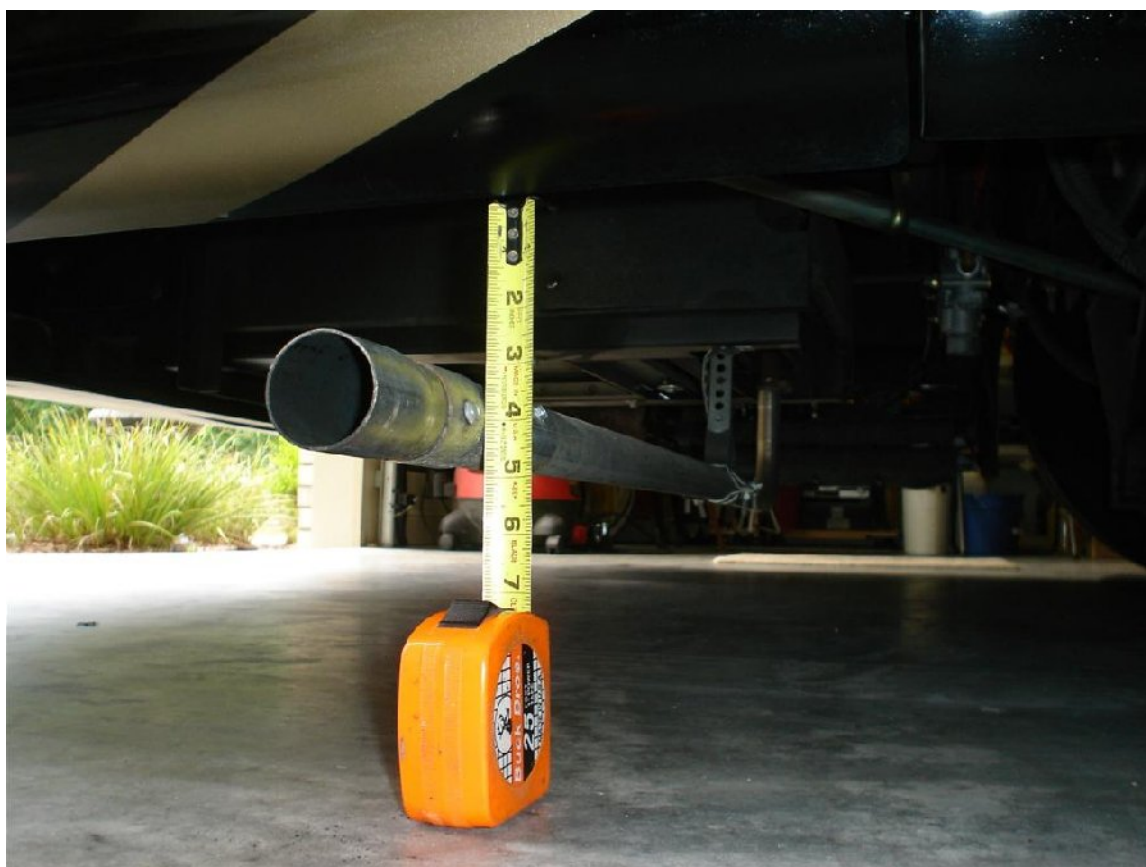
I suggest everyone should check those two generator tail pipe bolts to ensure they are tight. Tiffin installed the two bolts on my generator without using lock washers, which I highly recommend be installed if not already installed.

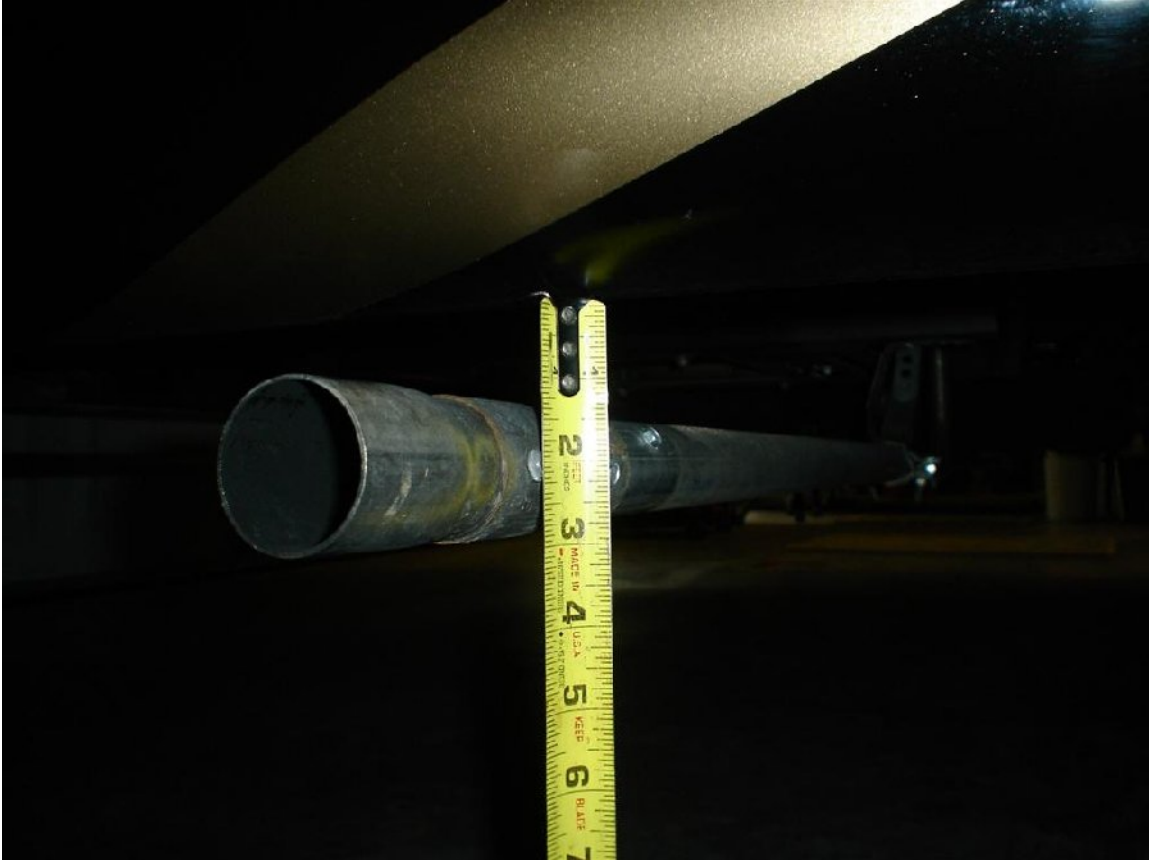
Comparing the above and below pictures shows the amount of generator tail pipe that was cut off in order to increase the generator exhaust pipes road clearance.

After removing two inches of the generator's exhaust tail pipe, the tail pipe was remounted to the generator with the stainless steel bolts and lock washers previously installed. Next the tail pipe was again mated to the exhaust pipe using the Tiffin supplied muffler clamp. Tiffin installed two exhaust pipe rubber/fiber mounted two hole clamps with attached metal strapping on the exhaust pipe then screwed the strapping to the bottom side of the generator's slide tray which allows the exhaust pipe to move side to side in relation to the generator's slide tray movement.
