2010 43QGP Allegro Bus

1/6/2012

FORTY-SIXTH - coach modification - **COACH INSIDE ASSIST HANDLE.** When we purchased this coach the handle was missing some of the tape, or so we thought. Regardless the dealer re-taped the handle for us. Over the past year we have seen many coaches and they all had the same tape on the handle.

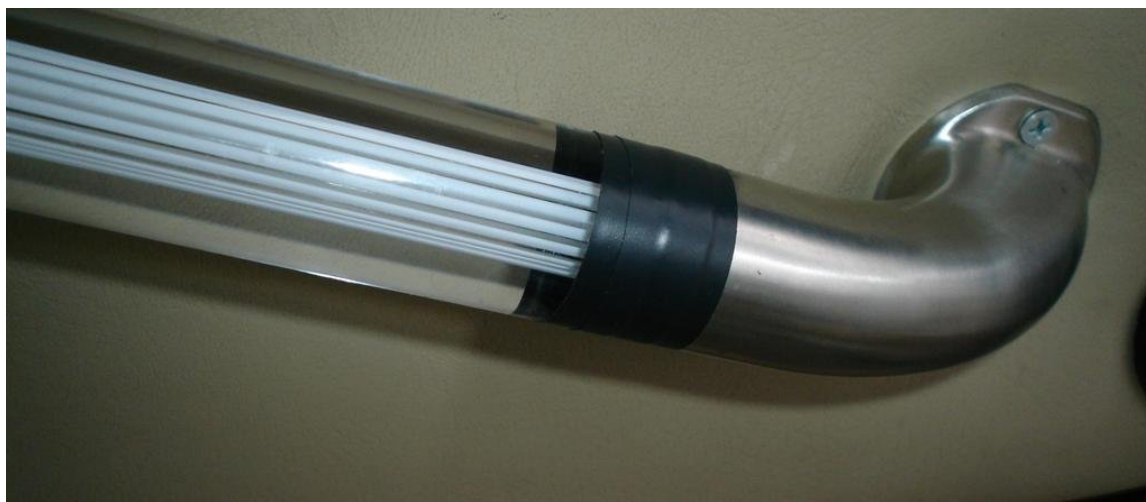
Yesterday after seeing the black tape had begun to unravel I decide to remove the handle after cleaning the residue from both the glass and metal then re-tape and reinstall the handle.

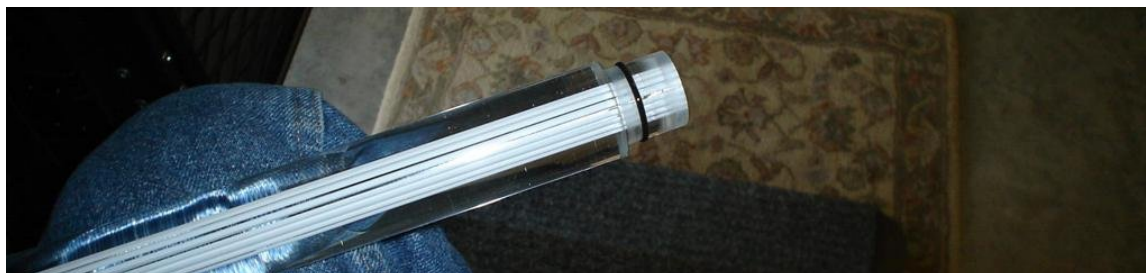
After removing the screws holding the handle in place I found the glass rod is just inserted into the lower metal bracket with a "O" ring used as a seal. The "O" ring was not tight thus allowed both the metal and glass rod to move around. That combination did not look very stable to be used as an assist handle. The lower handle houses the LED which when turned ON illuminates the glass rod.

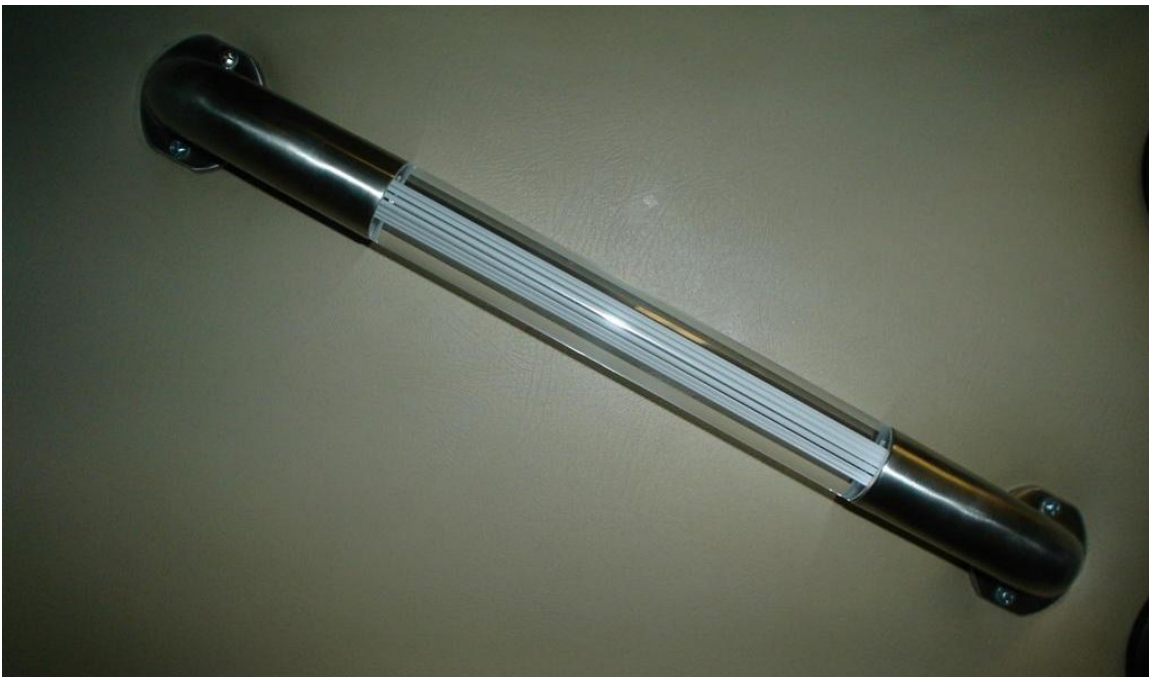
As seen in the two photos IMO the intent of the original black tape was to keep the lower metal bracket from being disconnected from the upper metal handle with the glued in glass rod from being separated DURING SHIPMENT. I think after making this modification the assist handle as it is now installed, is how the manufacturer intended the handle to ALWAYS look after installation.
