## 2010 43QGP Allegro Bus

**ONE-HUNDRED-SIXTEENTH, revision 1 - coach modification – AIR FILTER CANISTER SUPPORT.** While performing coach maintenance I noticed the air filter canister is strapped to a thin piece of metal which is secured by two bolts to the radiator housing. That thin metal support can be seen in the following photo, the metal is outlined in orange.

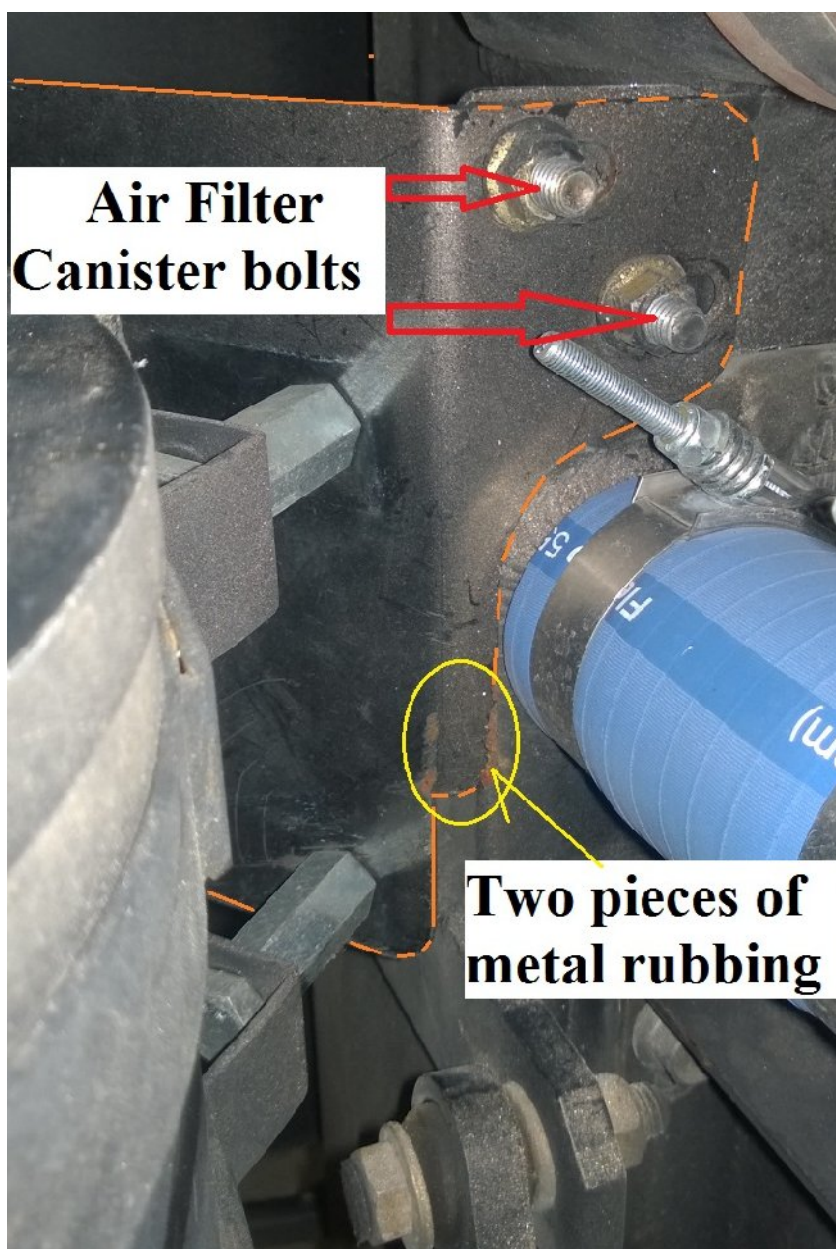
Looking inside the yellow circle shows where the two pieces of metal had been rubbing against each other as denoted by the rusted area. The metal air piping connecting the air filter to the turbocharger has **ONLY** about a 1/2" spacing between the radiator fan drive clutch and the air filter piping. After deciding something needed to be done to make everything safer. Deciding what could be done to make everything safer and at the same time easy to disassemble during

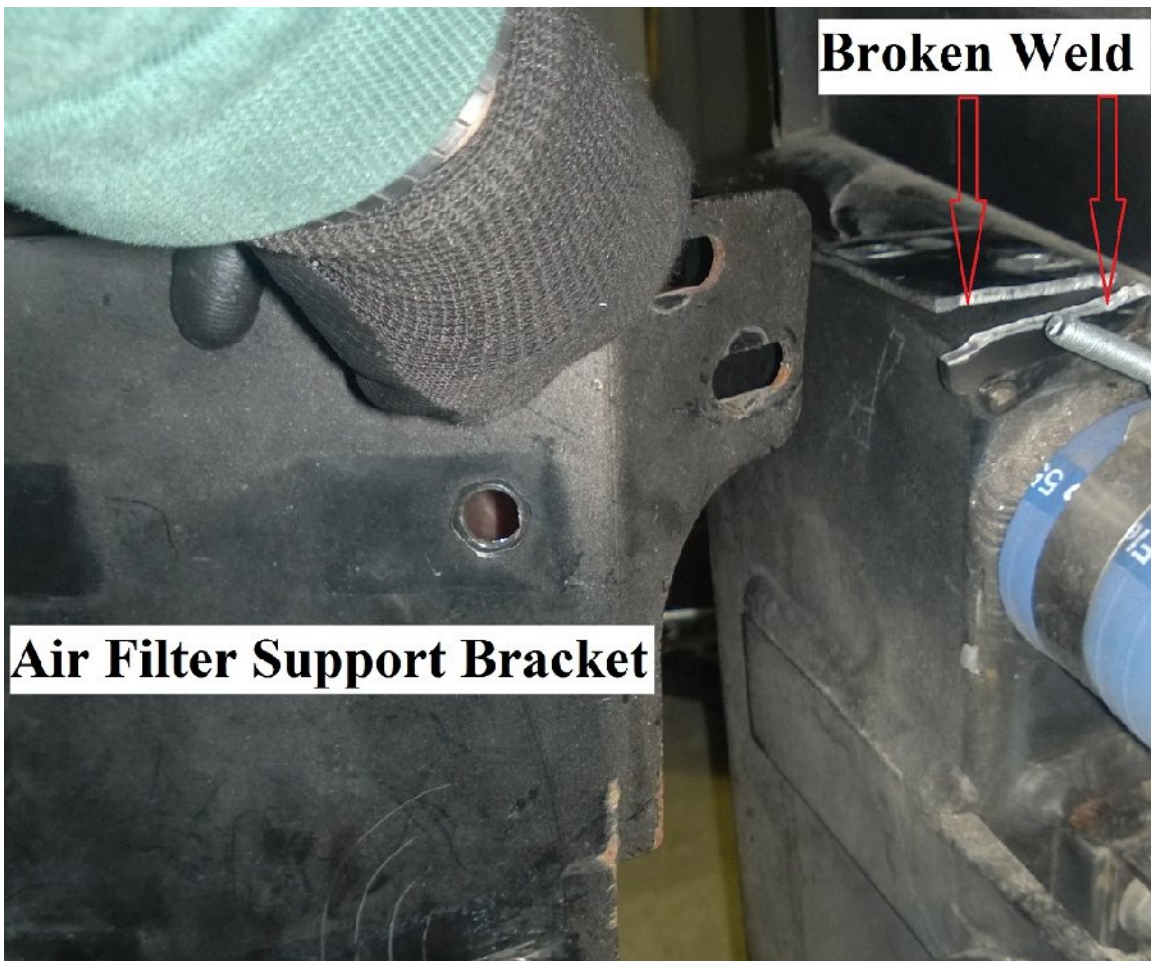
Fast forward two months, 12/2/2015 while servicing the coach I found this.

After deciding I did not want any welding around the radiator as that would present a chance for damage to the cooling package, another modification or in this case a REVISION to the original modification was needed.

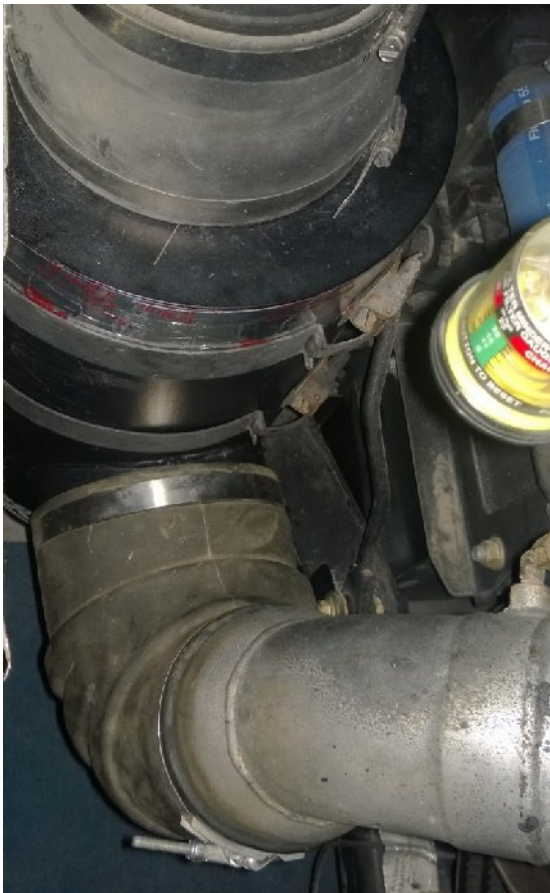
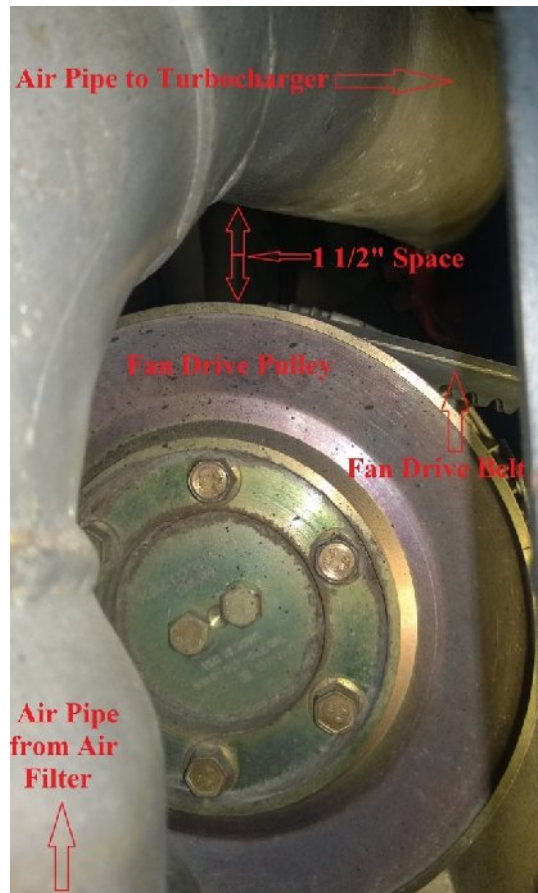
I have no idea if the OEM air filter canister mount Tiffin used on our PROTOTYPE coach was/is a ONE OF A KIND or not. However if the steel tab welded to the radiator housing is Tiffin's standard mount I doubt our air filter housings BROKEN MOUNT is a ONE of a kind OCCURANCE? The under the air filter canister support modification installed two months ago was re-installed under the air filter canister AFTER the ANNUAL cleaning of the K & N Air Filter had been completed. Aluminum foil (HACV) tape was used to re-seal the two parts of the air filter canister to prevent air infiltration.

Prior to this modification the SPACING between the Fan Drive Pulley and the Air Pipe to Turbocharger was ONLY  $\frac{1}{2}$ " , yes that statement is correct ONLY a  $\frac{1}{2}$ " OPEN space between the two components that is ONE reason I felt the need to correct what I see as a Tiffin engineering problem, another was to prevent what might possibly be serious damage to the coach. While designing the revision to the canister support modification spacing between components was increased by 200% increasing the  $\frac{1}{2}$ " spacing between the fan drive pulley and the turbocharger intake piping to  $1 \frac{1}{2}$ ". I feel better about preventing a breakdown after completing this revision.
