## 2007 40QSH Phaeton Tank Compartment Floor

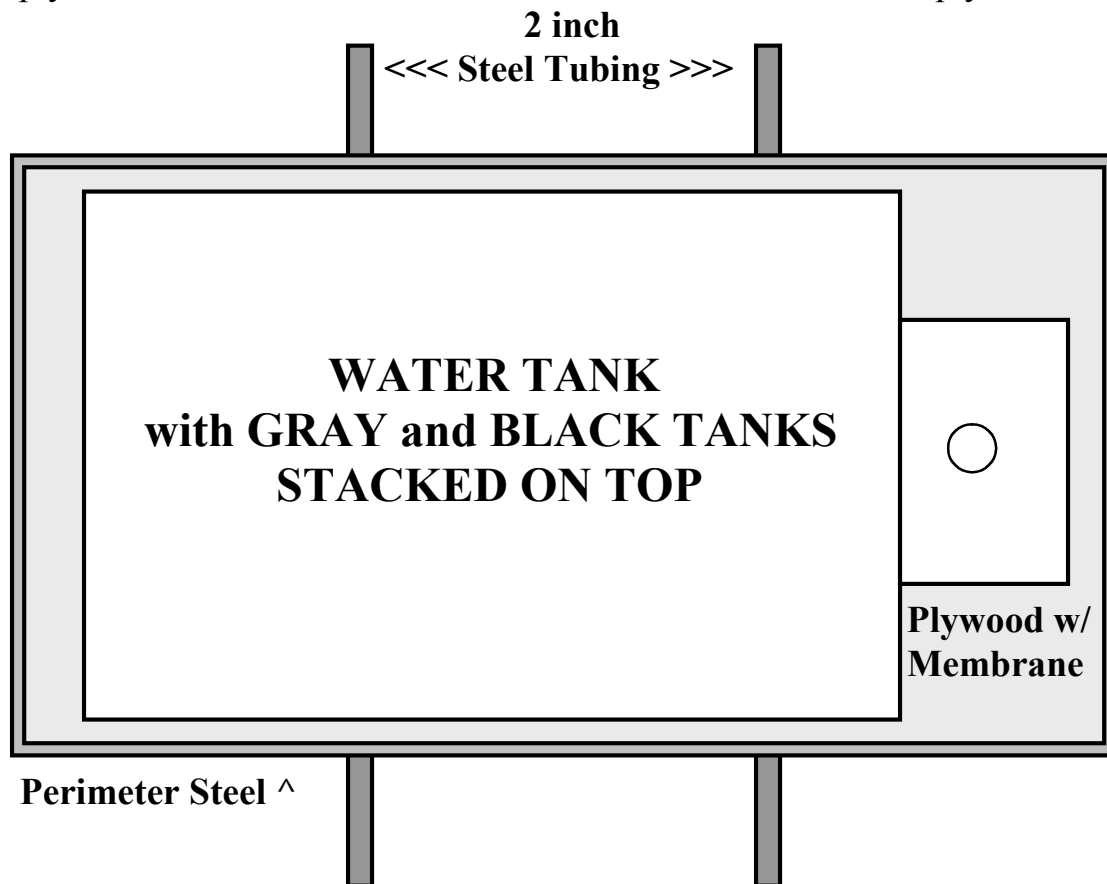
This is a pictorial of the tank floor with the tanks overlaid on it. As you can see the **ONLY** steel actually under the plywood **excluding** the one inch perimeter of the plywood are the two steel tubes under but not attached to the plywood.

**4370 square inches of plywood of which 436 square inches are resting on steel!!**  
**Less than 10% of the Floor, Tanks and Contents are supported by STEEL!!**
