## **Additional Support Underneath the Tank Compartment Floor**

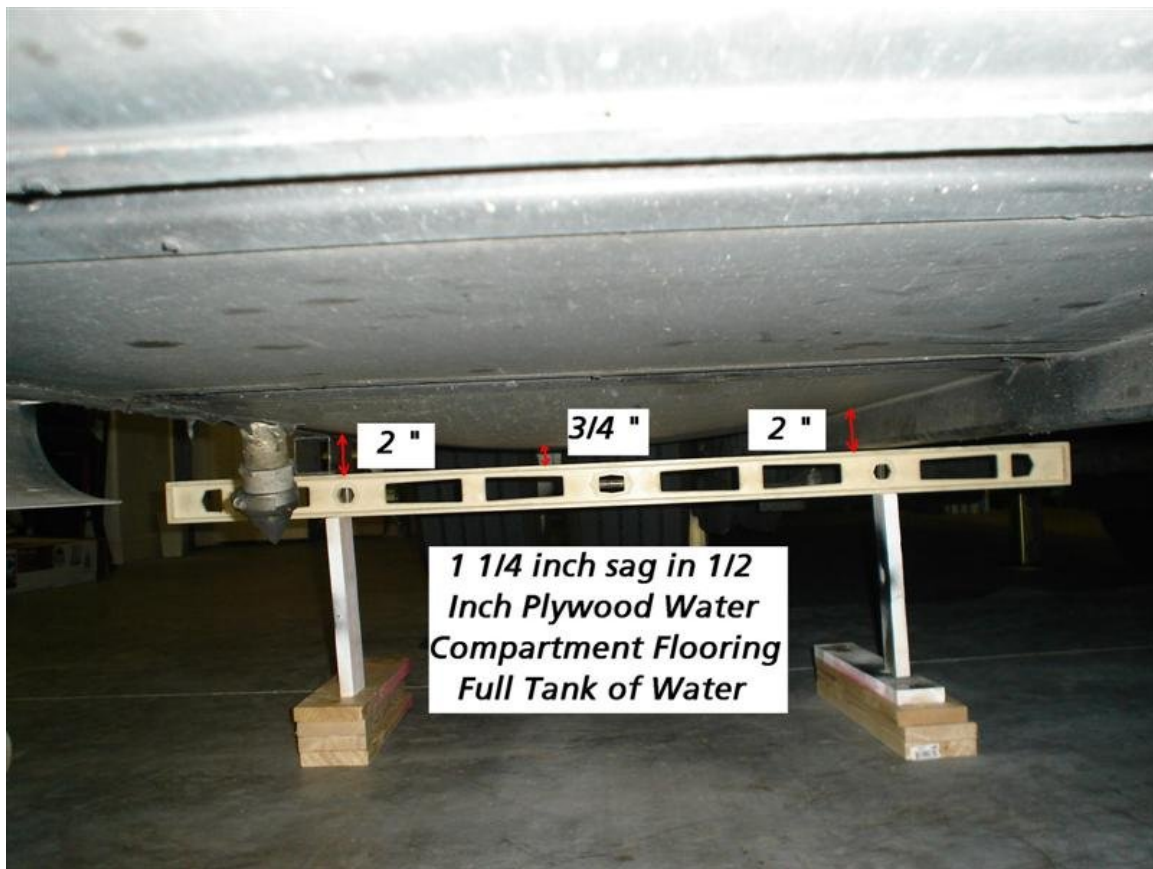
I did check the sag in the water tank compartment floor with the water tank full and the gray and black tanks empty. Below is a picture of results of that test. I was too chicken to add any water to the gray or black tanks based on the sag with just the water tank full.

As seen in the picture. The sag is more than I wanted to leave as it was. I am out of warranty by a long way and to me I believe I can figure out a better and cheaper way to correct the above problem without the trip to Red Bay. As I see this problem Tiffin did nothing to support the passenger end of the water tank and as a result the two tanks (black and gray) are nested on top of

the water tank. The water tank is 40 inches wide and 72 inches long when placed on the 48 inch by 96 inch sheet of 1/2 inch plywood there is nothing except plywood under the three tanks. On my coach there were only 18 screws secured the 1/2 inch plywood to the surrounding 1/8" x 1 1/2" angle iron perimeter supporting the three tank's. Tiffin installs two 2" square tubes under the basement compartment floor running from just in front of the rear suspension to the just behind the front suspension. These two tubes are not attached to the tank compartment floor they just run under the plywood flooring. The only support for the floor is just contact pressure of the plywood on the 2" square steel.
