# Charging Solenoid Problem

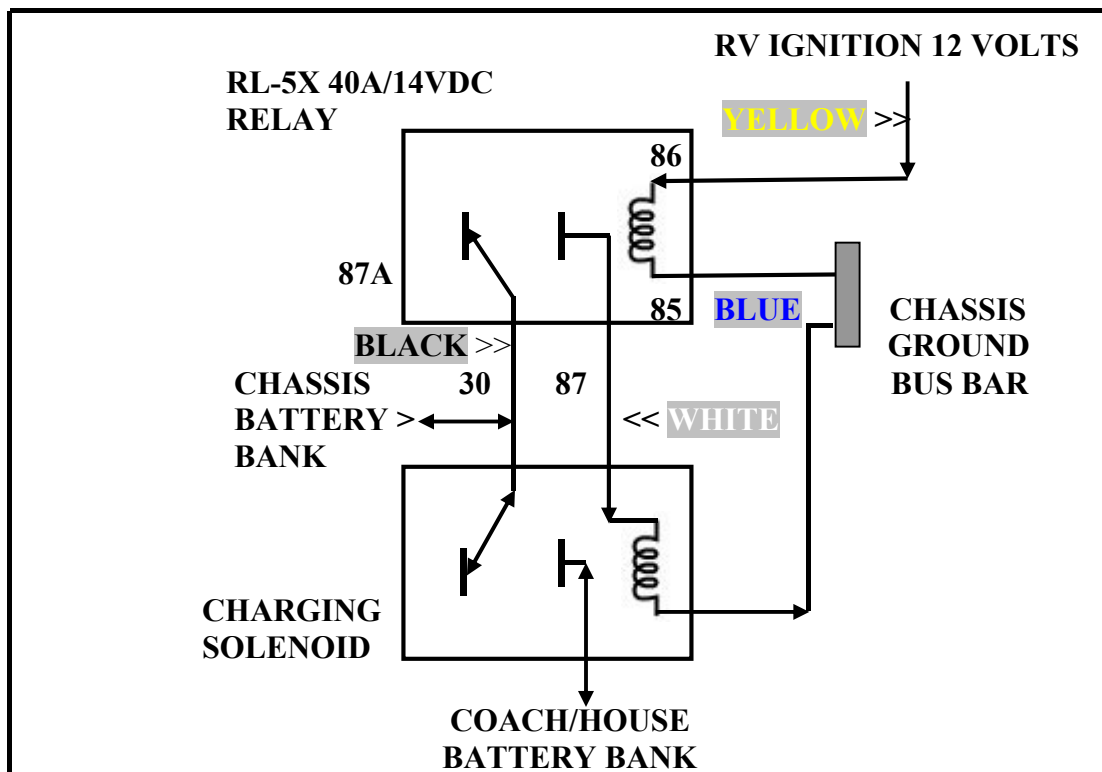
Last year my 2007 Phaeton had an intermittent problem with its "Charging Solenoid". We made a trip to Red Bay shortly after the intermittent problem began, at my request Tiffin provided me with a new Charge Solenoid which I changed out. I kept the old solenoid as a backup as a future just in case. Recently the problem came back but was no longer intermittent. While on our last weekend trip I resorted to using a rubber mallet to tap on the solenoid which would jar it into action. Today I re-installed the original solenoid after testing them both on the bench with a good 12 volt power supply. They both operated perfectly on the bench, so I decided to conduct further testing. I found when I turned on the ignition switch which feeds the solenoid's coil, the DC voltage was dropping almost 0.5 volts. Further testing showed the chassis battery voltage was not the problem. I found the voltage drop was related to the length of cable required to send voltage from the chassis batteries to the front coach firewall where the power was then sent to the Freightliner ignition circuit fuse and relay box under the drawers. From the box the 12 volts was sent to the passenger side rear electrical compartment to the coil of the Charging Solenoid. That round trip is nearly 90 feet. Too far IMO on the small cables Tiffin was using for this circuit. How to solve the Tiffin undersized cable problem? After thinking over the options, below is an diagram of the new modification with relay I installed.

I decided to install a SPDT automotive style relay (RL-5X 40A/14VDC) along with a mating 5 wire automotive socket in the passenger side rear electrical compartment. The relay uses Chassis Battery voltage to energize the coil of the Tiffin installed "Charging Solenoid". I used Tiffin's STANDARD ignition powered circuit to energize the coil of the new automotive relay. The 0.5 volt drop experienced in the original Tiffin circuit will never be a problem for the new relay control circuit. Voltage to energize the Charging Solenoid is now routed a matter of a few inches, where Tiffin had the Charging Solenoid control circuit running almost 100 feet.
