Tow Lighting for my 2009 Lincoln MKX

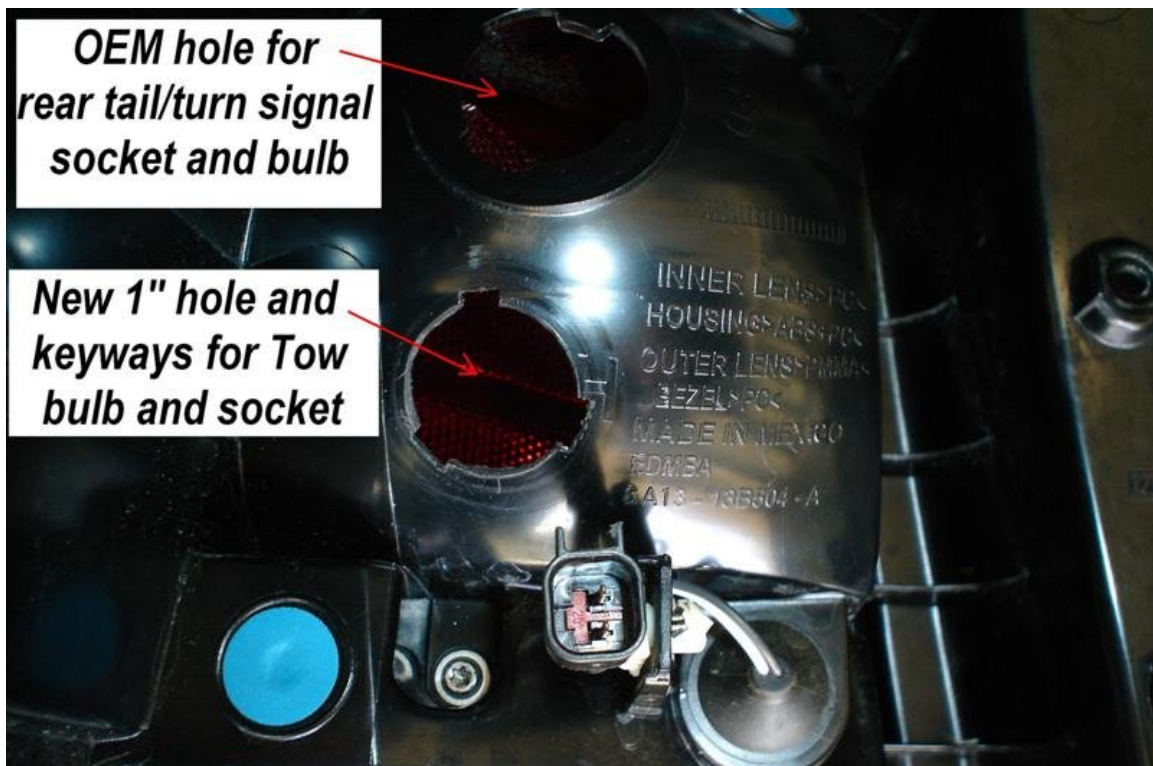
We have been towing our 2009 Lincoln MKX for about nine months and everything seemed to be going along without a hitch. However in the past month or so when I turned on a turn signal either left or right it did not matter the rhythm of the flasher seemed to gallop at times and have a steady rhythm at other times. I had noted on previous vehicles a faster flash rate was usually an indication of a blown bulb in the turn signal circuit, either in the front or rear fixture. After checking all of the bulbs and finding them good, while researching the problem I also found when my foot was depressing the brake pedal the rhythm was always smooth and no gallop. I finally concluded my use of diodes to add the tow lighting package was probably the cause. The MKX electronics was not seeing the proper load (bulb filament) versus the inline diode located before the bulb filament. So a couple of days ago, I went in search of a couple of bulb sockets and a couple of 1157 bulbs, I found what I wanted, for less then \$ 20.00. I already had the tow wiring and a four pin receptacle in place so no expense there. I first purchased the parts then went about testing my theory regarding the proper load on the flasher. I took the diodes out of the circuit and everything worked as it normally would, no gallop in the turn signal flash rate.

I had decided if the diode was the cause to add a socket to each of the rear tail light/turn signal fixtures.
