Wet Bay Door "C" Hinge Modification

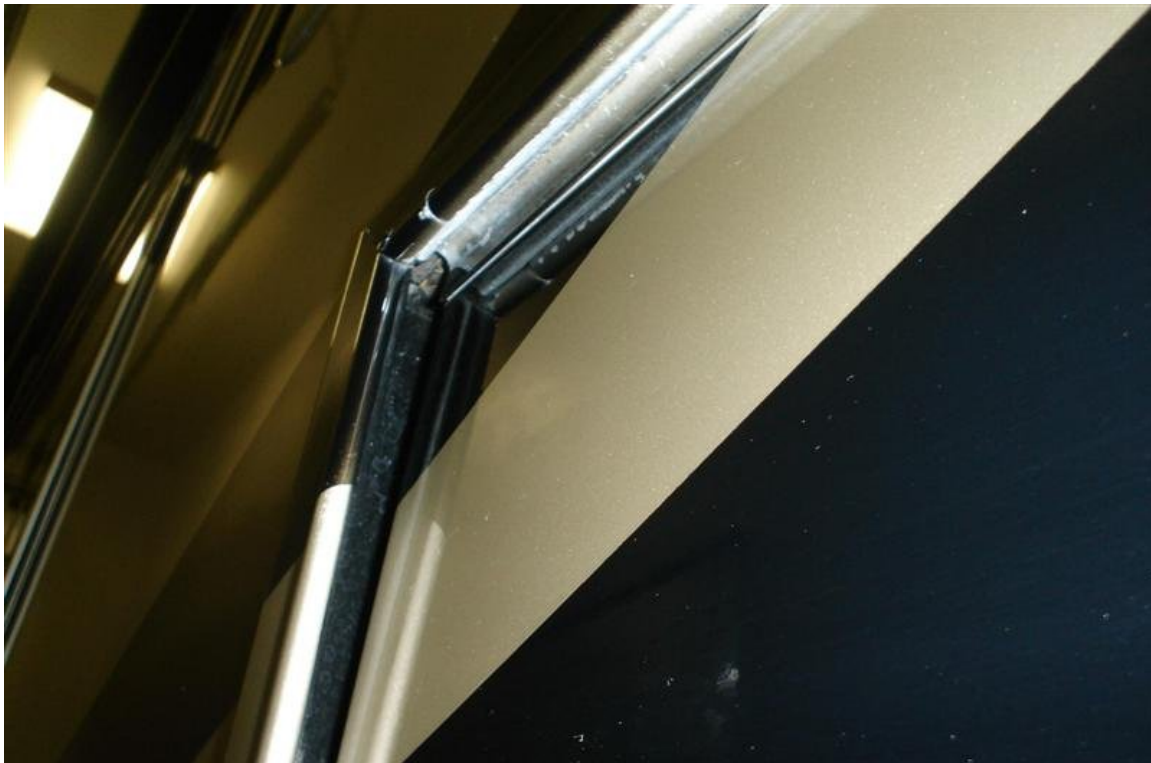
The next two pictures are of my wet bay door. The left and right top corners of the door (pictures were taken before modifications). As you can see in the upper left corner of the picture the two "C" channels have unhinged. The reason the channels can become unhinged is partly due to the offset door brackets TMH has installed on this door to cause the door to open further than the other top hinged doors on their coaches. As the door is closed the two door air springs resist being compressed, during their resistance to

this compression the two "C" channels are pushed apart. When TMH installs the door the two "C" channels are tight but after dozens of open and close operations the aluminum wears just enough to allow the channels to push apart and unhinge.

I therefore decided on a low tech modification to correct this TMH design problem. I decided to build and install three wooden blocks which would keep the door hinge "C" channel from being pushed away from the RV side wall mounted "C" channel. As the door is closed the backside of the "C" is pushed by the block against the other "C" channel preventing them from being separated by the air springs pushing upward and inward on the door. The three blocks prevent the "C" channel separation which the TMH design had been allowing to occur.

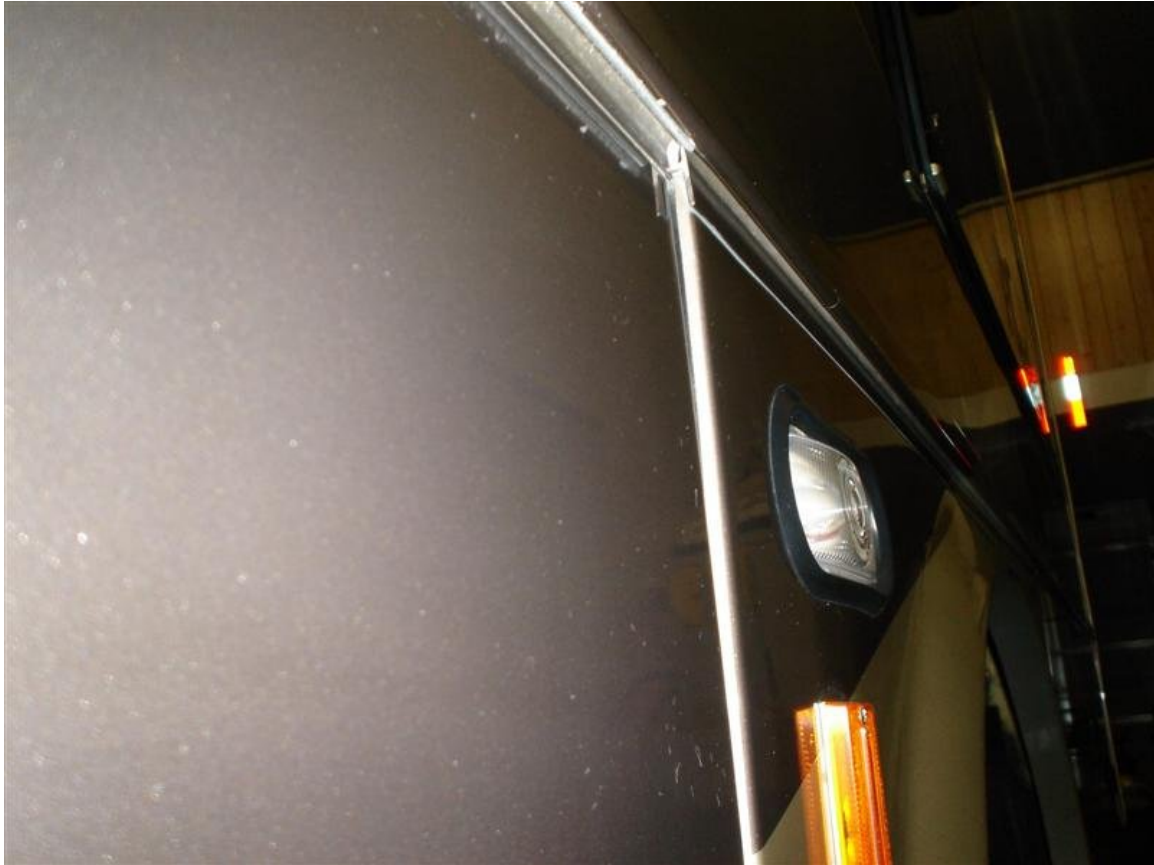
As seen in the above picture, this end of the hinge was not as bad as the left end however I do not think it would have been long before there would have been damage. I would never have been able to catch the door during opening or closing if the channels had become unhinged.

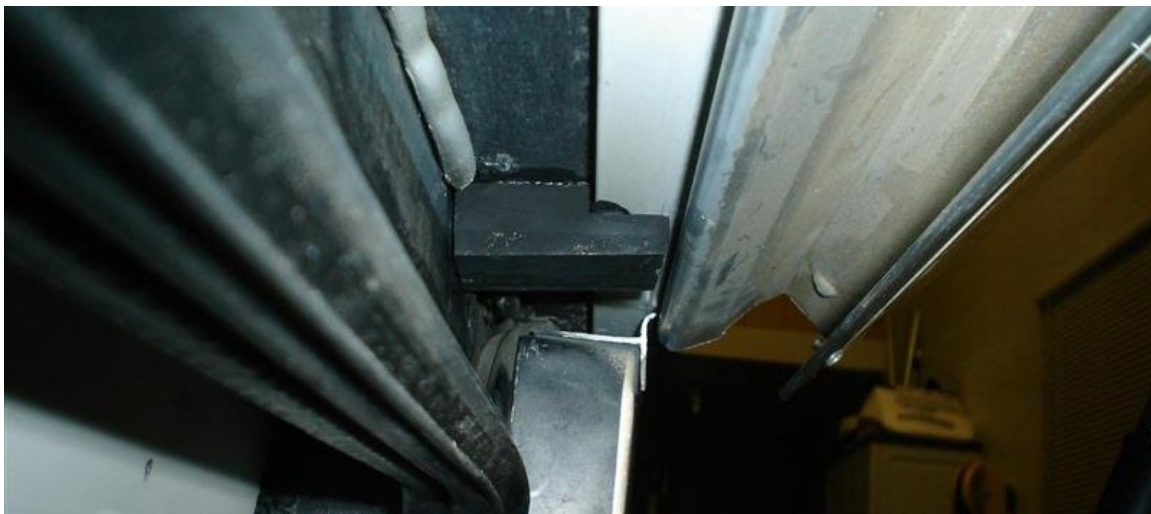
Notice the gap between the end of the block and the aluminum "C" channel, a small gap is needed as when the door is swung downward the gap will narrow as the door nears full closure. I needed to check and increase the clearance multiple times until I got the clearance correct. I began with too little clearance and increased the gap until the door would close almost completely before I felt pressure on the top of the door near the block. I performed the block clearance testing one block at a time until I got all three properly cut and closing without pressure on the top of the door at the hinge. Then I installed all three blocks and tested the door closing. I had to cut the gray sealant between the wall and floor where the three blocks were to be mounted. I used another low tech method of mounting the blocks, black silicone sealant. After sticking the blocks in place I installed wooden pressure sticks to keep pressure on my blocks until the silicone had time to cure. I think everyone will find the same problem I found on my wet bay door. TMH when they built the left side wall did not get the corner pushed in at the top as much as it is at the bottom. On my coach the top is pushed out 3/16 of an inch more than at the bottom. As seen in the below picture. The wood is flush with the wall at the bottom and as you can see there is a gap at the top. It is just the way TMH assembled the side wall.

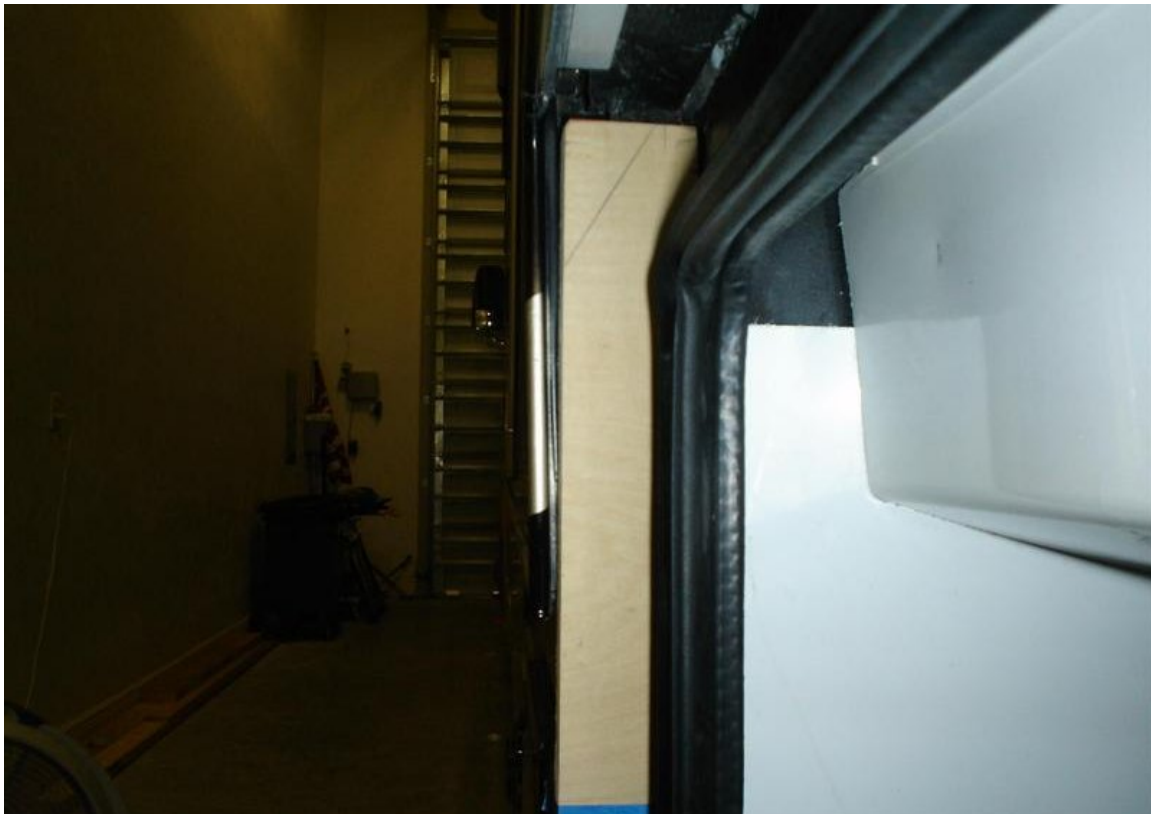
This is what the left end of the door looks like after my three wooden block modification. You can see the 3/16 inch gap which TMH built into the wall. There is no way to correct this in my opinion without major work by TMH.

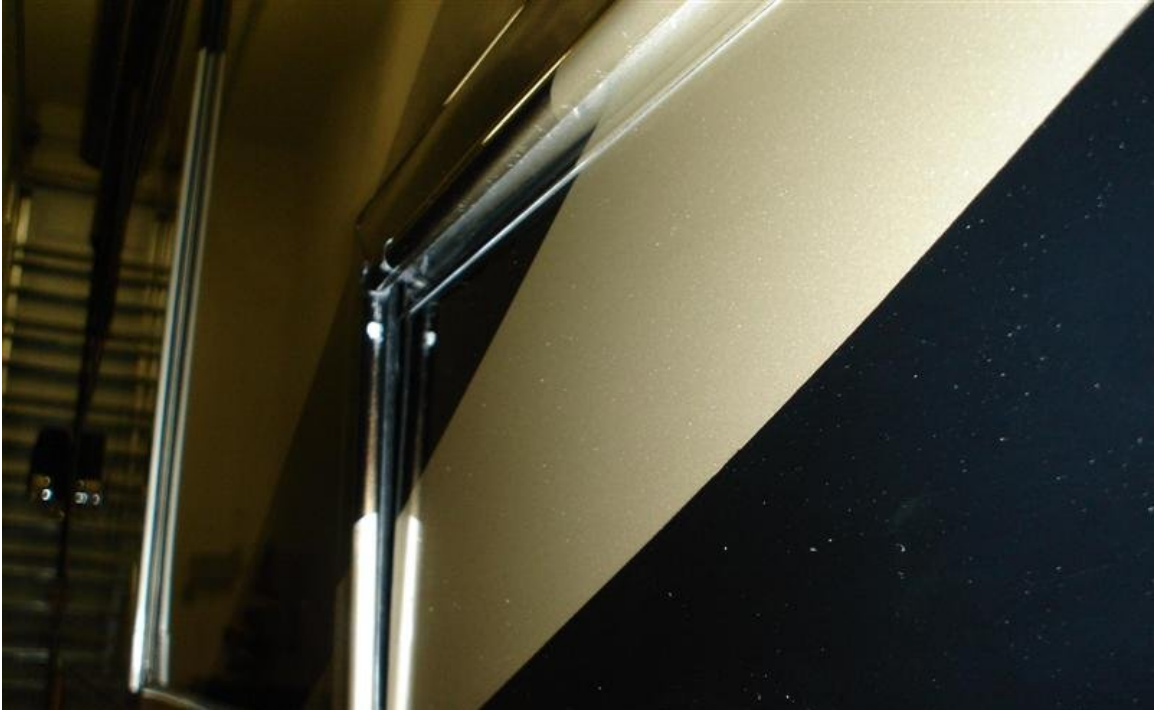
This is the right end of the door after my modification.

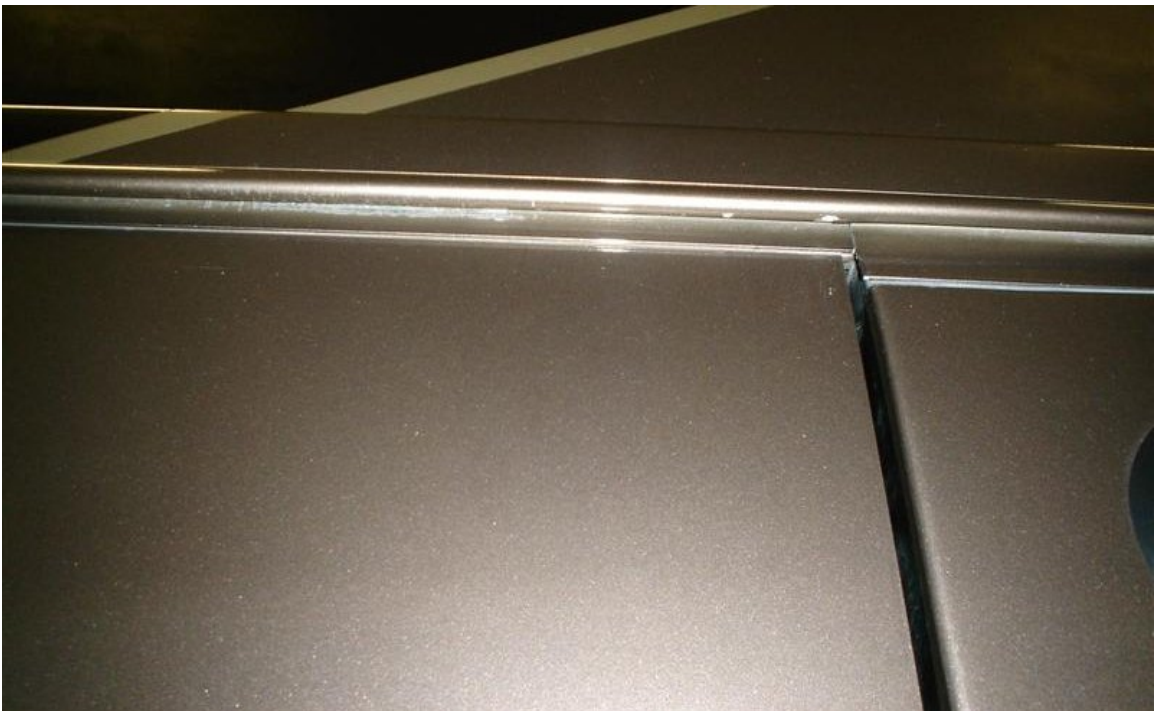
This is a picture of the whole door after modifying the hinge operation.

You can see the small 3/16 inch gap in the upper left top corner of the door. I see no way to correct this assembly error after the fact I'll just live with it. This modification took three hours of my time I used a few inches of pressure treated wood (3/4" x 1 1/2" x 2 1/2") for the blocks. A few dabs of black silicone and few wisps of black spray paint so the wood would blend in with the surrounding black painted metal.
