## Wet Bay Door "C" Hinge Revision

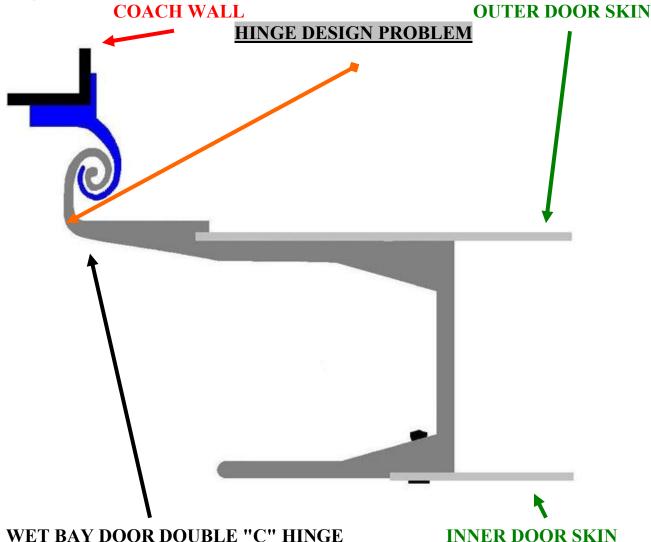
If you look at the orange arrow you can see where the bind will come into play without an adequate clearance gap allowed when installing the new blocks. Looking at the door hinge you can see it is not rounded (its more egg shaped on the corner) whereas the wall hinge is round.

To remove the top hinged doors, I recommend two people hold onto the door to prevent damage or injury. Remove the air springs from the door. To unhinge the top hung doors requires the door to be open at least 90 degrees then lifted at the hinge and pressure applied toward the coach. The inward and upward pressure in some cases a little up/down wiggle of the door will unseat the hinge. The door is not very heavy but it is awkward to handle for one person. I used a padded table with three wooden blocks to prevent damage to the bottom curved door lip and the door release mechanism.

An additional point I would like to pass on. It is my opinion that an attempt to bend the door hinge to prevent the hinges from unhinging would be a mistake. I believe the aluminum would crack at some point in the future and become an owner problem, not a warranty problem. If TMH bends the doors hinge to correct this problem. I recommend the owner document, names of who did the work, the name or names of who authorized the repair along with when and where the work was performed. Along with the above information keep all of the paperwork in a safe place as a **CYA** measure.
