Wet Bay Door "C" Hinge, Revision 2

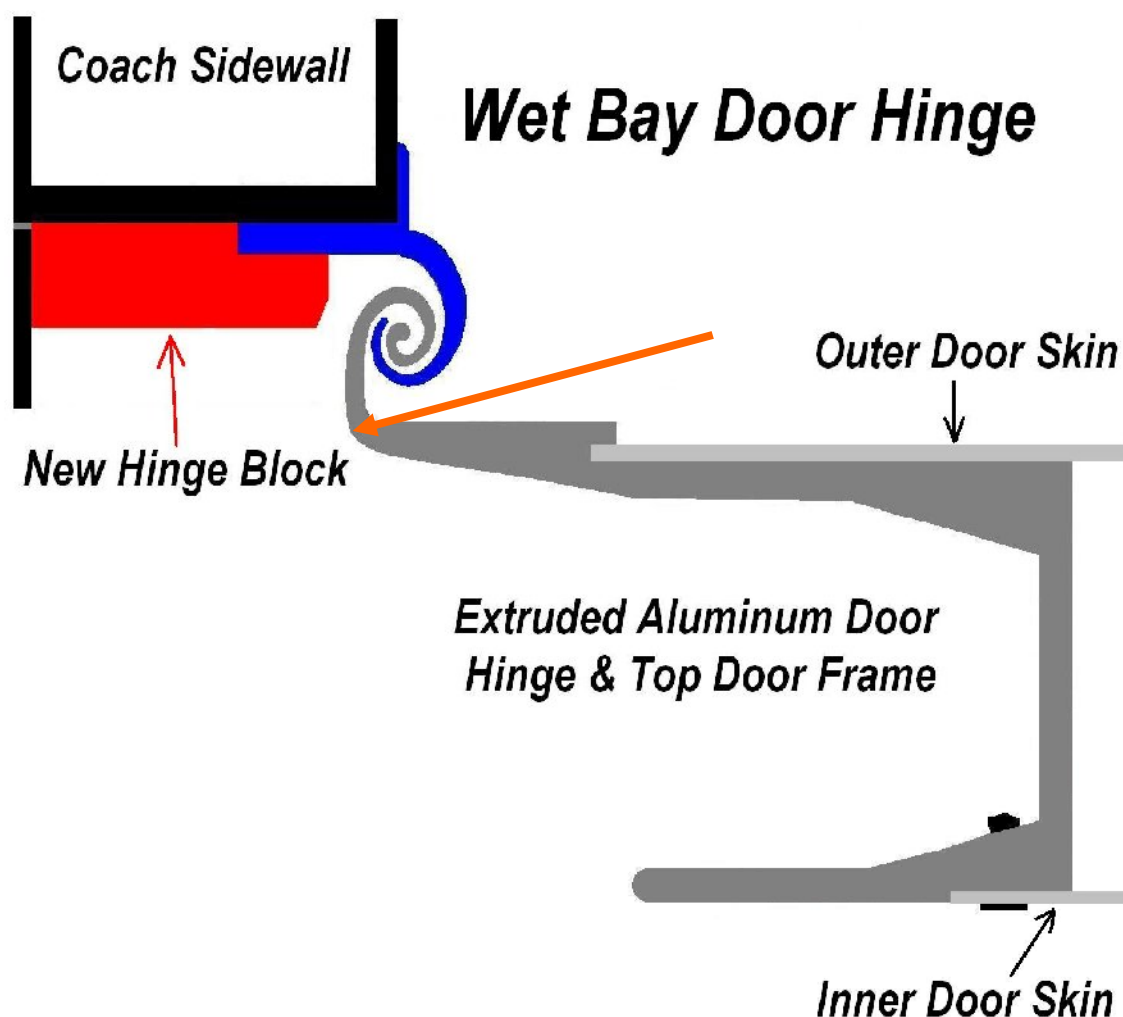
Looking at the orange arrow you can see where the bind will come into play as the door is closed, the channel will rotate and come in contact with the new door blocks without adequate clearance. Looking at the Wet Bay Door hinge you can see it is not rounded like the letter "C" but more rounded like the side of an egg.

I recommend using two people to hold onto the door when removing the top hinged doors to prevent damage or personal injury. Remove one end of both air springs from the door. To unhinge the top hung doors requires the door to be open at least 90 degrees, then while lifting up at the hinge, apply pressure on the door toward the coach. The inward and upward pressure and in some cases a little up/down wiggle of the door will unseat the hinge. The door is not very heavy but it is awkward to handle for one person. I used a padded table with three wooden blocks to prevent damage to the bottom curved door lip and the door release mechanism.
