2010 43QGP Allegro Bus

7/26/2012

55 – FYI – REVERSING LOCATIONS OF PUMP SWITCH AND PUMP ON LIGHT. As already suggested by Traveldawg and other owners, I recently moved the water pump ON lamp from the right end of the switch bank to the second space from the right. This allowed the water pump switch to be re-located to the right end of the switch bank. This makes turning the water pump **ON** or **OFF** when you wanted to turn **ON** a light less likely to be a problem.

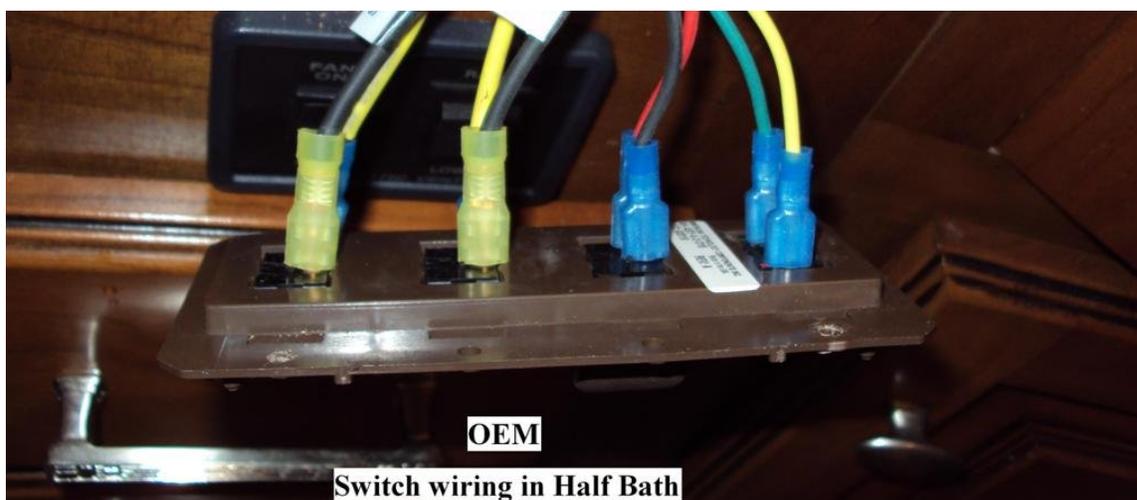
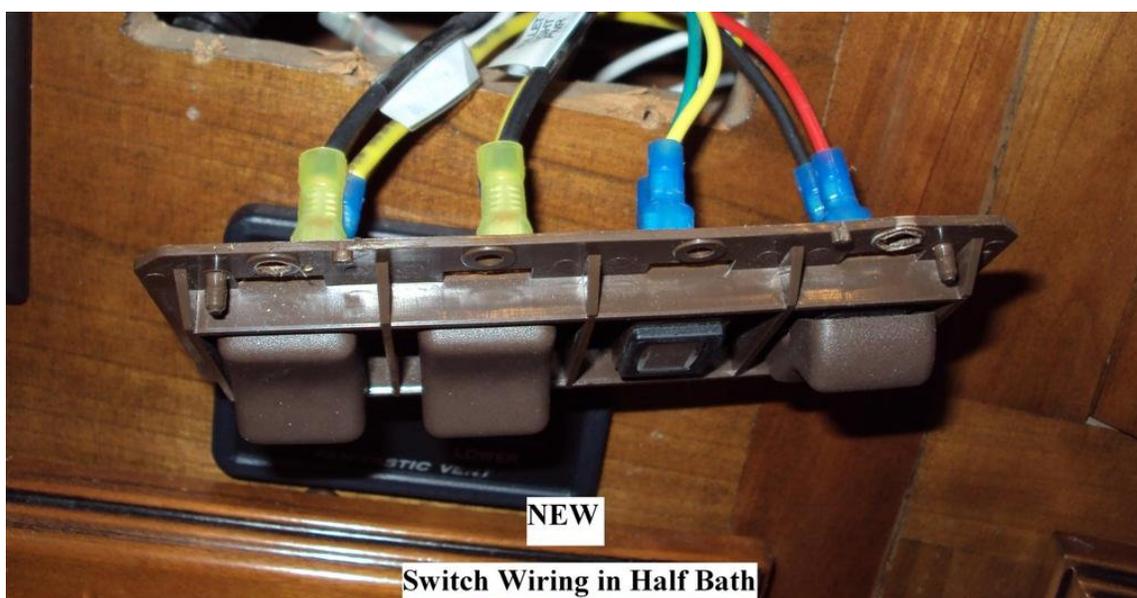
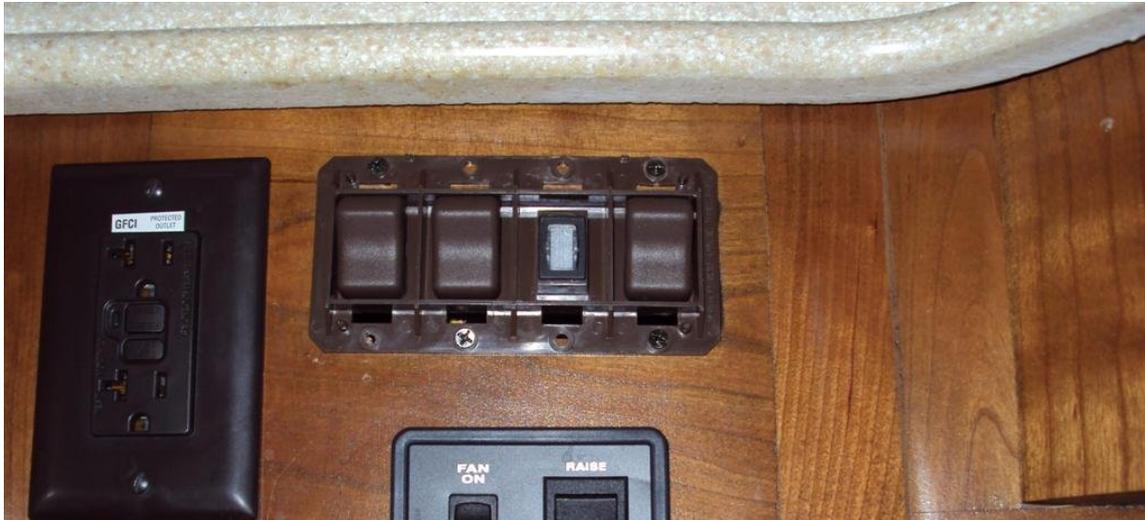
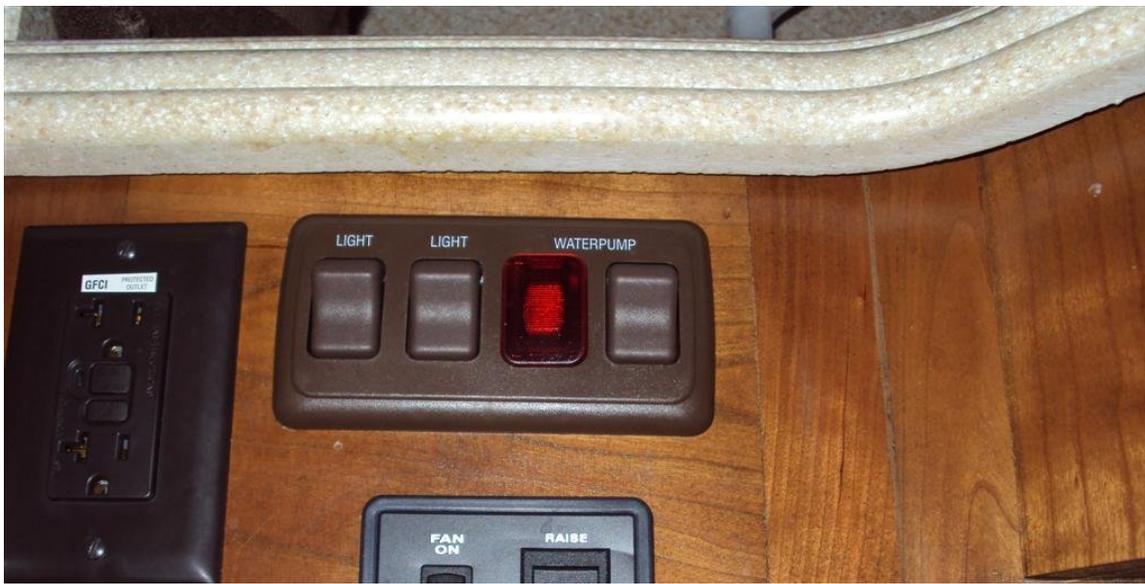
The above photos were taken of our coach's half bath switch bank. The four wires attached to the water pump switch and indicator light were both removed to allow removal of the water pump switch and light. The switch and indicator are removed from the front after the locking tabs have been depressed. After they were removed the water pump switch and indicator positions were reversed.

Not all water pump and light switch wiring is color coded therefore care must be taken to make sure you do not mix-up the wiring. The ON indicator incandescent lamp in most cases has been replaced with an LED which makes the wiring to the LED polarity sensitive. On our coach the YELLOW wire is connected to the top post and the GREEN wire to the bottom post. The RED and BLACK water pump wires are not polarity sensitive so their connections may be reversed without consequence.
