2010 43QGP Allegro Bus

3/20/2013

83 – A - FYI – <u>REASONS TO CLEAN YOUR RV'S FRONT WHEELS</u>

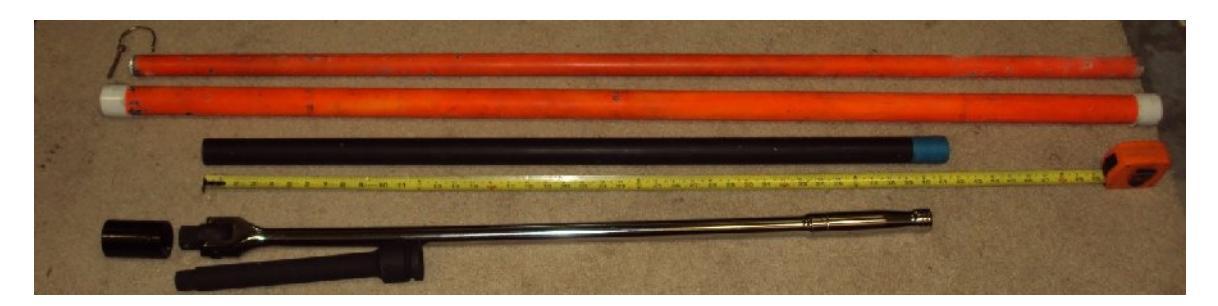
Back to me removing those lug nuts, I do not have the fancy 1" drive impact wrench. Instead I have a 1" drive 33MM deep well impact socket with a 12" long 1" extension joined to a 1" drive 40" long breaker bar. However even with four feet of extension my 175 pounds was not going to remove those lug nuts. However I learned during my teens working on log trucks and steel carrier wheels and tires all about leverage. I have all the leverage I need in two five foot sections of steel pipe. For storage, one smaller diameter pipe slides into the second pipe. The larger pipe slides over the 1" by 40" long breaker bar that gives me nearly 5 times my weight in torque well over 800 ft. lbs. If that is not enough torque the second pipe is slid into the larger pipe a couple of feet leaving me 8 feet of lever at my weight (8 x 175= 1400 ft. lbs.) There has not been a lug nut TOO TIGHT FOR ME TO REMOVE. To get back on track, Until this coach one of my semi-annual maintenance items was to remove, clean, check and re-install the wheels and tires on our coach's. Based on many reasons that wheel maintenance has not been performed on this coach and now our coach is three calendar years old (we purchased the coach as a Tiffin prototype one year old) when we purchased it two years ago.

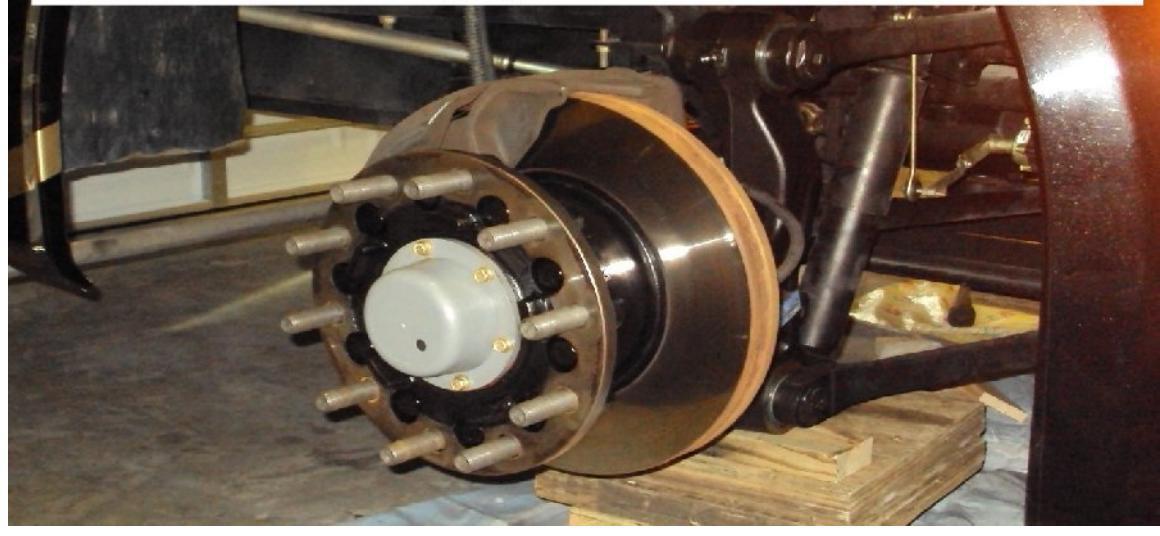
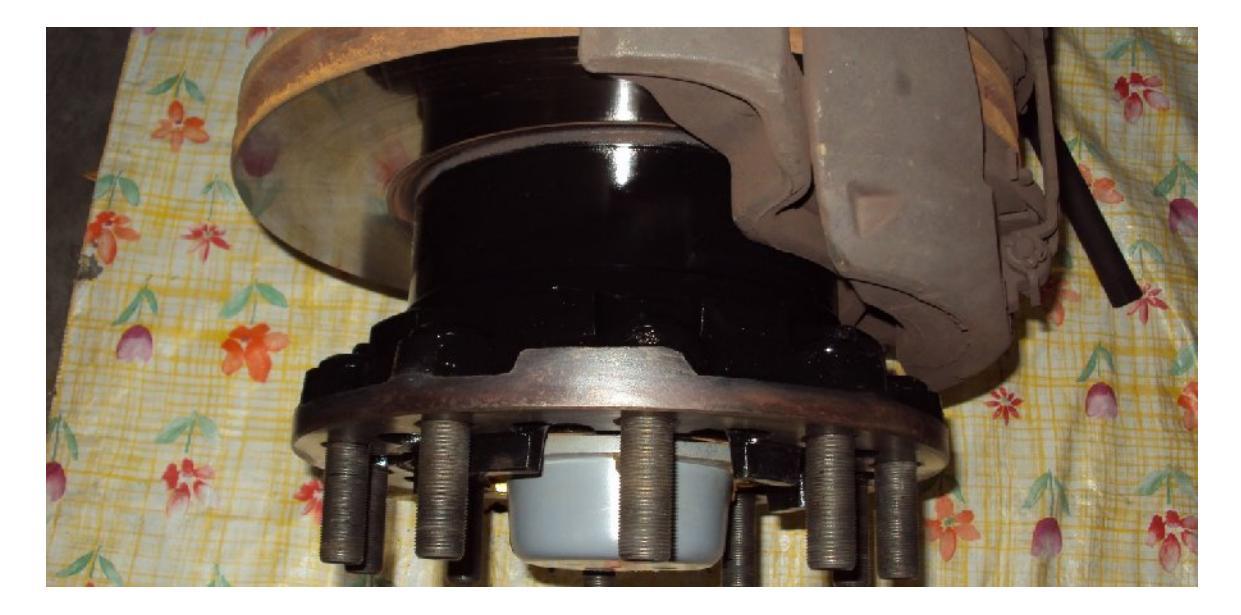
Next maintenance in line is to remove as much surface rust as possible prior to painting the exposed bare metal. Components which will be moving metal on metal will not develop rust as it will be worn off during operation. The rust I am referring to is the bare metal on the wheel ends subject to rusting then while driving in rain the rust migrates to the outside of the aluminum wheels leaving rusty streaks from the center hub outward.

The wheel ends were first cleaned then painted BLACK to prevent rust from forming on the bare metal then showing up on the aluminum wheels

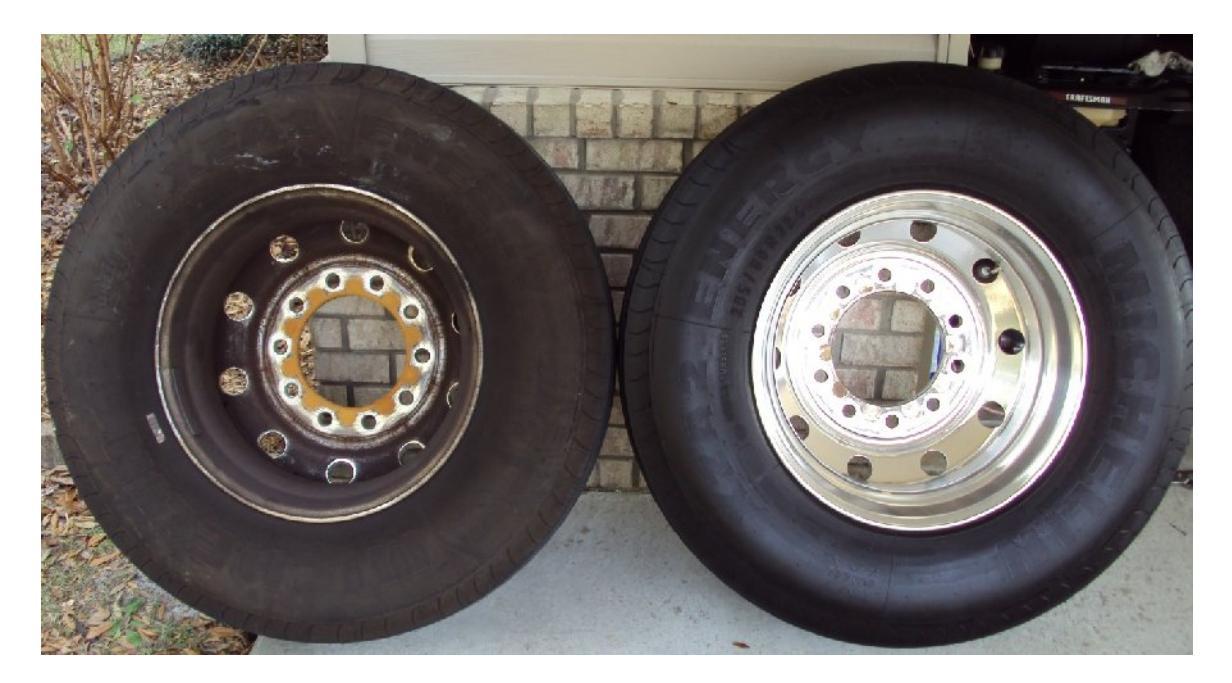
More often than not, I get carried away with my coach maintenance, in this case three years LACK OF CRUSINGATOR'S MAINTENANCE was really showing.

Cleaning the wheels and tires was the next operation prior to reinstalling the wheels and tires. I will not go into my long drawn out cleaning method I'll allow a photo to explain most of the work involved, I used six or seven applications of 303 protectant to the inside and a couple applications to the outside of each tire after the tires were degreased and cleaned. The wheels required plenty of elbow grease and Acetone. This photo was taken after cleaning one wheel and showing the other wheel as it looked when removed.
