2010 43QGP Allegro Bus

6/16/2012

FIFTY-NINETH - coach modification – <u>LOW OPERATING</u> <u>**PRESSURE CONTROL VALVES.**</u> Since purchasing our coach in January 2011, we have been trying to resolve the front axle over-weight issue which seems to be occurring with our Powerglide 43QGP floor plan. As of this date the front axle has almost completely been rebuilt to increase the axle's weight rating from 14,600# to 15,600#. Both automatic tag axle proportioning valves have been replaced with manual proportioning valves. The Tiffin installed tag axle suspension control valves (P2LB592008) Parker Viking Xtreme Air Control Valves are designed to operate down to 51 PSI, any operating pressure lower than 51 PSI WILL NOT consistently allow the control valve to be energized (dump the suspension air pressure) or when deenergized will not consistently turn OFF the valves air flow as it was designed to turn OFF using a simple return spring for the closing operation.

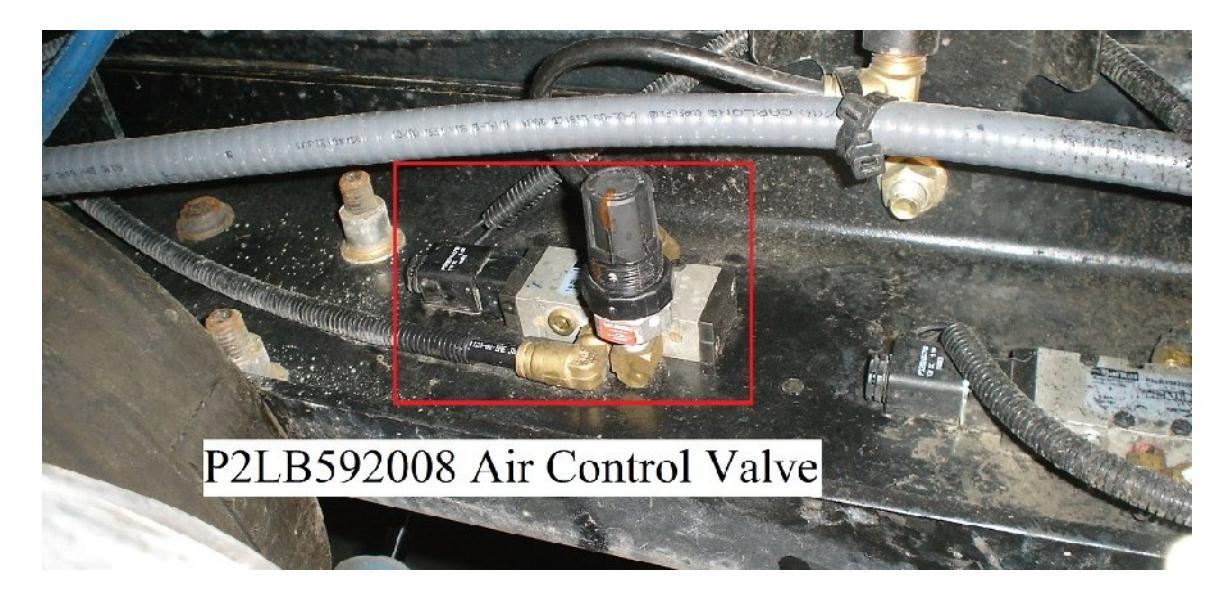
Our coach operating with the minimum rated operating pressure for those valves (51 PSI) forces TOO much weight to be carried on the coach's front axle. Multiple trips have been made to Red Bay with the normal Band-Aid approach to correcting the problem until our last trip after two weeks we were finally able to gather enough engineers and technicians together in a physical group to get an answer to the problem. The Powerglide chassis engineers (Gary Harris and Brad Warner) called Parker the company which

manufacturer's and supplies the air control valves used by Tiffin Motorhomes, Parker makes air control valves of the necessary type which are designed with an operating pressure down to 20 PSI.

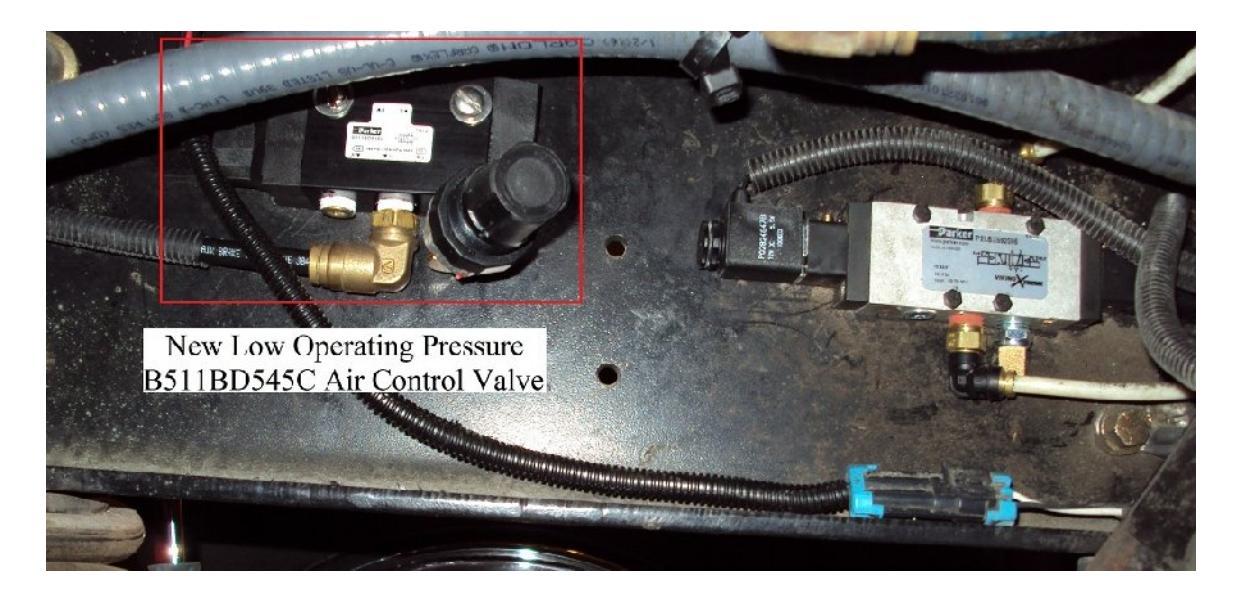
The new air control valves are designed to be operated with a control air pressure down to 20 PSI the valves (B511BD545C) use some of the 30 PSI supply air pressure to return the valve to its NORMAL (no air flow) deenergized state after solenoid control power has been removed. After installation the new control valves were tested multiple times using the cockpit manual dump valve switch and by placing the transmission in reverse to simulate backing the coach. The air control valves were found to consistently operate down to the desired 30 PSI in the tag axle suspension system.

We have not had the opportunity to be on the road with this modification however it is my belief the major issues involving too much weight on the front axle and the intermittent or non-responsive tag axle dump valves have finally been put to rest.
