## 2010 43QGP Allegro Bus

## 4/21/2013

**SEVENTY-SIXTH -** coach modification – <u>**BEDROOM BEDSLIDE</u></u> <u><b>GASKET.**</u> When we took delivery of our coach, ALL of the coach's carpets clear protective plastic was still nailed to the floor. That would have been fine except the gasket attached under the bedrooms bed slide did not prevent water from entering the coach then running under the plastic onto the carpet.</u>

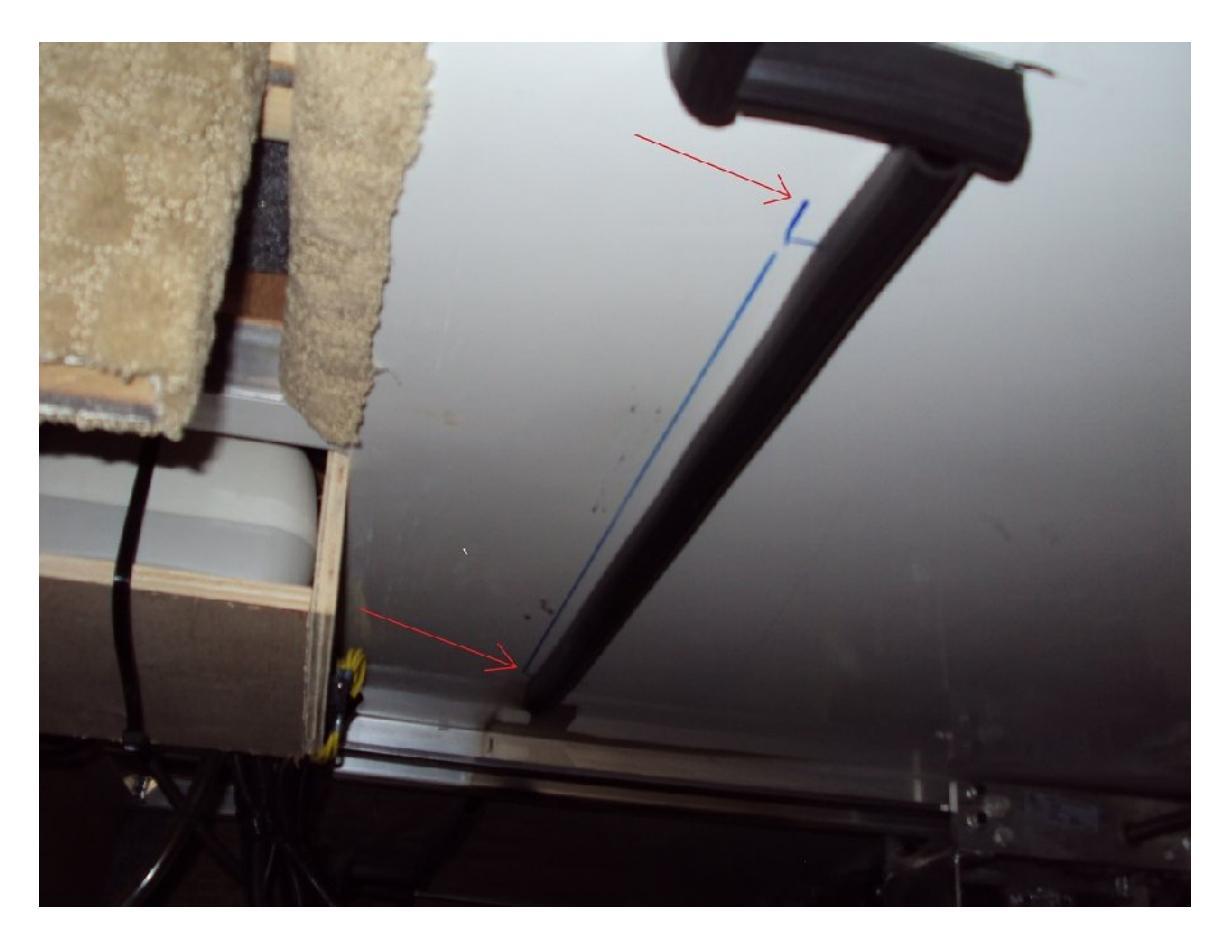
After a little research it became evident how the water was getting into the coach. Tiffin stuck two short pieces of black rubber gasket to the bottom of the bed. When the slide was extended the intent was for the slide's sidewall bottom gasket to mate with the two rubber gasket pieces stuck under the bed.

The idea has merit, however Tiffin's installed gasket was stuck along the blue line seen in the above photo and between the two red arrows on either side of the slide mechanism. The two pieces of gasket were a total length of maybe 5 feet however the beds slide width is over 7 feet wide. That left several feet of unprotected slide width with no mating gasket to prevent water or sunlight to enter. At first we did not even think about the morning sunlight as being a potential problem until one morning we were presented with what looked like a spotlight shining from under the bed. This was one of those early modifications we completed while on the way to the 2011 TRVN Cherry Blossom Rally at Cherry Hill RV Park in Maryland. The following photo shows where we installed the rubber gasket to the underside of the plastic bed platform. The portion circled in GREEN is the additional gasket we installed which had not been done by Tiffin. Both sides of the plastic bed platform required the same treatment. Recently we noticed

a couple of ends of the gasket had become unstuck from the bed. I decided to prevent any further gasket problems to install  $\# 6 \frac{1}{2}$ " long self-drilling screws at the end of each gasket piece. I hope that will prevent any further gaskets from getting loose.

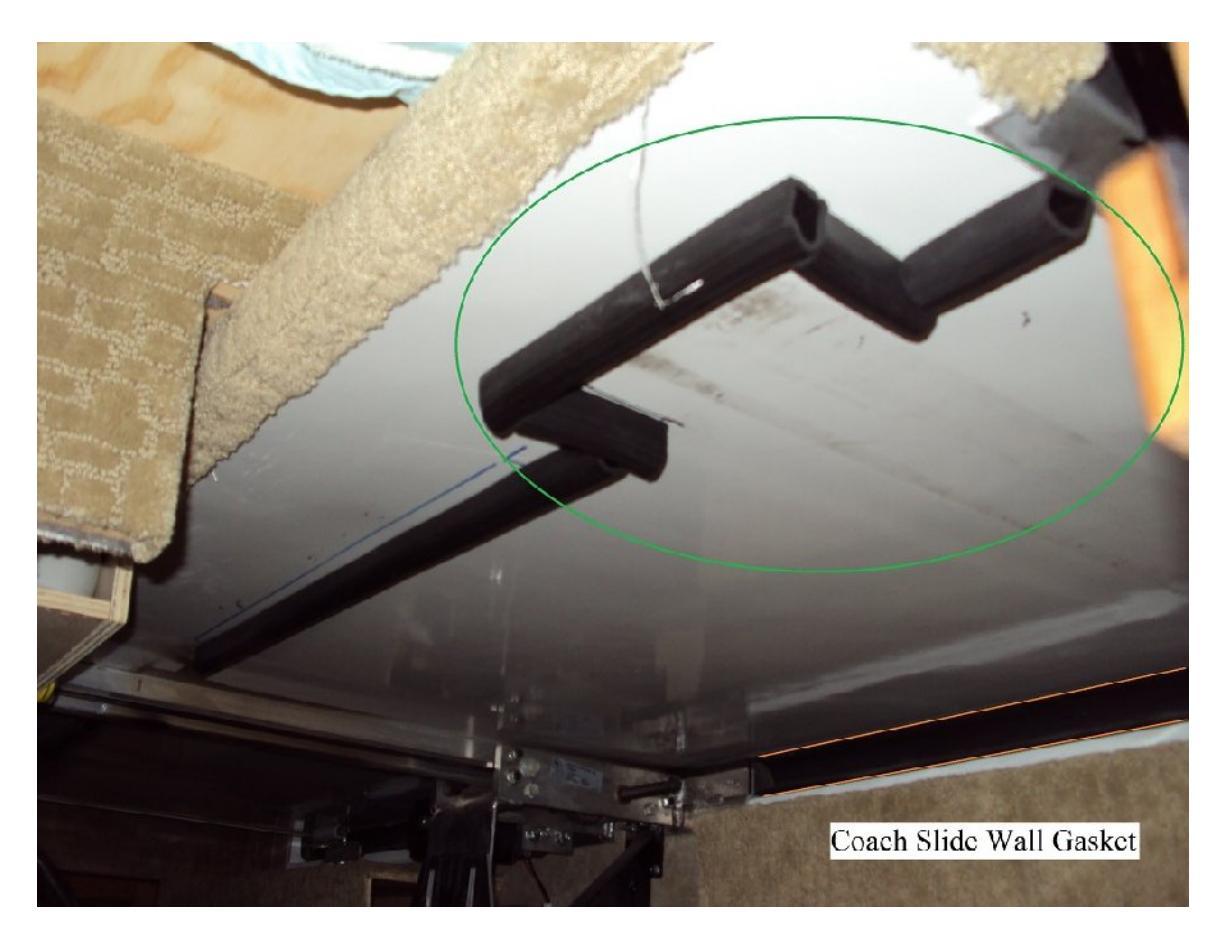
The Tiffin installed mating gasket is mounted to the top of the sidewall above, between the two ORANGE lines. When the slide is extended the idea is for the two gaskets to meet (mate) to prevent water or sunlight intrusion. To take the casketing a step further gasket material was installed around the paths of the two slide rollers.
