## 2010 43QGP Allegro Bus

**SEVENTY-NINETH - coach modification – ADDITIONAL LED FIXTURES IN THE REAR BATHROOM.** This modification was made based on a rare request by my wife. Cathey found the location of the over the sink lighting in the rear bath on our 2010 Allegro Bus did not allow her to clearly see what she was doing while putting on her makeup. The OEM location of the lighting placed too much light on the mirror and very little on her face and provided no lighting over her head.

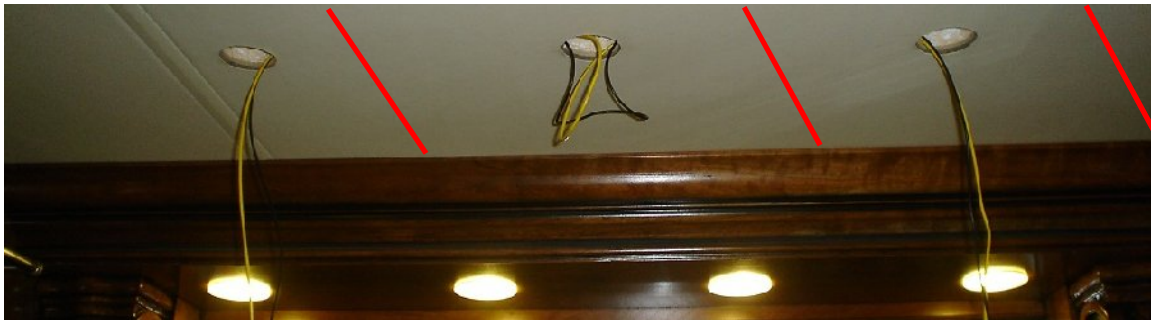
There are three structural members in this portion of the ceiling two of them are located between each of the new fixture locations the third member is located between the closet and the new fixtures. The structural members are denoted by the **RED** lines in the above photo. Those members are located on 16" centers at least in the area of this ceiling modification.

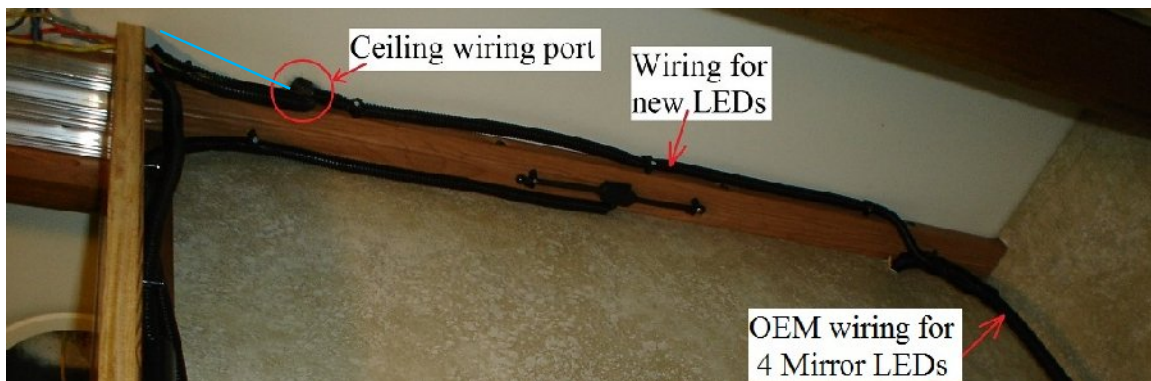
A heavy gauge steel wire was pushed thru the dense foam above the structural members located between each new fixture. 20 gauge wiring was used to power the LEDs 12+ VDC (yellow) and 12- VDC (black), after the hole was made the pair of wires were fished from hole to hole thru the ceiling foam. It was quickly discovered the easiest method was use the AC/HP supply duct as a chase for getting the wiring for the new LEDs back to the closet where the wiring for the four OEM fixtures was located.

To route the wiring the rear supply duct vent was removed, a stiff wire was pushed thru the wall of the supply duct into the hole made for the fixture on the right in the below photo. A ceiling wiring port in the closet seen in the above photo was used to push a wire back into the same supply duct where I was able to connect to the new wiring pull that pair of wires out thru the ceiling wiring port where the new wiring was soldered to the OEM wiring for the OEM 4 mirror LEDs. A piece of ¼" black loom was used to protect the wiring at the top of the closet. The **BLUE** lines denote the location of the wiring for the new fixtures. After all above wiring connections were made the seven LEDs are controlled by the OEM mirror light switch. After the wiring was installed inside the supply duct aluminum foil tape was used to secure the opening punched thru the duct for the wiring.
