5/8/2011

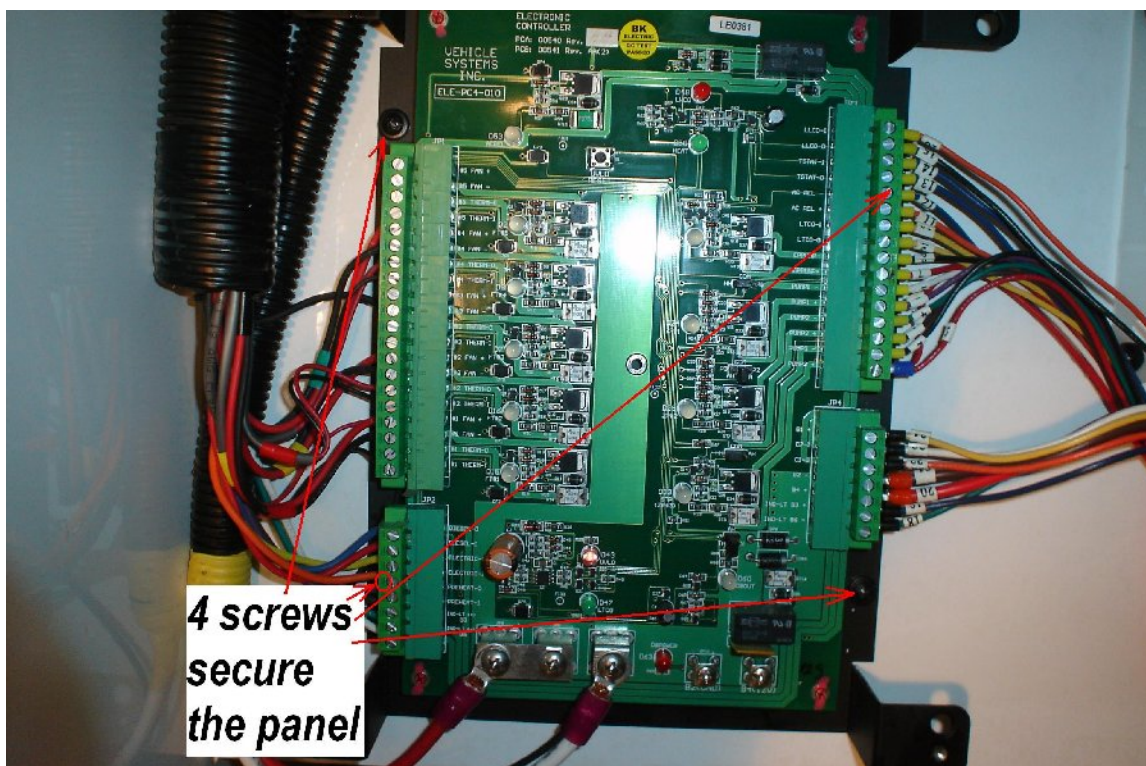
The one purpose for this FYI is to inform owners of an Aqua-Hot system of a potential problem which may affect your unit. On my unit the Tiffin worker did not properly secure the JP2 connector on the Aqua-Hot's electronic control panel. The only reason other than lazy I can think of is after installing the four screws which mount the control panel on the white back board the installer did not have a short screw driver to properly secure the JP2 connector screws to the control panel. The JP connectors JP1 through JP4 are mated with board mounted JP1 through JP4 connectors. At the top and bottom of each connector are small screws which are designed to be screwed into the board mounted connector. The JP2 connector was mated with the board mounted connector however the screws were not tightened. As already stated I believe the Tiffin employee did not have a screwdriver short enough to properly complete the installation, so the connector was just pushed on and left.

IMO, the JP2 connector **CAN** if not properly secured eject itself from its board mounted mate connector.
