2010 43QGP Allegro Bus

31A – FYI - COACH-STEP RV STEPS. The Lippert Component Company's "Coach Step" RV steps have been causing me a few problems recently. I will make this FYI in several parts to enable me to keep under the file size limit of 640KB.

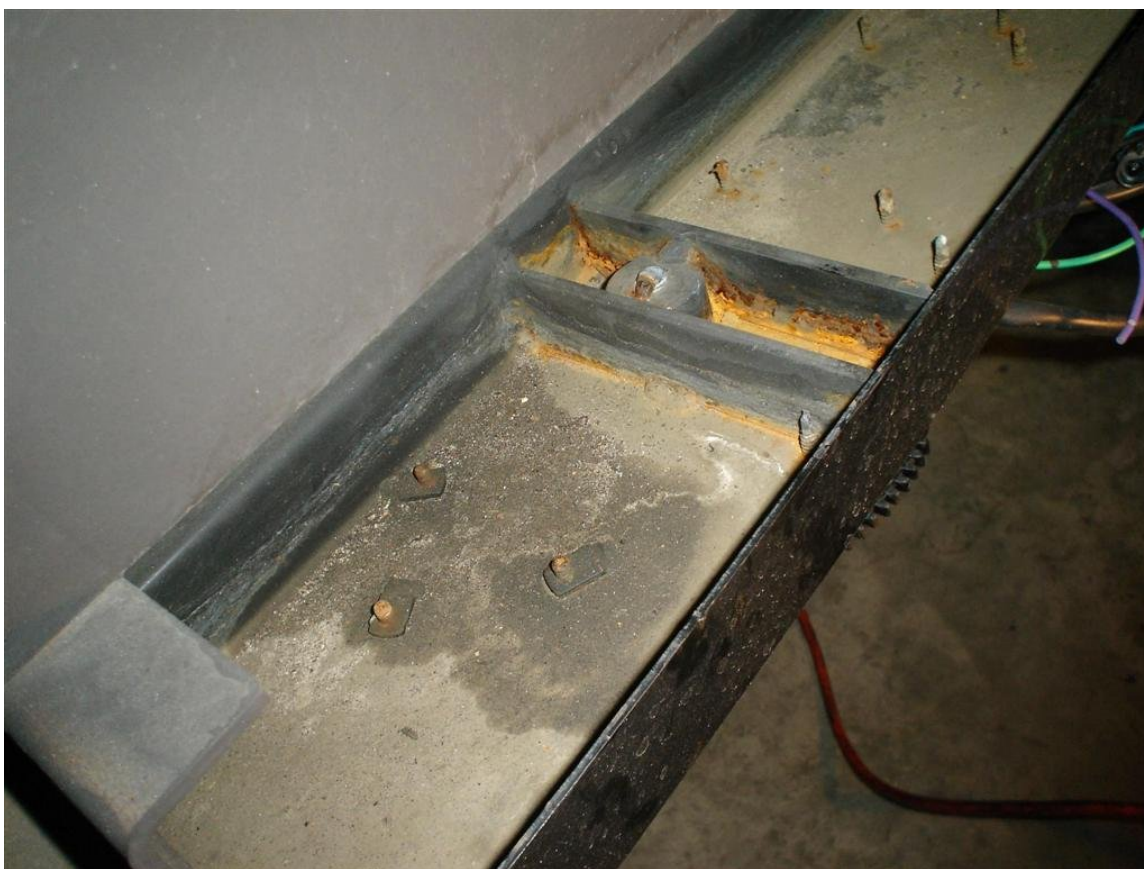
While replacing the step motor today I came upon the following mess, I decided to post my modification to the step assembly in a FYI in hopes it may help other owners to deal with this.

What can you do when presented with this type of mess? If nothing is done the step mounting assembly is are going to rust out, then what do you do? My first order of business was to clean up the mess, get rid of the rust and collected debris then drill two 3/8 inch drain holes in each of the three pans which had been accumulating water, dirt and anything else kicked up.

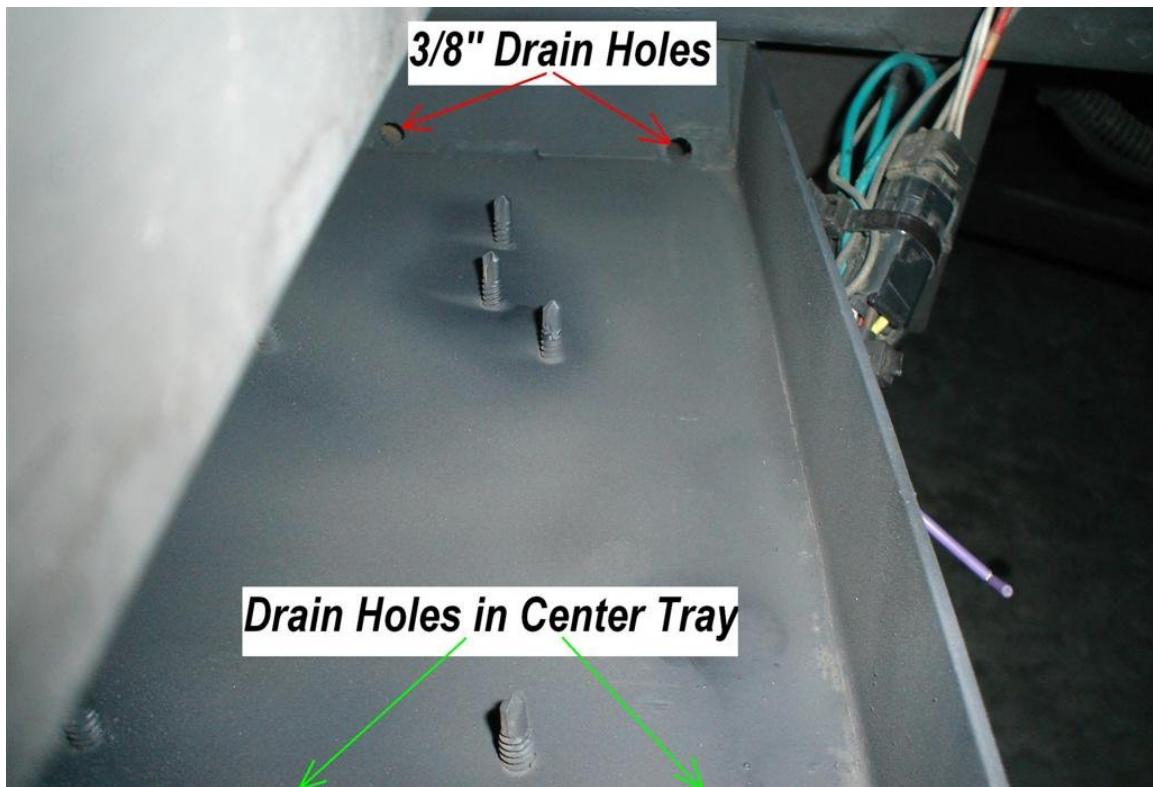
After cleaning the metal and drilling the holes, the metal was first primed then painted in an effort to retard rusting.
