2010 43QGP Allegro Bus

36 – FYI – CLEANING THE SLIDE END WINDOW. As a result of a thread on the TRVN forum, I checked the window on our Allegro Bus. We have one small window in the driver side slide and two of the same windows installed on both sides of our bed which is located on the bed slide.

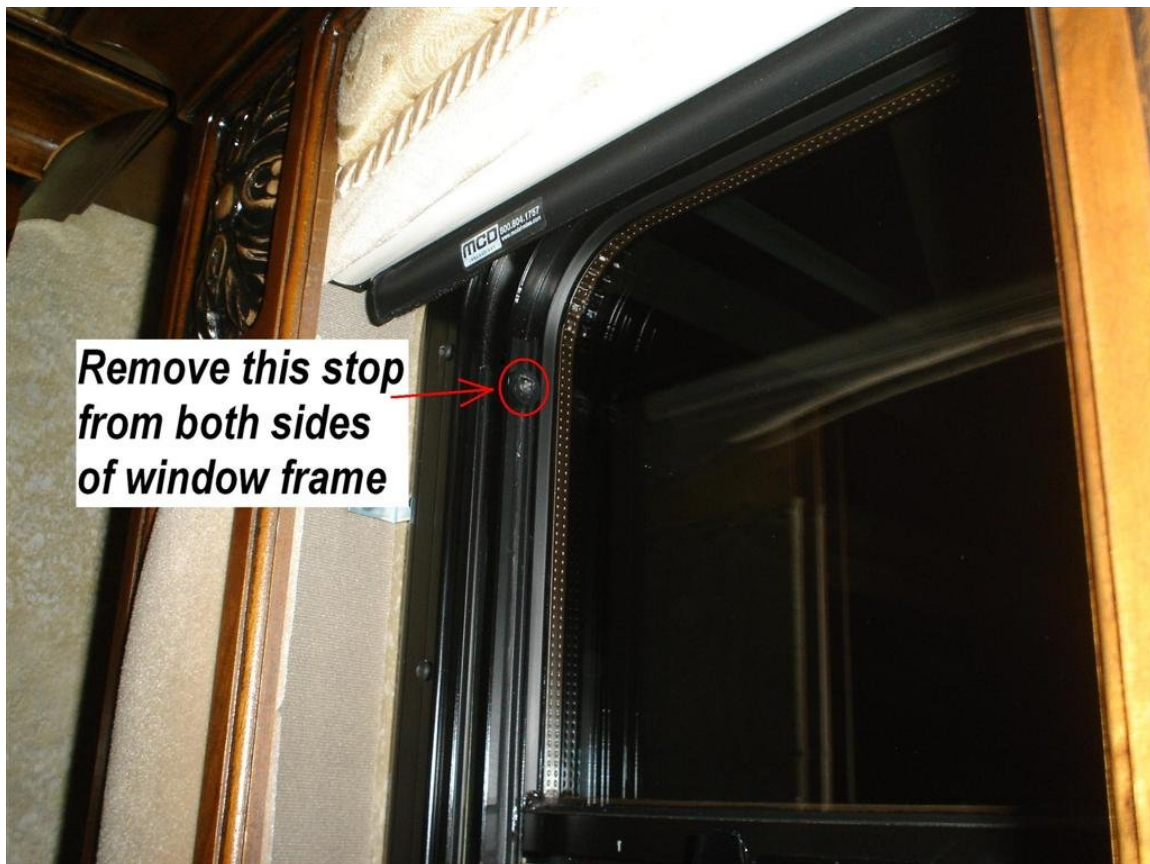
I found as others have posted the screen cannot be removed without removing the window's inside trim. I do not think removing the trim is a safe method to clean the window. So after thinking the situation over this is what I decided to do. I removed the two window stops screwed into the window track. After the stops are removed the window can be raised high enough to allow cleaning the entire inside of the window without removing the screen.

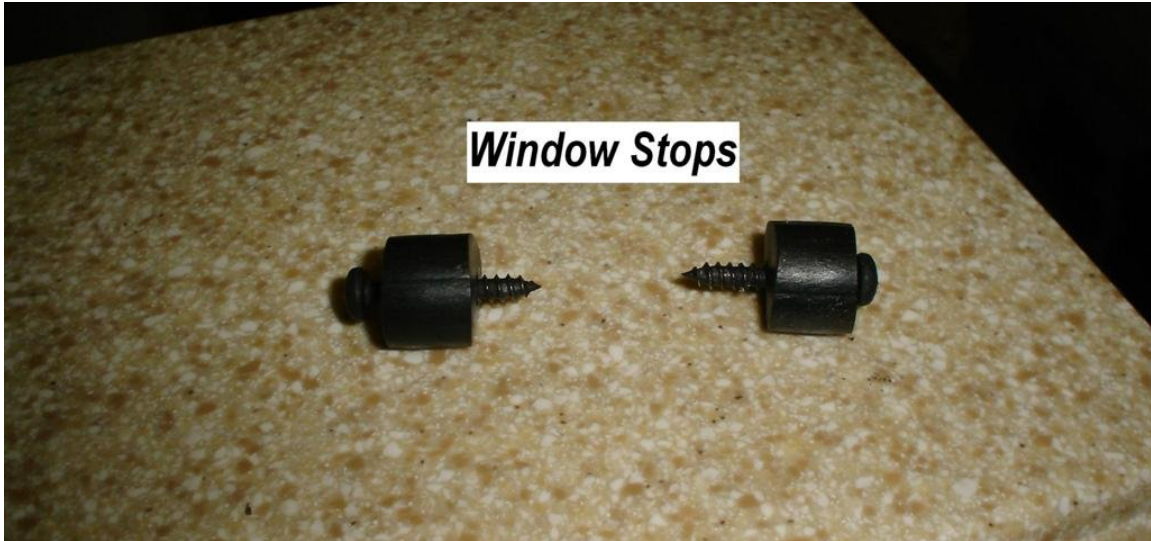
The window clip used to hold the window open is mounted on the right side of the frame. The window clip must be held back so the window can be raised past and above the clip.

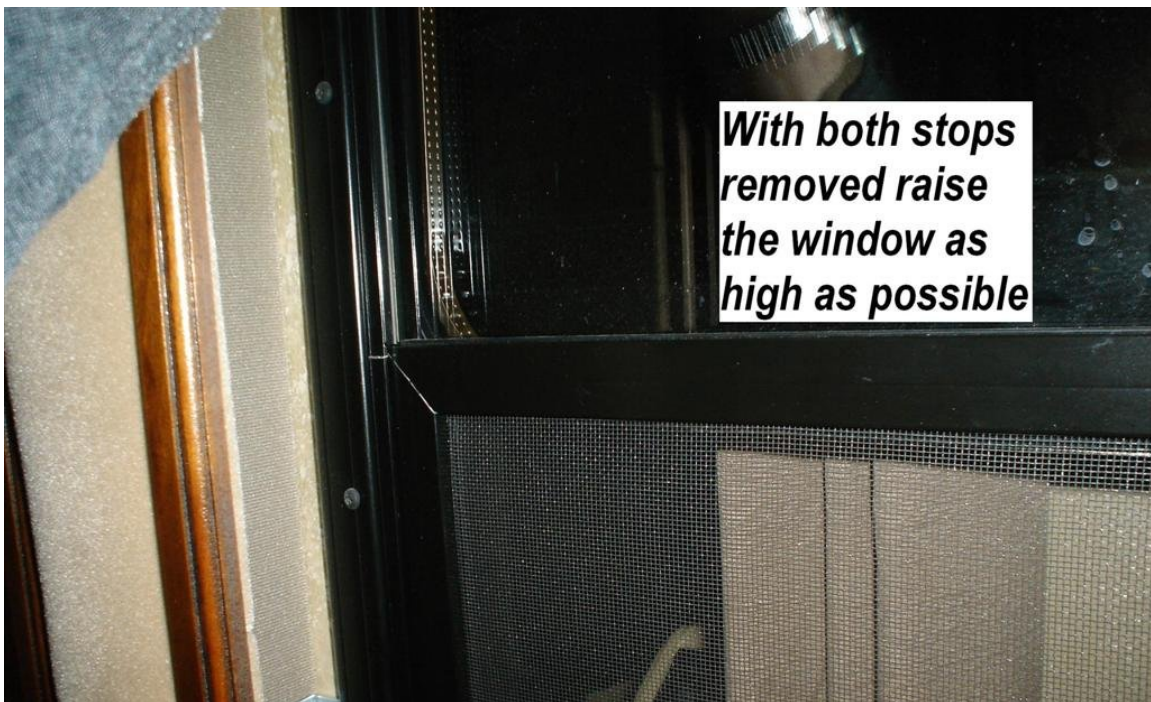
As seen in the below photo the window can be raised enough with the two rubber stops removed to allow accessing the entire inside of the slide window for cleaning.

The above allows access for easy window cleaning on our 2010 Allegro Bus.
