## 2010 43QGP Allegro Bus

**44 – FYI - OPENING THE GUEST SPOTLIGHT.** Why you say do you need to open the spotlight, because the bulb is blown, the only way to install another 50 watt Halogen sealed beam bulb is to open the housing. What does Tiffin do to make this job harder then it would usually be they paint the spotlight enclosure which hides the seams making disassembly impossible if you do not know the location of the painted over/hidden bulb housing access seam.

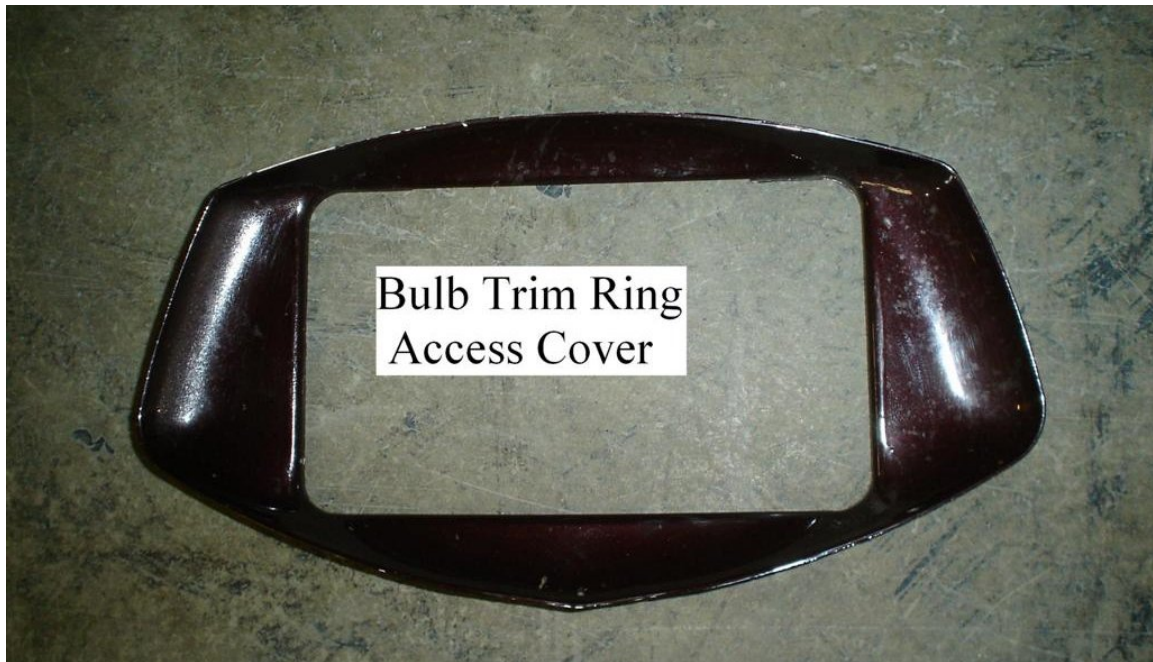
This Guest Remote Control Spotlight Model number 22200 uses a 50 watt Halogen bulb with a 100,000 candlepower beam, the bulb part number is 22230. This spotlight is also known by the name, Guest M-100 Spotlight. The whole secret is the knowledge of where the trim ring seam is located under that layer of paint.

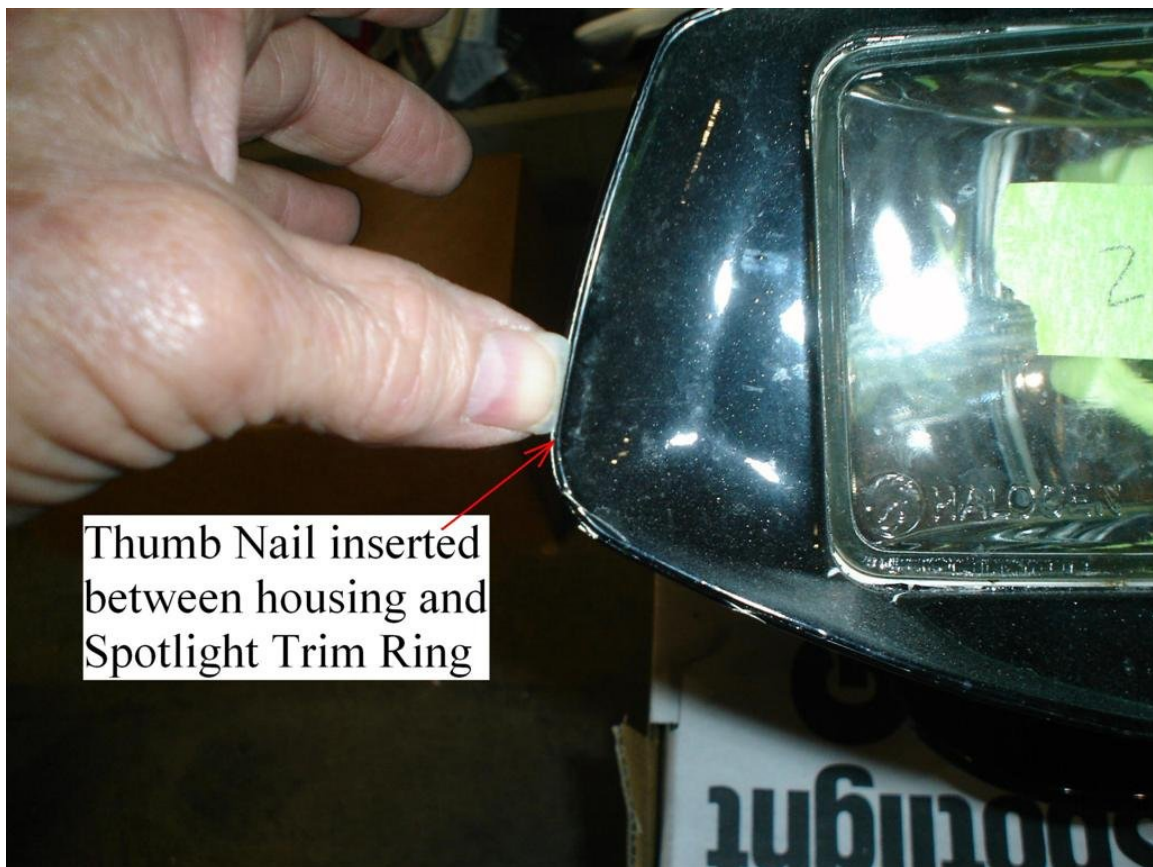
To demonstrate the location of the trim ring to housing seam I inserted a thumb nail between the two pieces.

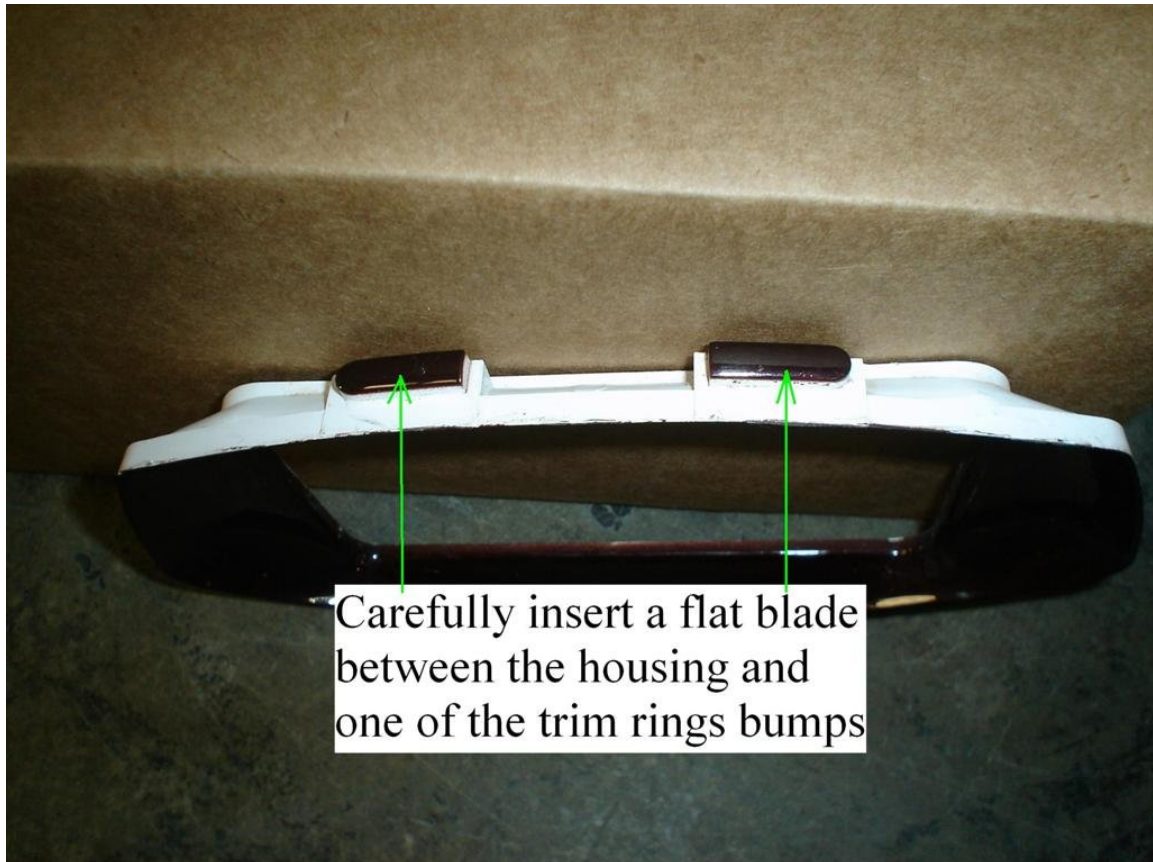
At the bottom of the housing near the trim ring is a single bump which locks the trim ring in place at the bottom of the housing. While on the top of the housing are two similar bumps. By carefully inserting a flat blade into the seam between the trim ring and the housing the ring can be separated from the housing.

Taking this FYI to the next step can be done by someone whose spotlight bulb no longer illuminates the night.  
Good Luck.
