2010 43QGP Allegro Bus

4/3/2012

49 – FYI - NEW DRIVER SIDE DRIP RAIL. During the Aluminum cap rail installation Tiffin is installed new drip rail on the driver side. Previously the driver's side did not have a drip rail just a piece of aluminum trim with screws through it to hold the roof to the sidewall, then a vinyl trim installed to cover the aluminum strip.

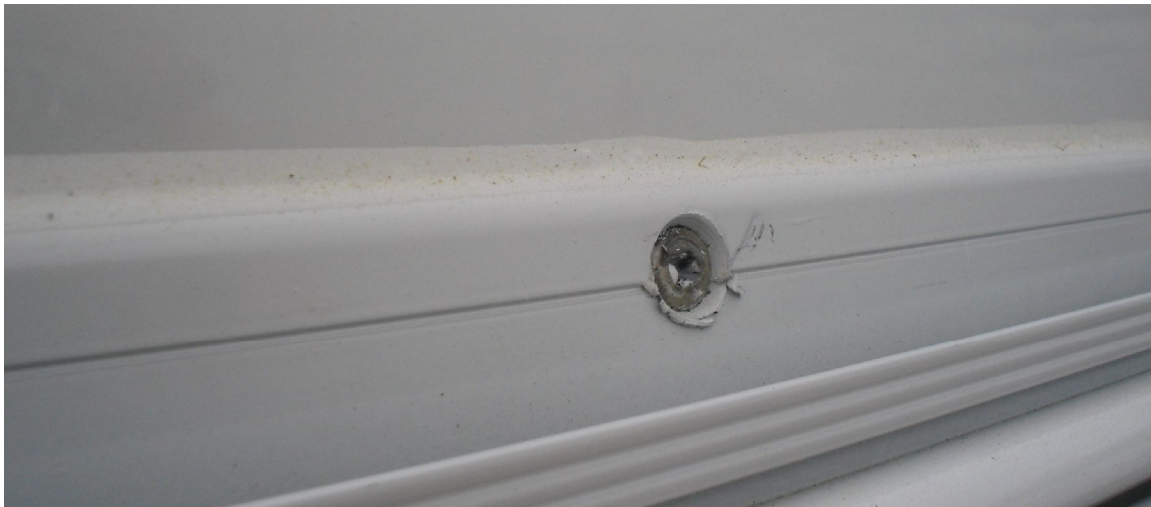
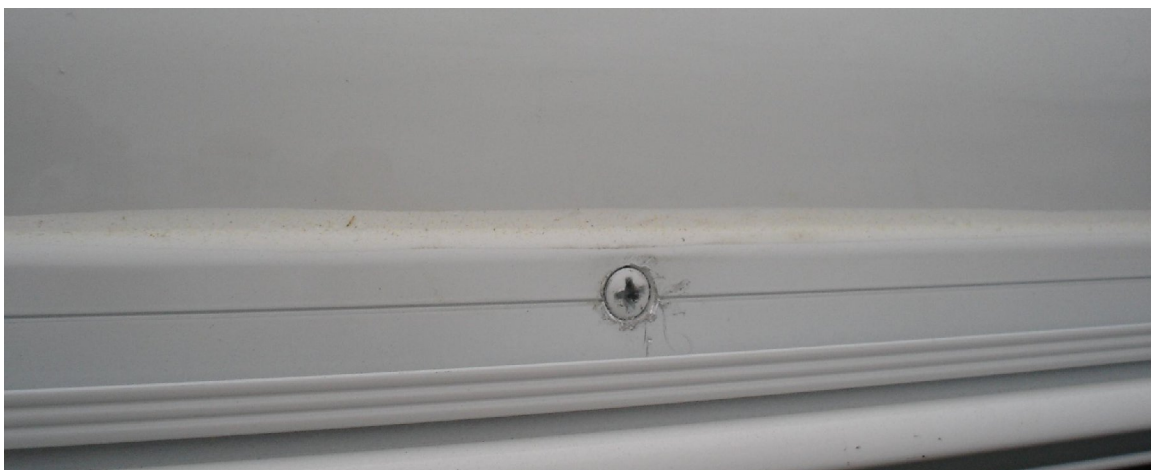
I looked at the two 20 foot pieces of drip rail as they lay on the floor prior to installation on our coach. I noticed the drilled mounting holes were not cleanly drilled leaving many burrs around each hole. Little did I know at that time during installation after the screws were installed the burrs were left intact to snag any cleaning cloths that would pass its way.

After Victor and George, bay 36 finished installing the cap rails, when we got back into the campground I got out my ladder and proceeded to remove any burrs from around each hole in the new drip rail. After the burrs were removed a flat punch was used to make sure the area around each hole was flat and would not snag any of my cleaning cloths in the future when the coach was being cleaned. In my opinion the burrs needed to be removed prior to the painting of the cap rails, the painting was scheduled for the following day. Attempting to remove the burrs AFTER the cap rails had received their final coat of paint would have made a mess of the new paint.

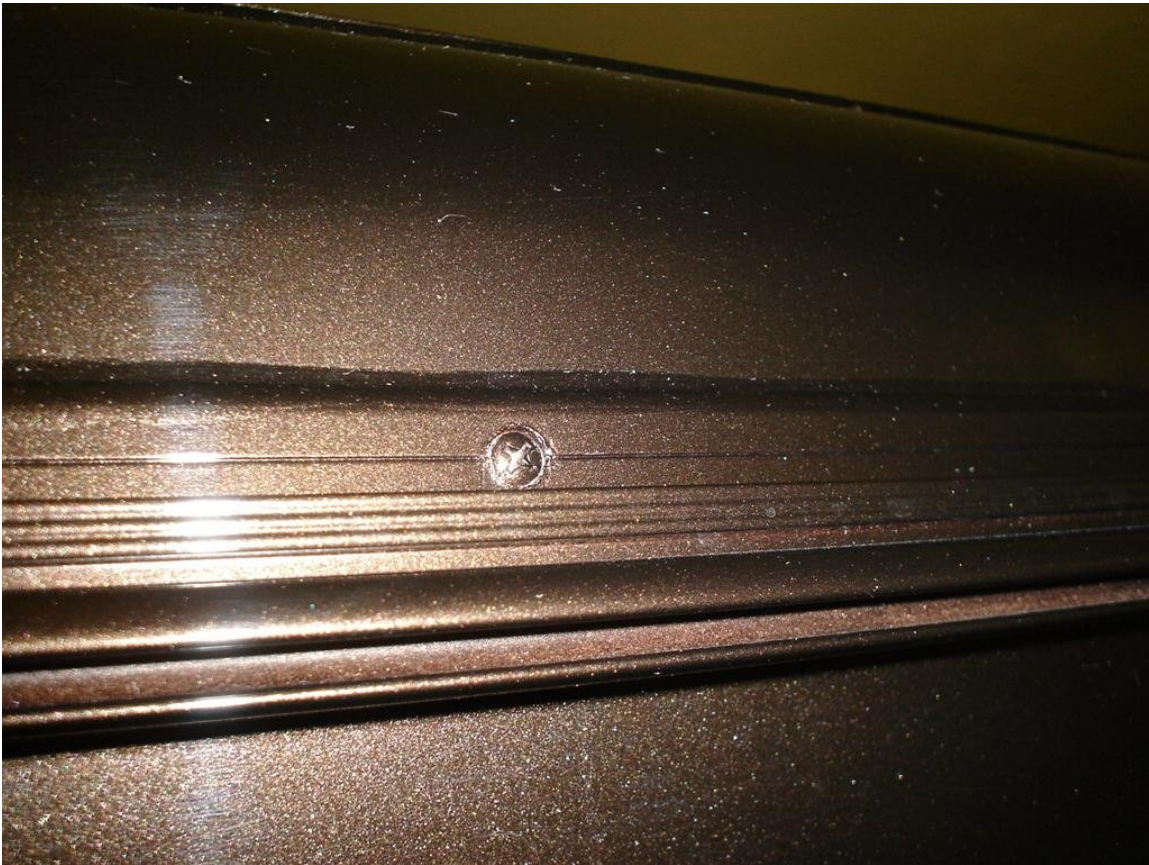
The new cap rails and new paint is not the prettiest in the world, but we hope they serve their primary function. That function is to keep the coach dry with minimum maintenance in the future.
