2010 43QGP Allegro Bus

4/8/2012

50 – FYI - CAP RAILS OVER THE YEARS. As a piece of interesting trivia I took photos of Tiffin coach's with three different types of Cap Rails. The first photo was taken at Red Bay of an older than 2007 Phaeton it may have been a 2006 or older I really do not know. However below is the photo, you can see Tiffin used a more domed roof with this method of cap rail installation. The fiberglass roof to aluminum cap rail was secured with an aluminum trim strip then vinyl was installed with screws securing the completed method, then self leveling caulk was applied to the screws.

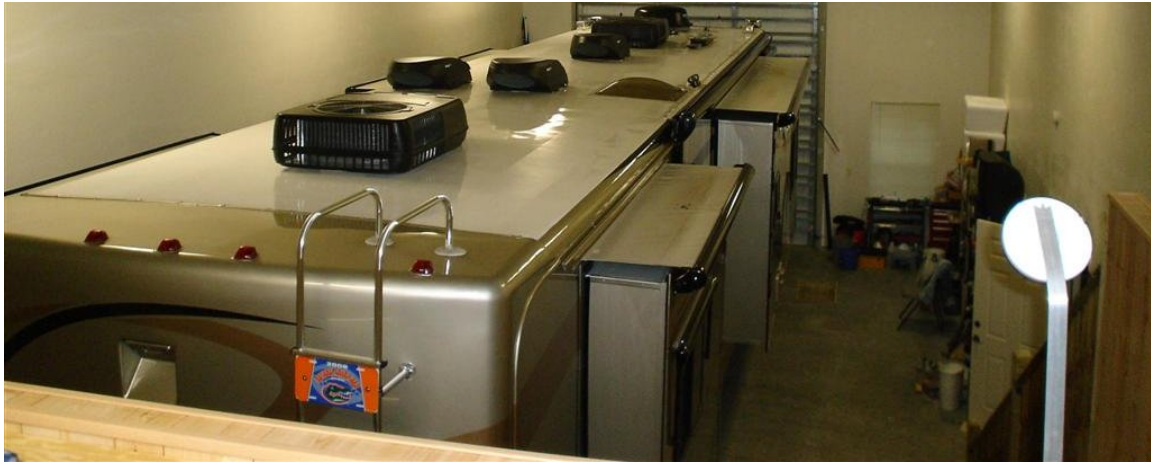
I believe during the 2007 model year Tiffin began using full sized roof panels which were manufactured with both cap rails as part of the complete fiberglass roof panel. The panels were all manufactured longer than needed for each specific model rolling down the line. If the coach was going to be a

40 foot Phaeton the panel was manufactured long enough to do the job and no longer to save waste. Below is a photo of my 2007 Phaeton with the one piece roof panel, notice the flatter roof design.

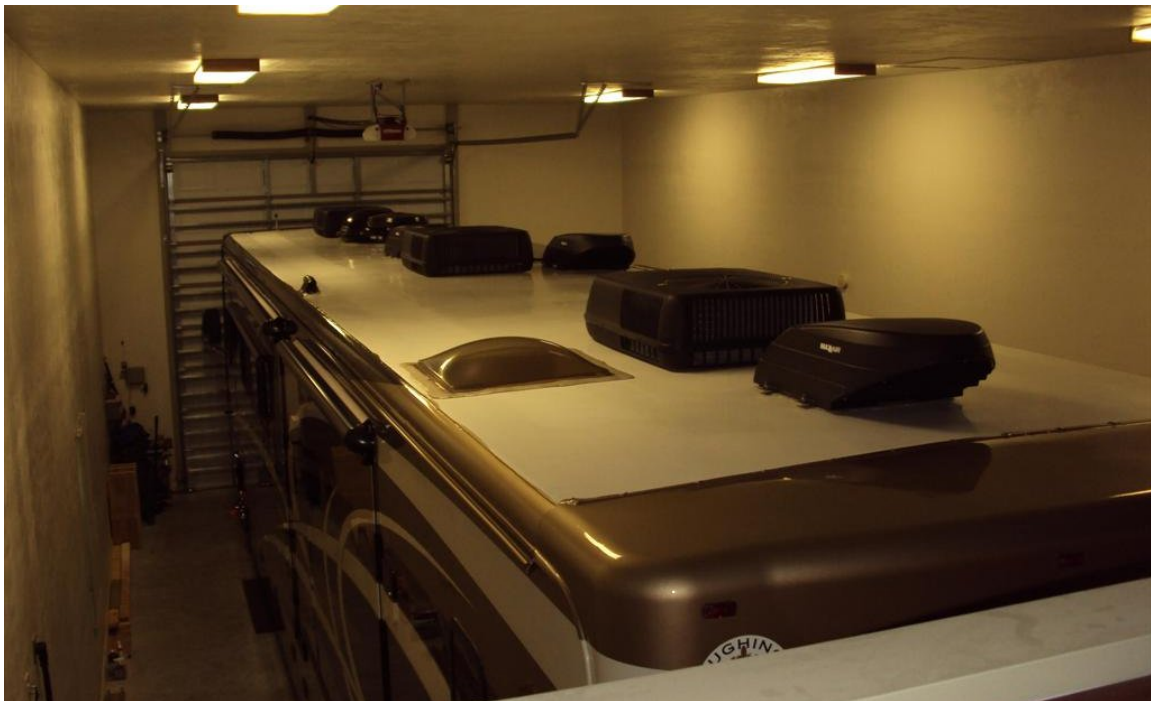
Now we come to our 2010 Allegro Bus with the new aluminum cap rails which replaced the OEM fiberglass cap rails.

We all hope this is a long term fix for this Tiffin problem. At this point the finished product looks good the glue used to form the aluminum to fiberglass bond looks good and tight. Time will be the ultimate test of this repair.
