## 2010 43QGP Allegro Bus

**83 – C - FYI – REASONS TO CLEAN YOUR RV'S DRIVE WHEELS AND TIRES.** To begin the drive axle wheel removal I start by loosening the lug nuts prior to jacking up one end of the drive axle using a 20 ton air over hydraulic jack just high enough to allow removal of the wheels and tires. **CAUTION:** THIS IS WHERE I POINT OUT A KYAS (Keep Your Axx Safe). This is my method of safely removing the drive axle's brake drums. Make sure the coach has maximum air pressure in the air system. When you are ready to remove the drive axle brake drum, block the front and rear of the opposite side's drive axle tires to prevent the coach from moving. Go inside the coach and DEPRESS THE PARKING BRAKE SWITCH (just like you would if you were traveling). The air pressure will keep the brake shoes RETRACTED allowing the brake drum to be slid off the brake shoes. While the brake drum is removed DO NOT PLACE ANY BODY PARTS TO BE EXPOSED TO INJURY IF THE SHOES WERE TO SUDDENLY EXPAND.

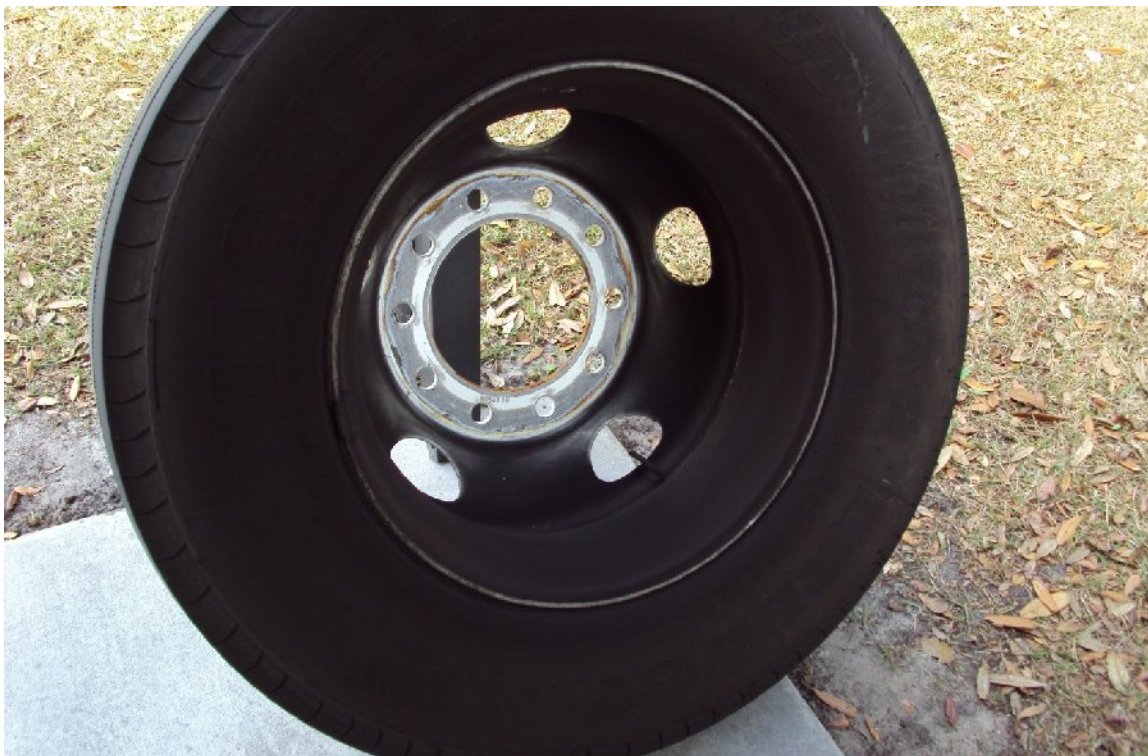
The previous photo shows three years of dirt, grease, road tar, Tiffin's undercoating and coach paint over-spray on inner tire and a WHITE steel wheel. As previously mentioned in file "B" it takes several applications of de-greaser, and Acetone to remove the built up layers. The paired aluminum wheel after cleaning is polished to remove stains then buffed to a high shine.

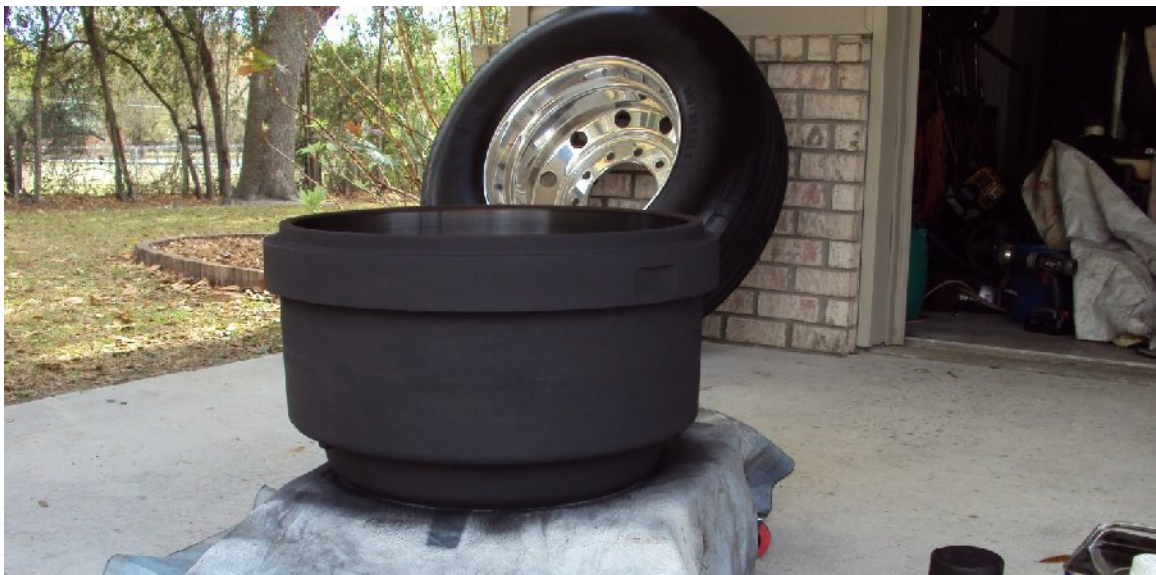
Not much to add to these photos. The top photo shows the brake foundation after cleaning and light sanding of the brake shoes to remove any surface debris.

The brake drum riding on the creeper has a drop cloth over the blocks to protect everything from my over-spray while painting. After wire brushing and cleaning the brake drum was painted using high temperature black paint.
