2010 43QGP Allegro Bus

87 - FYI – DRAINING AND REFILLING THE ALLEGRO BUS POWERGLIDE FAN DRIVE GEARBOX LUBE.

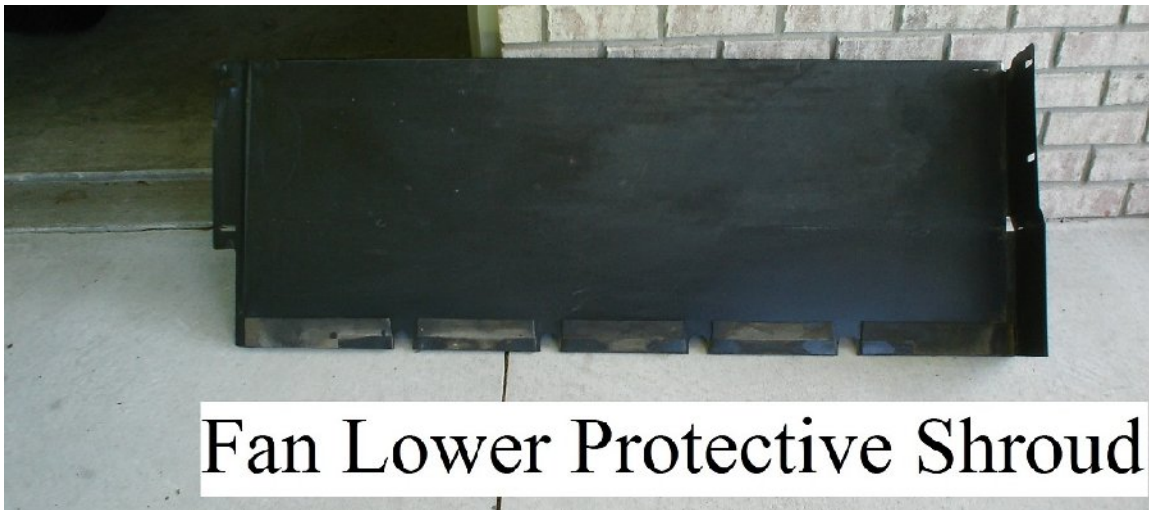
While researching the coach maintenance I received mixed maintenance data on the lube in the gearbox, one source stated the lube is to be replaced on an annual interval while a second source states replacing the lube on a bi-annual interval. This maintenance will be performed on bi-annual interval. I found the easiest method to access the gearbox for draining the old lube was to remove the fan's lower protective shroud secured with eight bolts, after the shroud was removed I was able to access and remove the 3/8" hex plug and drain the old lube.

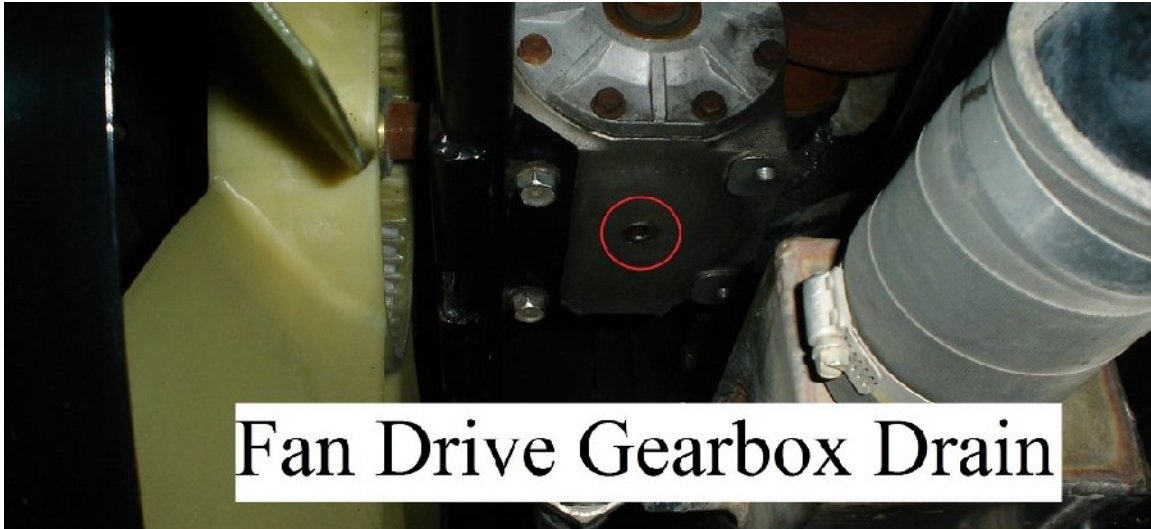
Tiffin installed Shell Spirex 75W90 synthetic gear lube when the coach was constructed the fluid capacity of the gearbox is 24 ounces or $\frac{3}{4}$ quart. Locating a source for the synthetic lube took several months as most suppliers wanted to sell quantities too large for my needs. Finally located a source in Red Bay, Bay Diesel where 5 gallons was purchased at \$ 37.00 per

gallon. The Shell Spirex lube is also used in the coach's rear differential which will be serviced in January 2014 using 14.5 quarts of the remaining 19.25 quarts.

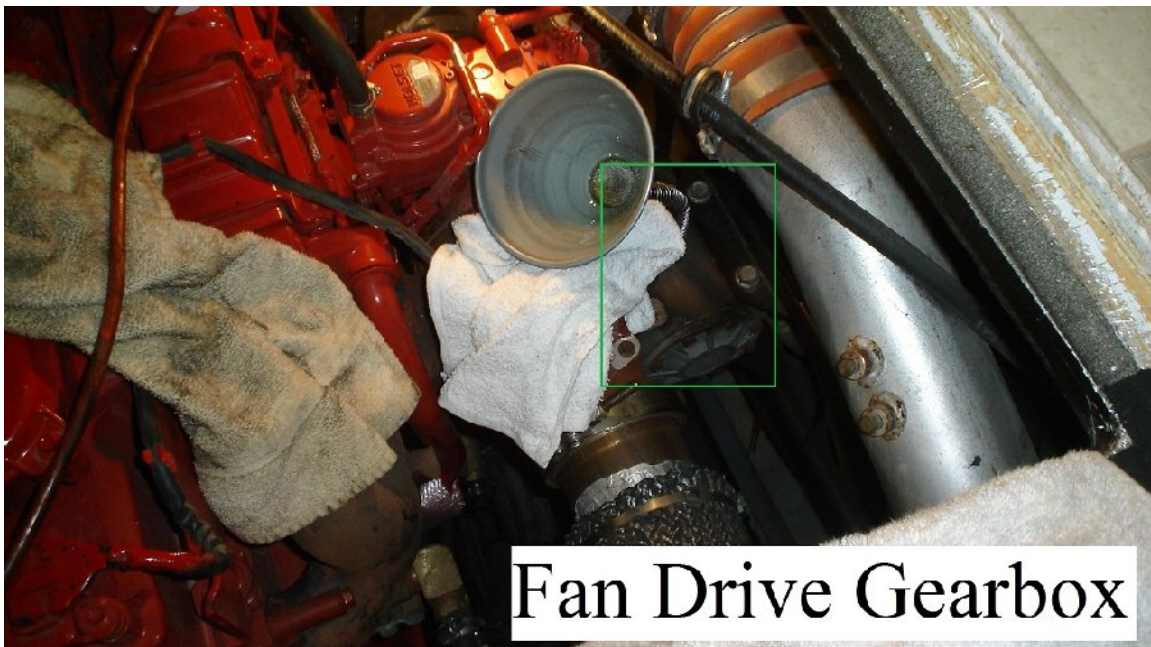
After the old lube had been allowed to completely drain the 3/8" plug was reinstalled. The engine access cover was removed to gain access to the 3/8" plug on the top of the gearbox where 24 ounces of new Shell Spirex 75W90 synthetic lube were poured in using the below funnel with a long flexible tube.
