## 2010 43QGP Allegro Bus

### 89 - FYI – REPLACING THE POWERGLIDE COOLANT TUBING.

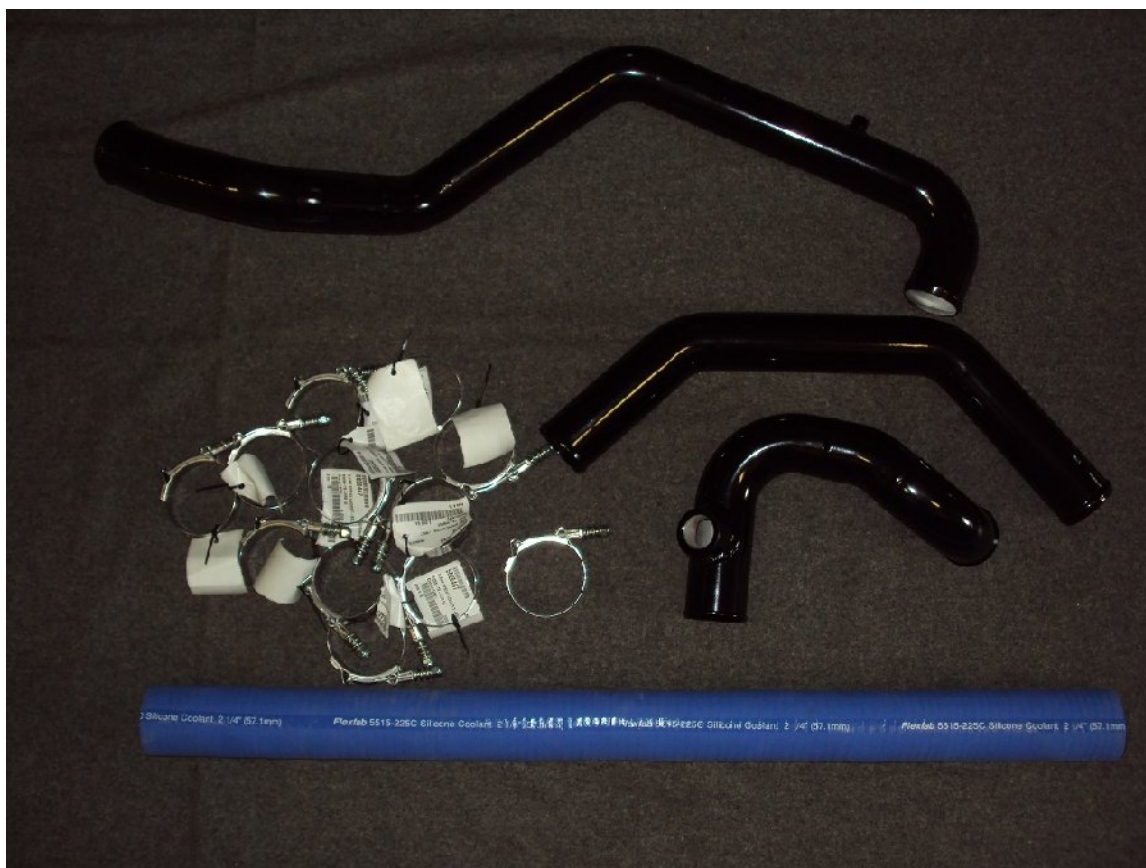
Three black powder coat painted coolant tubes, twelve constant tension “T” bolt clamps, and three feet of 2 1/4” silicone water/heater hose.

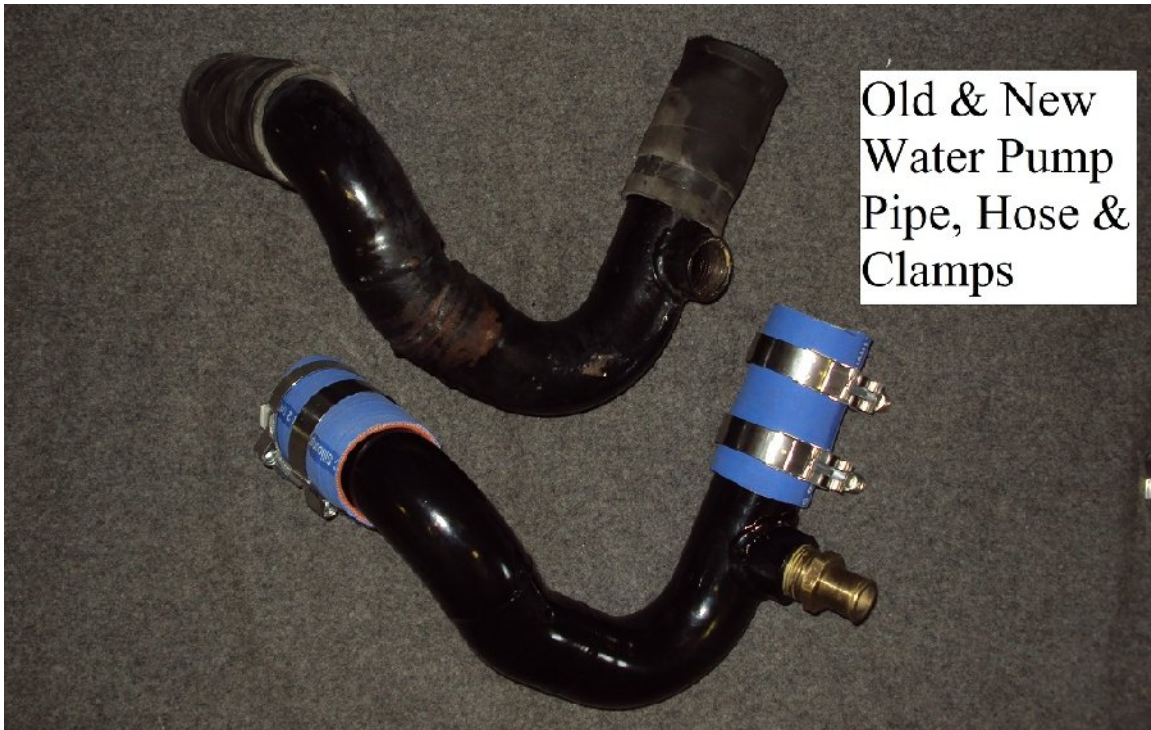
Two hours were consumed draining 11 gallons of coolant into three five gallon buckets thru the engine mounted coolant drain petcock near the water pump. Next item on the list remove the three coolant tubes, starting with the lowest tube first (above photo) in order to drain the remainder of the coolant still collected in a few low points. Next removal of the tube in below photo.
