## 2010 43QGP Allegro Bus

### **122- FYI – WINDSHIELD WASHER WIPER ARM HOSE**

**REPLACEMENT.** After almost five years the driver's side Windshield Washer wiper arm hose decided it was time to break. Replacement wiper arm hose kits had been previously purchased from Tiffin's Campground Store, the kit is # 83860 and cost at the time of purchase \$ 2.80 for a four foot section of hose.

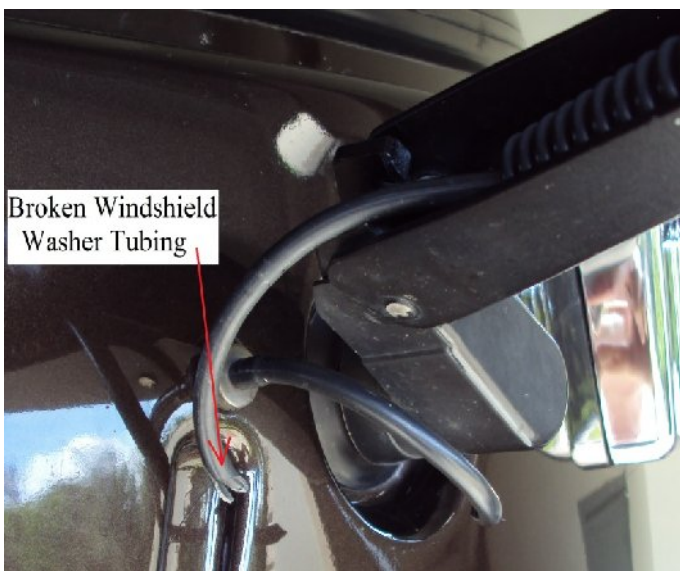
As seen in the photo the wiper arm hose cracked requiring the hose to be replaced. Tiffin sales the wiper arm hose in four foot sections, on our 2010 Allegro Bus the four foot section is just barely long enough to replace both hoses using one kit. The hose reaches from the brass hose attachment mounted in the front cap to the spray nozzles mounted on the wiper arm.

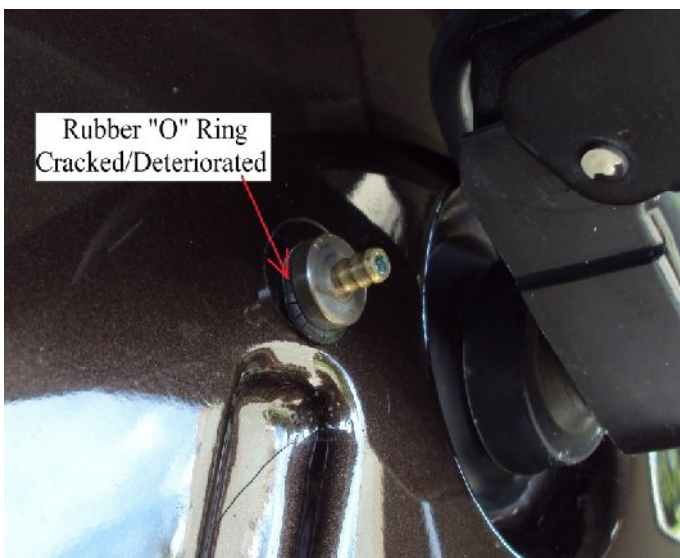
In addition to the hose, the small rubber "O" rings installed between the brass hose connector and the fiberglass front cap had deteriorated and cracked. While working on the wiper arm spray system decided it was also a good time to remove the hose spray connector from the front cap, install new rubber "O" rings and remount the connector.

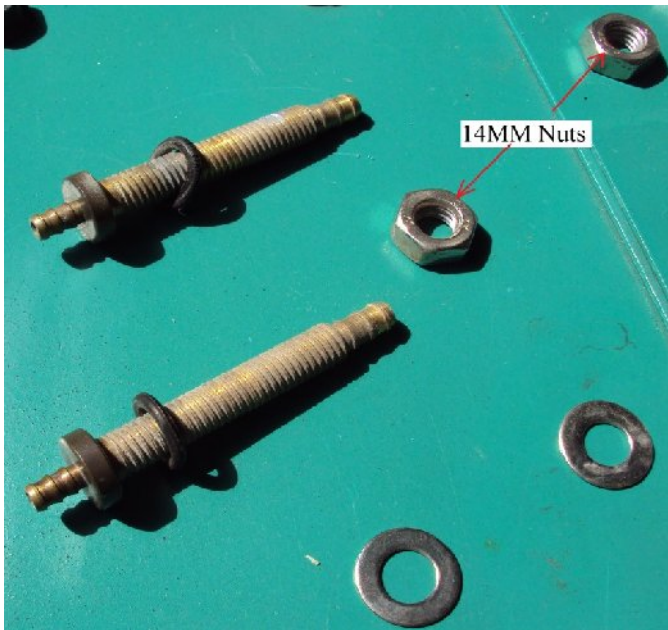
The spray hose brass connectors are inserted thru the front cap a washer is placed over the brass connector on the inside of the front cap then a 14 MM nut is installed.

I used the smallest diameter rubber "O" ring in my toolbox however care is necessary because as the nut is tightened the rubber "O" ring will distort and bulge out from between the front cap and the brass connector. If the nut is

too tight causing a bulge just back off a turn or so on the nut to relieve the "O" rings bulge.

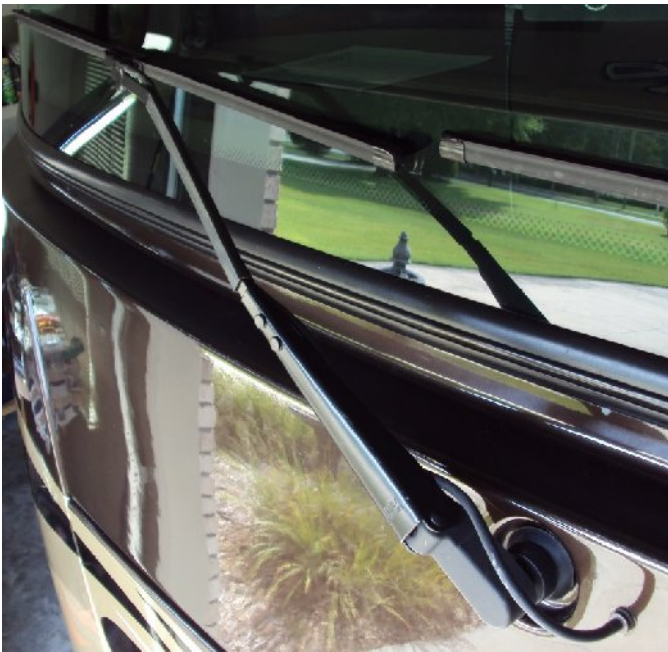
As seen in this photo the finished product looks just as good as the OEM unit.
