2010 43QGP Allegro Bus

123 - FYI – HOUSE BATTERY SLIDE TRAY, BATTERIES AND BATTERY CONNECTIONS.

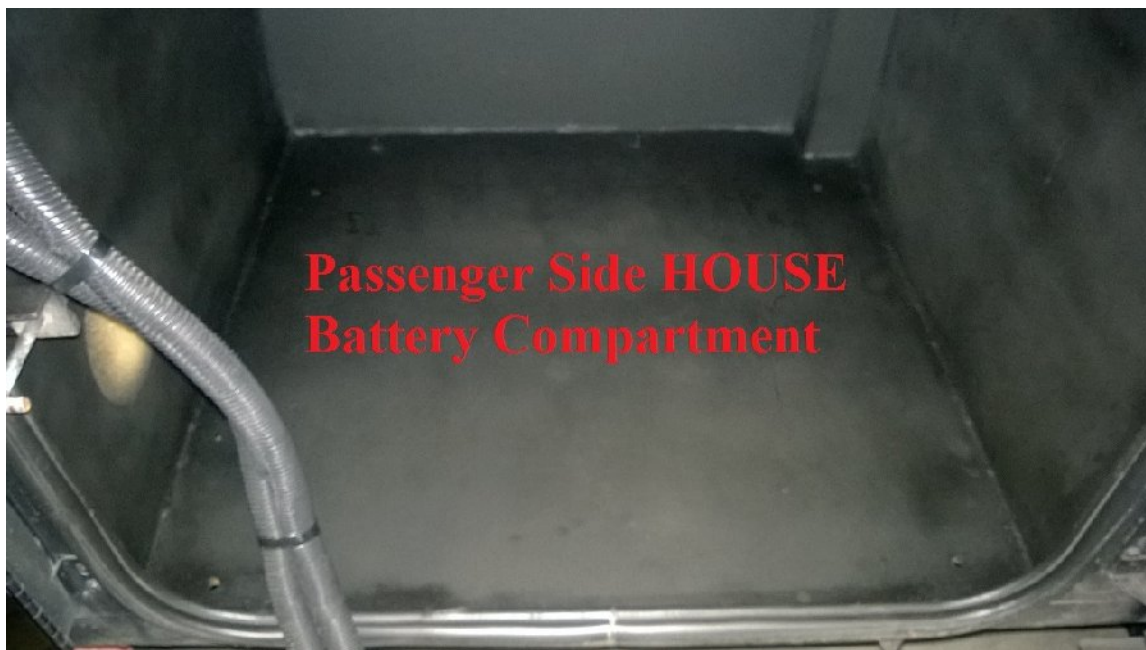
Our coach has **TWO** HOUSE battery compartments after the event where everything in the battery compartments got wet. Everything was removed from both HOUSE battery compartments the compartments were cleaned the surface rust was removed along with the dirt and other debris thrown up from the road. The compartments were painted with two coats of black rubberized paint then allowed to dry. While waiting for the paint to dry the batteries were checked, the battery terminals were cleaned to remove the old terminal protectant. The battery trays were cleaned, the black paint on the trays was touched up where needed before lubricating the battery trays slide mechanism.

After waiting for the rubberized paint to completely dry the battery tray was reinstalled. I use stainless steel bolts, Nylock nuts and washers to secure the

tray in place. With six batteries and the tray extended there is a lot of weight cantilevered out to the side of the coach.

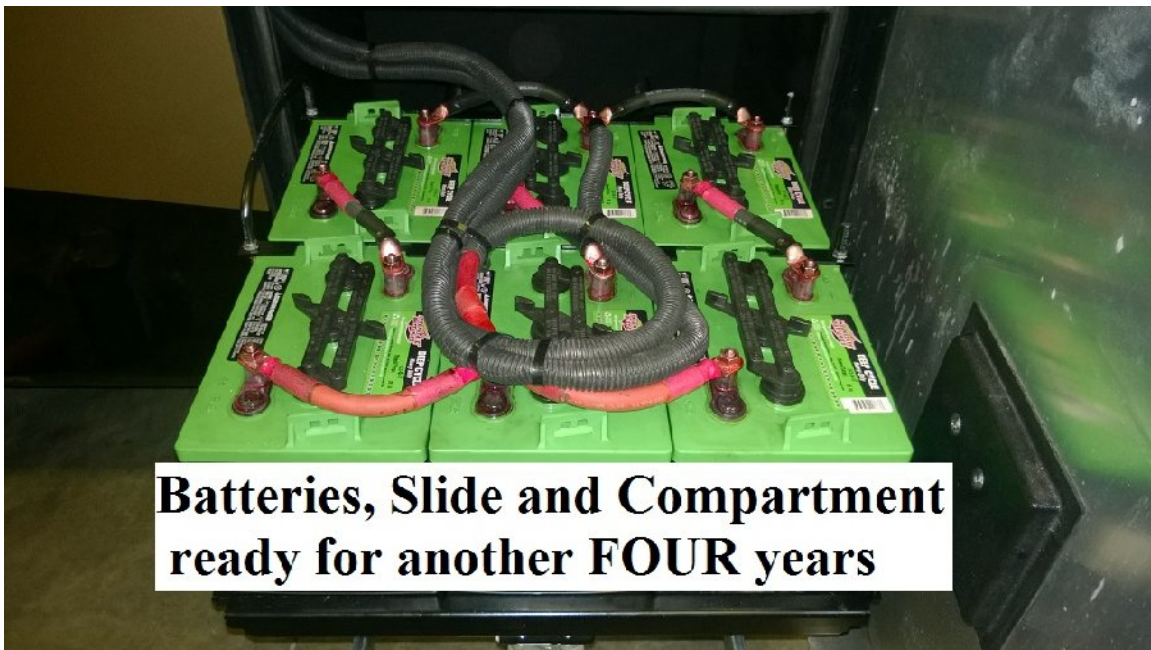
Two pieces of cardboard protect the batteries from overspray from the painting of the terminals with protector paint. Care is taken to make sure the terminal and cable connection are both well covered.

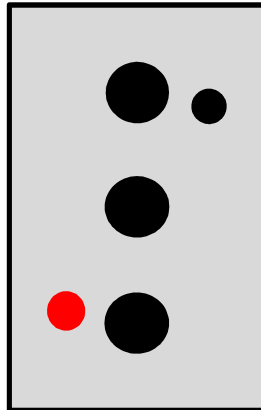
Interstate GC2-HD Battery Dimensions

7.12" WIDE

10.25" LONG

10.25"
LONG

11.12"
TALL

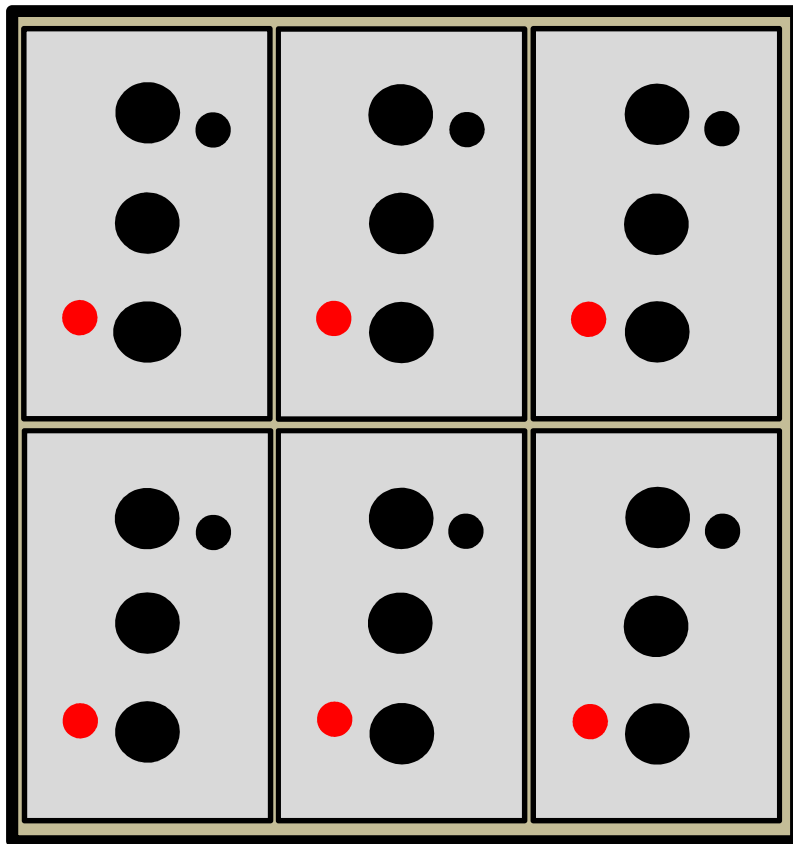
Battery Tray Dimensions 21" x 21 9/16"
