## 2010 43QGP Allegro Bus

**126 - FYI – REPLACING THE SLIDE TOPPERS.** Our coach is over five years old, when not on the road it is stored inside an enclosed garage so we were surprised at seeing light shining thru all four slide toppers recently while parked under bright lighting, tailgating at our favorite college. As many other owners have done we ordered the four slide toppers thru Tough Top Awnings. From time of order to delivery was five days that time included a weekend. After reading the replacement information on the Tough Top Awning website, we were ready to install the new slide toppers yes, WE I drafted my wife to assist me with replacing the slide toppers. After the new toppers were delivered and before stopping outside work for the day we removed the awning topper cover from the passenger side front slide. The next morning everything was ready to start replacing the toppers until the phone rang, Cathey's niece called to tell us Cathey's sister had been taken to the ER with chest pains during the night. So off to the hospital we go, after lunch Cathey told me to go home no sense in me sitting there waiting for test results.

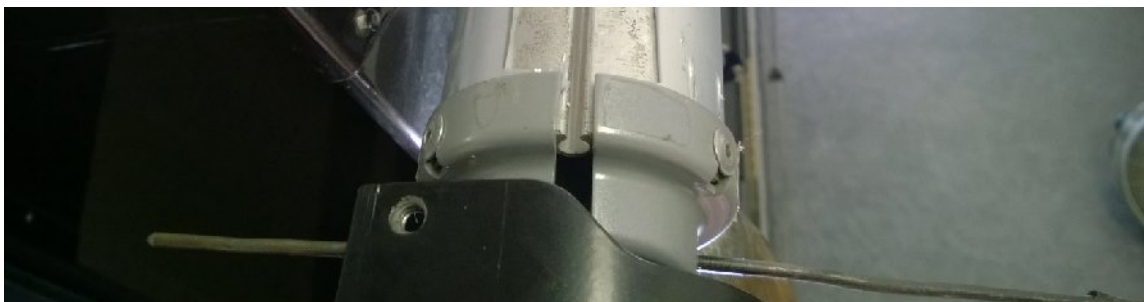
At a loss (no assistant) I decided to at least remove the old PS front topper. The method used in this case was to partially extend the slide then using a pair of locking oil filter pliers the roller tube was unwound, a half turn at a time. After each half turn a 10 gauge (1/8") steel wire six inches long was inserted thru the left end cap shaft preventing the spring from unwinding. The pliers were rotated locked in place the wire was removed allowing the tube to be rotated another half turn. The wire was reinstalled locking the tube in place this sequence was repeated until the fabric was completely unrolled from the tube leaving the roller tube groove accessible for the next step. Screws installed in the coach mounted topper bead were removed prior to pulling the old fabric from the roller and side wall of the coach.

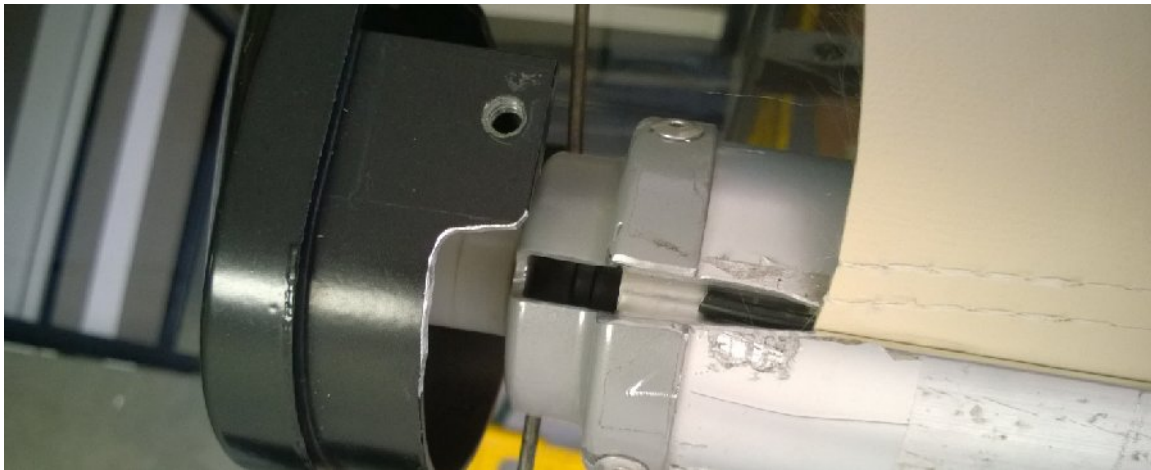
After the slide topper fabric had been removed, the next step was to prep the roller tube for installation of the new fabric. Foil tape around the left end of the tube was cut than removed allowing easier access to the groove in both roller tube and end cap.

As seen in the previous photo installing the new slide topper bead into the groove is hard work with very little space to work, based on suggestions seen on a Tough Tops Awning video a few modifications were made, making the installation of the topper fabric easier. A 1/8" Dremel with a high speed tapered cutter was used to remove some of the aluminum from the left end awning housing along with widening the bead groove in both end cap and roller tube about two inches tapering back to the original groove width in the roller tube. A small file was used to smooth any rough edges on both end cap and groove preventing damage to the new fabric.

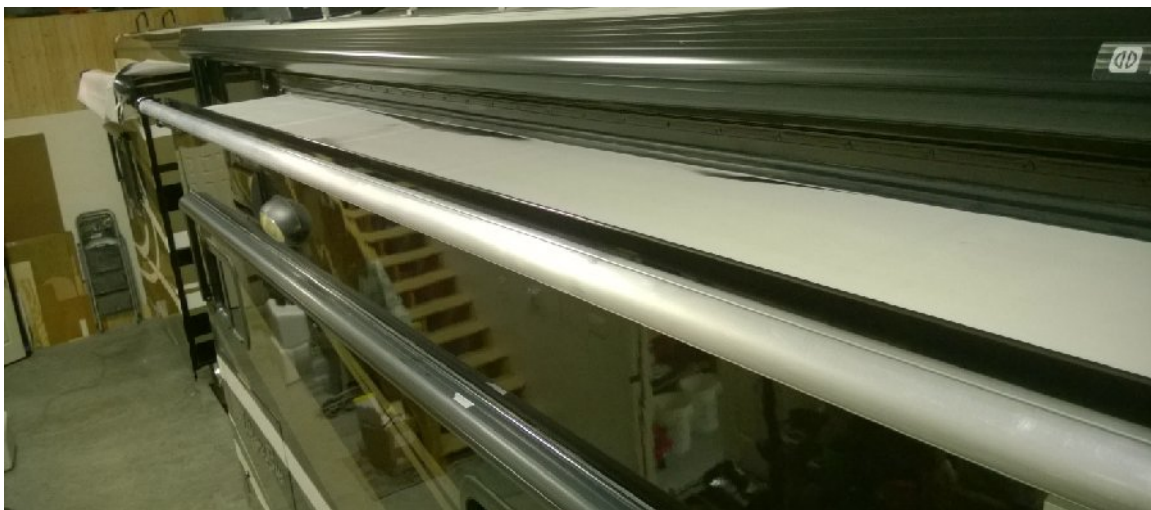
Photo below shows the slide after old topper removal and after the top of the slide had been cleaned, than checked for seal damage or potential leaks.

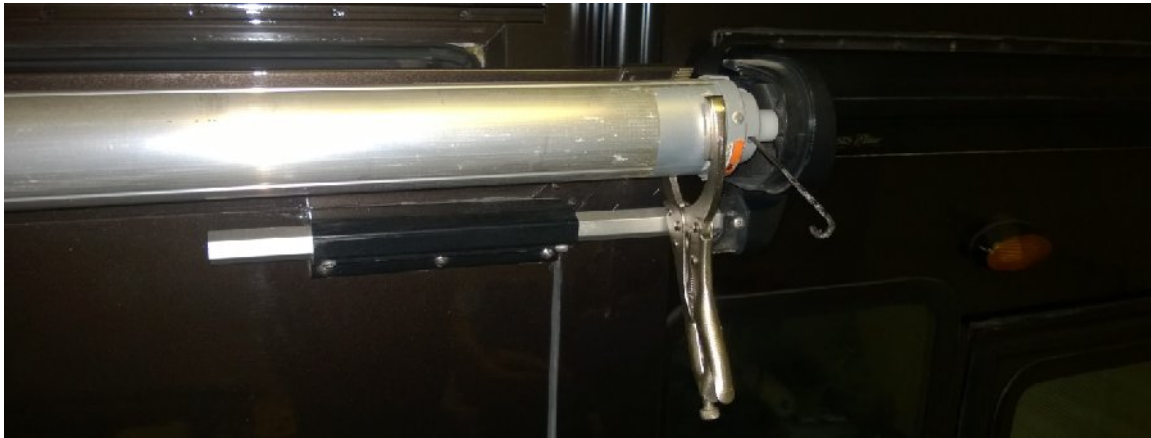
In an effort to work extra safe while home alone the right end of the roller tube was secured with a second piece of wire along with a pair of locking oil filter pliers preventing possible injury if the wire securing the spring tension on the left end were to break allowing the roller tube to suddenly release the spring tension on the tube.

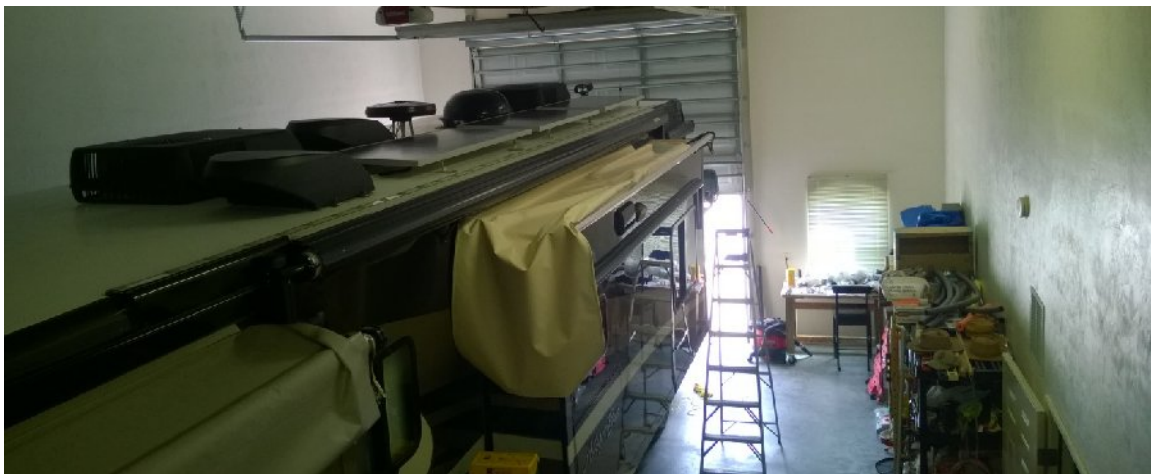
Needle nose pliers were used to open the left end of the bead channel mounted on the coach wall, then the metal was filed smooth preventing damaging fabric snags, it was now time to begin installing the fabric. Now the fun begins, installing the topper fabric without assistance. Both fabric beads were carefully started into the bead grooves, the fabric was worked an INCH at a time side to side as far as safely possible from one ladder. After that two ladders were used, moving back and forth between the ladders as stated an inch at a time until the fabric was worked into both grooves.

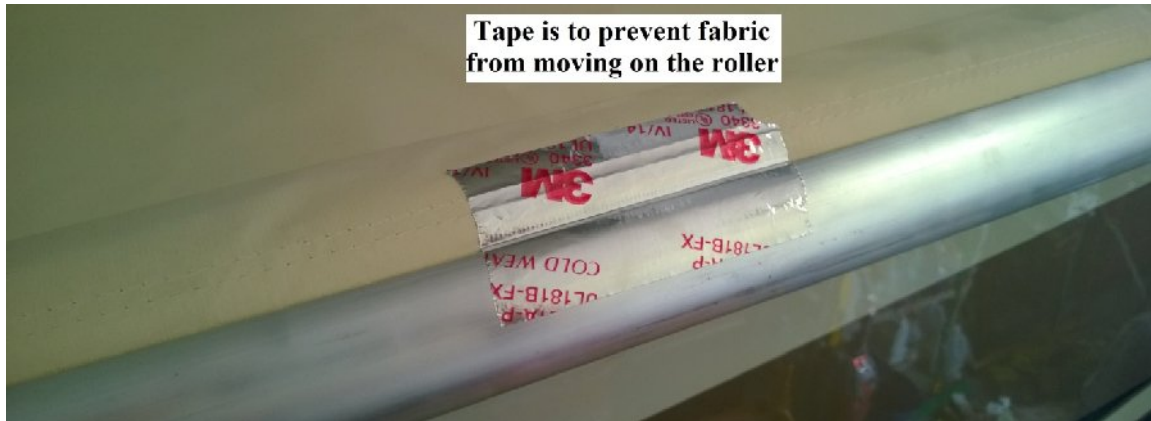
After all the fabric was pulled thru the two beads, the fabric was centered on the roller tube leaving about  $\frac{3}{4}$  of an inch on each end of the tube exposed.

The next step is to prevent the fabric from crawling toward either end of the tube as the slide was extended and retracted. The method chosen by me was to install a six inch long piece of aluminum foil tape over both fabric and tube at the center of the roller tube.

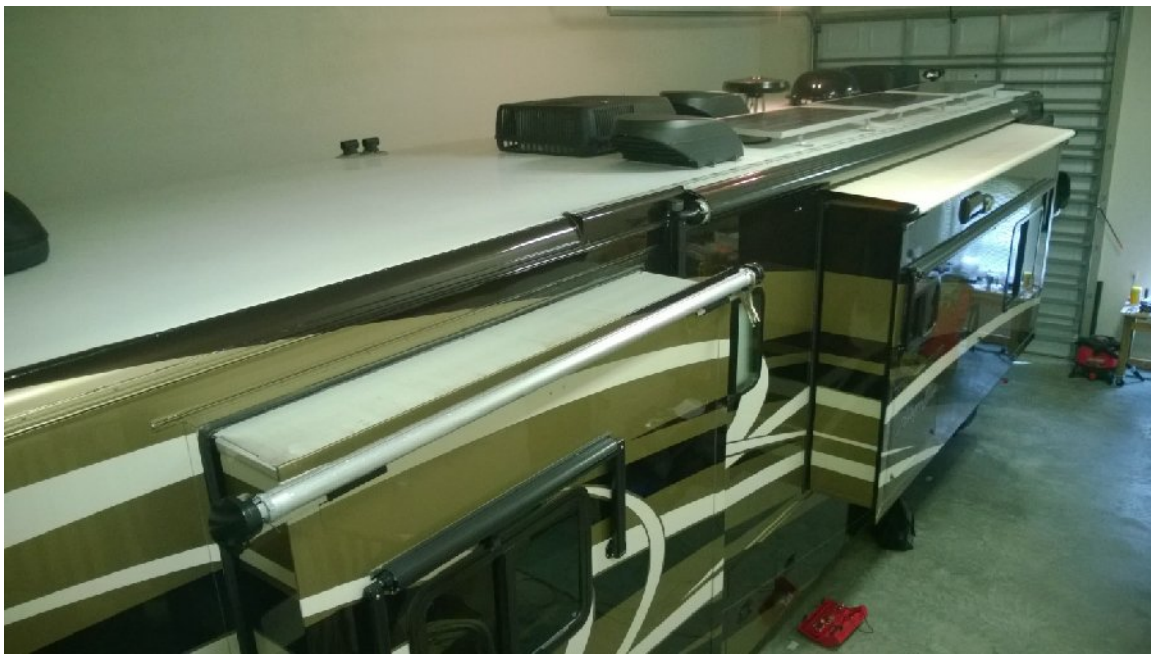
Three hours were needed for me to install the NON ASSISTED slide topper, the aluminum cover over the roller tube waited for help from my assistant.

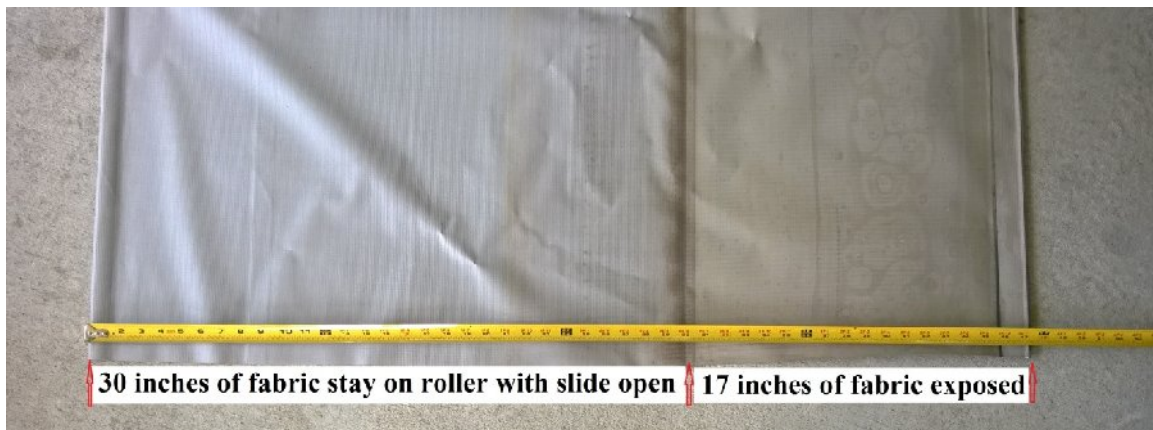
The old topper fabric shown above was removed from the PS bedroom slide, as seen in the photo the portion of fabric left rolled on the roller when the slide was extended was 30 inches long, when the slide was fully EXTENDED the roller tube had 30 inches or about 3.8 revolutions of fabric still rolled on the tube.

Tough Top Awnings cuts the new topper fabric providing only about 1.8 revolutions of fabric left on the tube when the slide is extended plus the width of the slide, IMO those two spring tension revolutions make the tension on the new fabric GREATER than the tension on the OEM fabric. For the long term, will more tension on the fabric be better or will more tension cause the fabric to break down sooner?
