2010 43QGP Allegro Bus

130 - FYI – COACH STEP SHOULDER BOLT. Our coach has the same problems many other Tiffin coach owners have with the Lippert Industries “Coach Step” brand of entry steps.

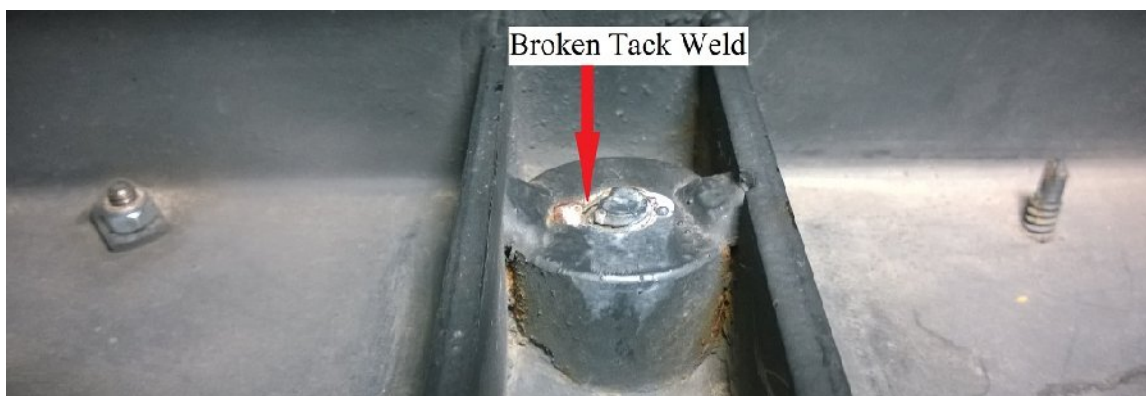
I’ve written other files about step motor problems this file will be about the SHOULDER BOLT used as a pivot point for the steps to open and close. All of the Coach Step steps used by Tiffin have the shoulder bolt, after the steps have been assembled the step manufacturer tack welds the threaded end of the shoulder bolt to prevent the bolt from working itself loose over time as the steps are extended and retracted.

The problem many owners have or will have, the tack weld breaks as shown above when that happens the shoulder bolt will slowly work itself loose, when the bolt works loose a gap develops as shown below, as the gap develops the operation get nosier then normal if not corrected parts break.

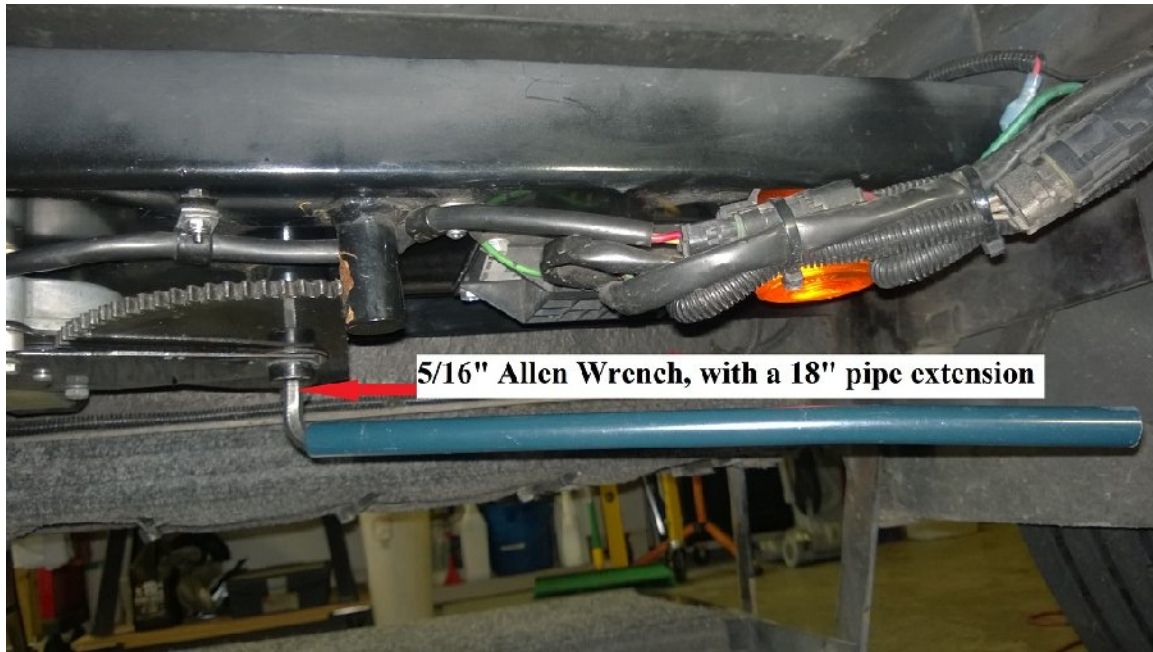
I've gotten to listening for the noisier than normal step operation, when I hear the noises that is my prompt to perform step "Shoulder Bolt" maintenance as shown below.

In past step maintenance Blue Lock Tite was applied to the threads of the shoulder bolt even with the Lock Tite applied the bolt will slowly loosen it may take a year however it will still loosen. The head of the shoulder bolt has a 5/16" Allen socket. The bolt on our steps is tight enough I need to use a piece of pipe 18" long to tighten the bolt. The gap seen in the second photo required a complete revolution (one turn) of the bolt to ALMOST completely tighten the bolt. The bolt should not be completely tightened if the bolt is completely tightened the step (window) motor will not be able to turn the gear opening or closing the step.
