2010 43QGP Allegro Bus

2/8/2011

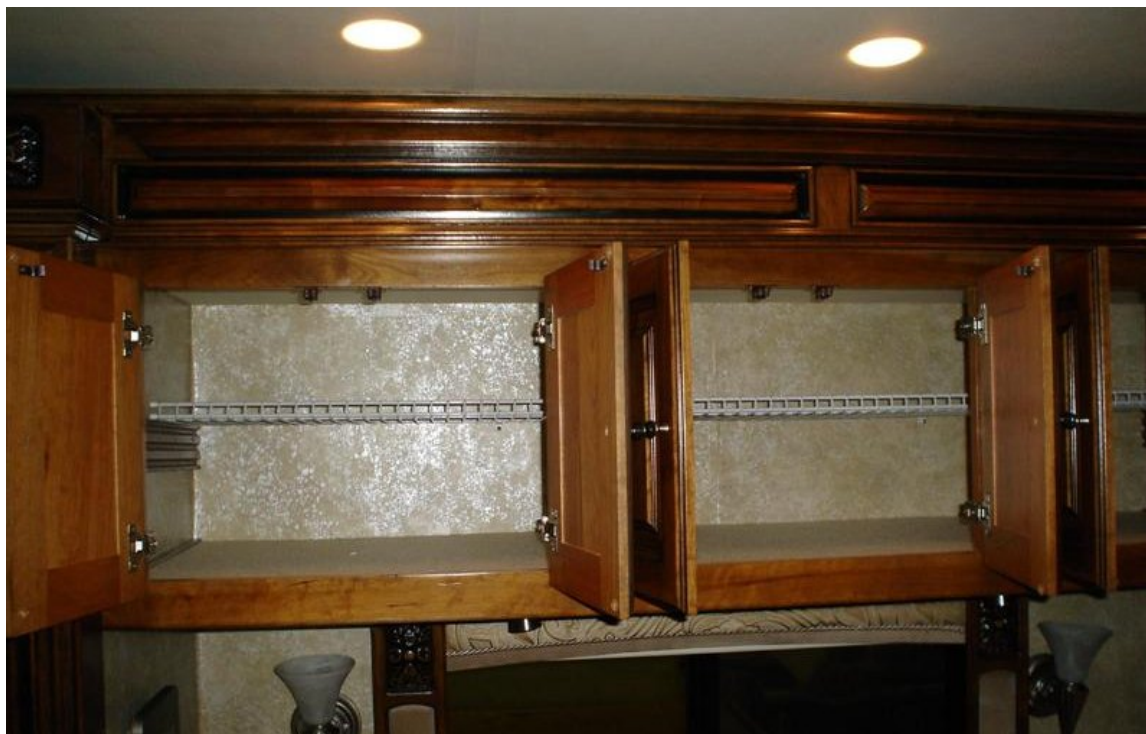
FIRST modification **INSTALL ADDITIONAL VENTILATED SHELVING**. Install in PS living-room cabinet and the PS hanging closet. The ventilated shelving was purchased from our local Lowe's, we found the six foot long 12 inch shelving was a exact fit in the over PS sofa cabinet. Our cabinet has six doors which make access easy for installing the new shelf. Two hardwood shelf supports were installed, one on each end. The shelf when installed would split the height of the seventeen (17) inch tall cabinet making the new top shelf about eight (8) inches while the bottom portion would also have about eight (8) inches. The shelving was installed with the shelf lip up to prevent items on the top shelf from sliding off. We found the best way to install the shelf was to remove the cabinet door nearest the kitchen. Once it was removed the shelf can be slid into position and laid down on the new shelf supports. To keep the shelf tight against the cabinet back wall and prevent the shelf sliding away from the back wall we installed two two-hole cabinet clips with screws, one close to each end. That also allows the front edge of the new shelving to be lifted making it easier to add or remove objects from the lower shelf.

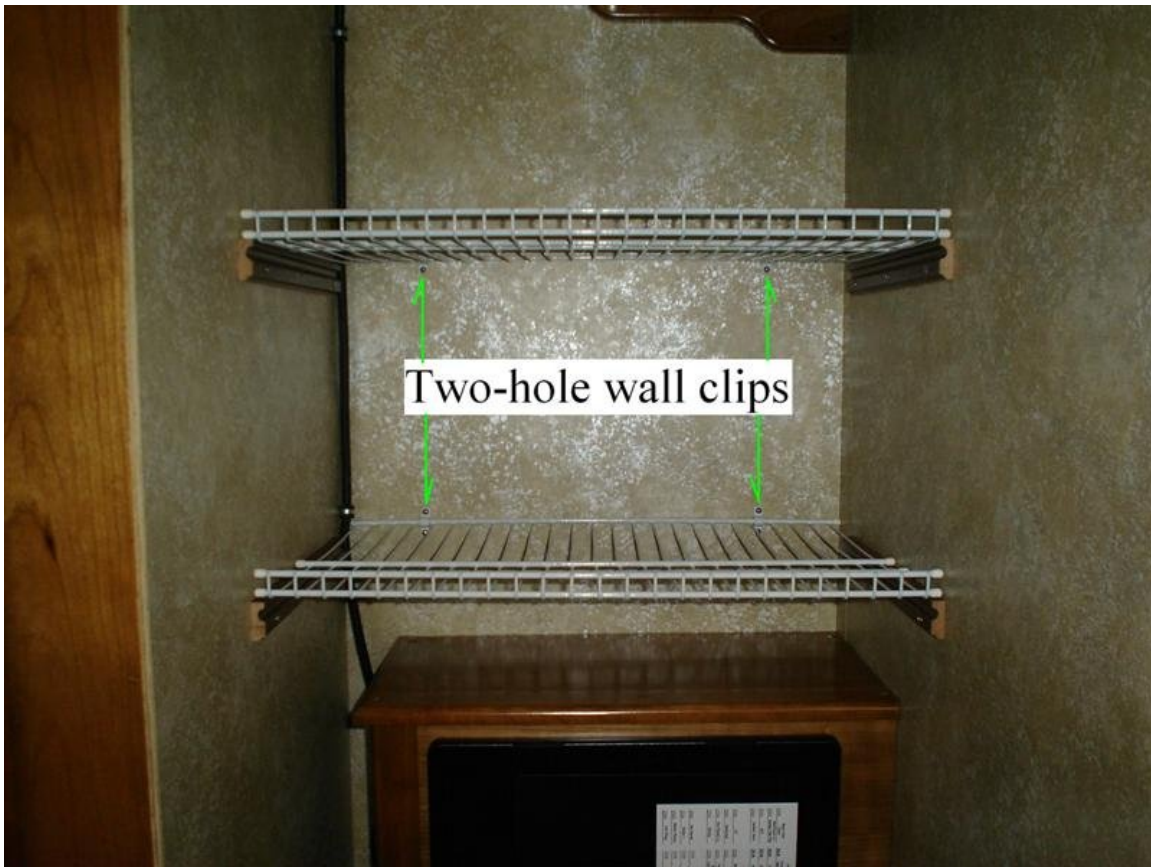
The second shelving addition was to the bedroom closet. Tiffin installed the electrical circuit breaker panel on the floor on the passenger side of the hanging closet. Since about 16 inches of the hanging length had been compromised we decided to install two 16 inch deep shelves in that corner over the electrical panel. Four hardwood shelf supports were cut and installed in order to support the new shelves. Take care to insure the forward wall depth will support the screw length you are using before installing the screws for the left end shelf support, or the screws may protrude through the wall into the bathroom.

After installation the lower shelf is mounted six (6) inches above the wooden top of the electrical panel. The distance between shelves is thirteen (13) inches and the top shelf is about fourteen (14) inches below the closet's top wooden shelf.

All shelving after they were cut had rubber caps installed to prevent damage to the adjacent wallpaper. Again these shelves were secured to the wall behind the shelf to prevent the shelf from sliding away from the wall and also allow the front of the new shelf to be lifted making storing or removal of stored items easier.
