#### 2010 43QGP Allegro Bus

11/7/2011

THIRTY-EIGHTH - coach modification - <u>CONVERSION TO</u> <u>MANUAL PROPORTIONING VALVES</u>. After several attempts at having our coach properly weighed (all six positions) we finally achieved that goal. However we quickly found the driver side of the front axle was too heavy for the tire and wheel it was mounted on. The weighed weight was 8,239 pounds 409 pounds over the tire's capacity and 239 pounds over the rim's capacity.

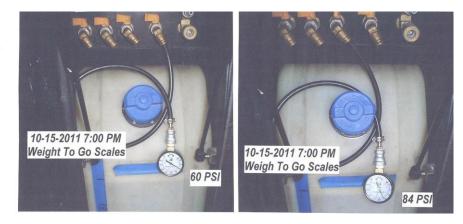
The weights quickly got my attention. Fortunately we were scheduled for an appointment the following week in Red Bay. In an attempt to find out what was happening I assembled various fittings, 3/8" OD air brake tubing and a gauge which was connected to the ping tanks drain valves. Those drain valves are attached to the tag axle air bags the pressure in the ping tanks is also the pressure in the air bags. The air pressure in both tanks **SHOULD** be equal when the coach is on level ground. The pressure was tested several times and the readings were never consistent. At one point the PS air tank

held 84 PSI while the DS tank held 60 PSI. We attempted to weigh the coach a second time, but were unable to drive up onto/mount the scales due to high air pressure in the tag axle's air bags. The drive axle did not have enough weight to drive onto the scales as most of the rear weight of the coach was being carried on the tag axle. The below photos were taken during the attempt to weigh, as previously stated the air pressure was excessive in both air bags. The coach was level during the attempt to weigh.

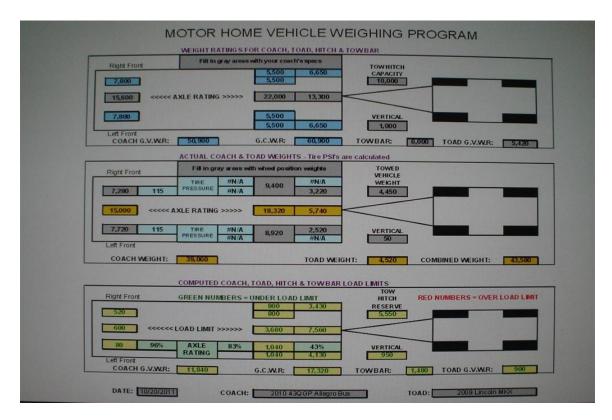
After explaining the problem at the service center to Kyle and Ricky the automatic proportioning valves were replaced with manual proportioning valves. After replacing the valve's we drove over to the Sunshine Dog Food Plant to weigh the coach. Below is a table of that weighing.

Looking at the above weight table it is easy to see a major difference in the front axle weight, especially on the driver's side of the coach.

The automatic valves **SHOULD** distribute the rear suspension air pressure 60% to the drive axle and 40% to the tag axle. The automatic proportioning valves were failing in their job. The manual proportioning valve air pressure was set at 36 PSI by Kyle and Ricky.

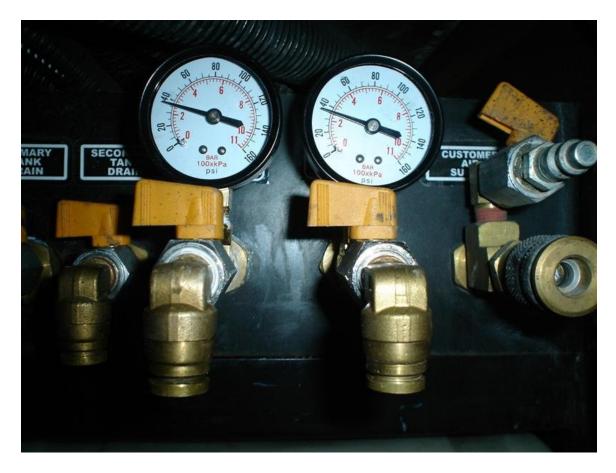
After we returned home from Red Bay the tag axle air pressure was again tested, the valves were found to be set at 38 PSI on the Passenger side and 30 PSI on the driver's side. The manual valves were again adjusted in hopes they **WILL CONSISTANTLY** maintain 36 PSI in both sides of the tag axle's suspension when the coach is level. The bad part of all of this, we are not anywhere near a set of scales to weigh the six individual positions at this time.

The driving test begins tomorrow we will be on the road for a few days. This permanent gauge setup should allow us to observe what the actual air pressure is in each side of the tag axle suspension. The gauges were installed into the PS and DS ping tank plumbing before the manual drain valves located in the DEF tank compartment.

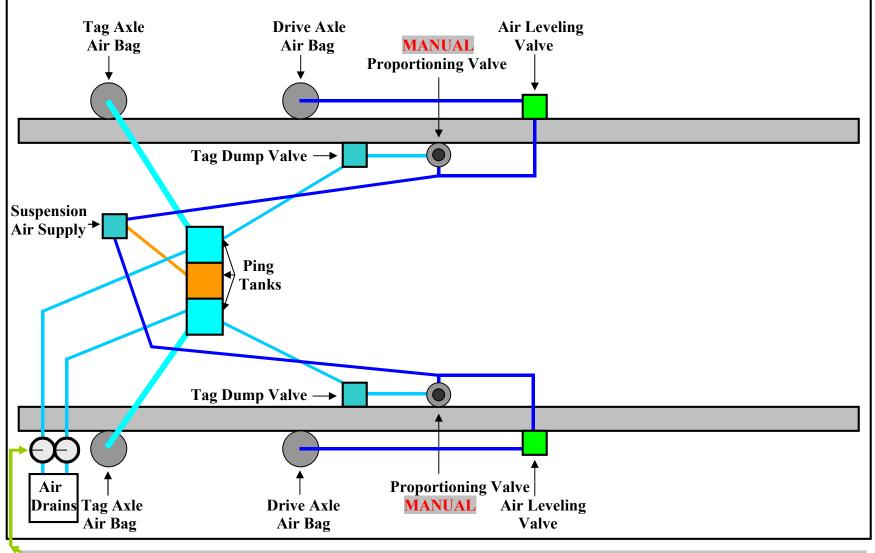
# MANUAL PROPORTIONING VALVES

# 2010 43QGP Allegro Bus <u>REAR</u> Air Suspension and <u>TAG</u> Dump System

Air Pressure Gauges installed to display PS & DS Tag Axle Air Bag Pressure, PSI set to 32 #.

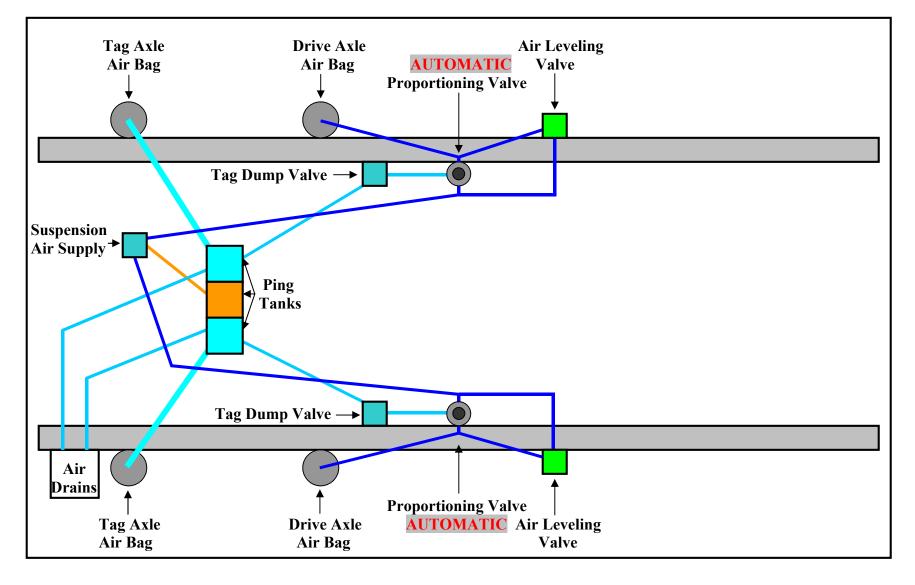
# **AUTOMATIC PROPORTIONING VALVES**

# 2010 43QGP Allegro Bus <u>REAR</u> Air Suspension and <u>TAG</u> Dump System
