## 2010 43QGP Allegro Bus

**FIFTY-THIRD - coach modification – CO-PILOT SEAT MOUNT MODIFICATION.** Cathey has a low back problem which causes nerve pain if she sits upright for long periods. In an effort to make her travel easier it was decided to modify the location of her passenger/co-pilot seat. The back pain problem was made worse by the implementation of the newer wider coach door. This problem came about because the wider coach door pushed the passenger seat back further toward the passenger side slide which prevents the back of the seat from being reclined as much as it could be prior to the installation of the wider door.

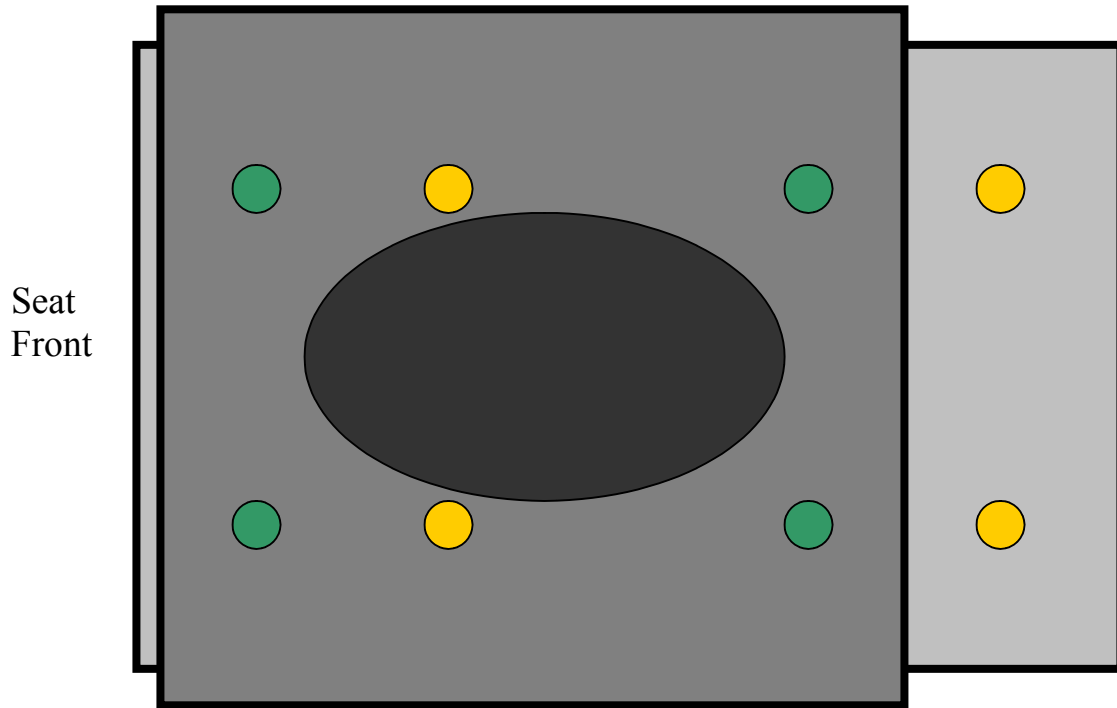
It was decided to install an 8” wide 13” long 1/4 thick sheet of steel plate (Light Gray Color) between the four chassis seat mount studs which are welded to the floor frame and the regular seat mount which is bolted to the bottom of the seat mechanism. The sheet of 1/4 inch steel was purchased from the local welding shop the seat bolt pattern was measured as 4.5 inches wide by 7.5 inches long. After measuring a decision was made to make the new mount capable of moving 2.5 inches further forward, by moving the seat that far forward it is possible to lay the seat back much further backward than was previously capable to being done.

The OEM chair mount is 9 inches wide by 8 inches long depicted by the darker gray color.

The frame to seat bolt pattern, depicted by the gold color above are the four studs welded to the floor framing by the Tiffin welding shop. The new steel plate is depicted by the lighter gray color it was mounted over the four gold colored studs using four 1/2" 13 TPI couplers. After the couplers were threaded onto the studs the 1/4 inch steel plate was laid over the couplers then the plate was bolted to the couplers using four one inch long 1/2" bolts threaded into the couplers. At this point the new steel plate (light gray) has been attached to the coach floor frame. 1 1/2 inch bolts were installed from the bottom side of the steel plate with the stud end facing upward (depicted by the green circles), nuts were then installed on the bolts for two purposes one to act as spacers in order to provide space between the steel plate and the chair mounting plate to prevent conflict with the bolt heads securing the steel plate to the coach frame, second as a set of four mounting studs for the co-pilot's chair mount to be bolted to.

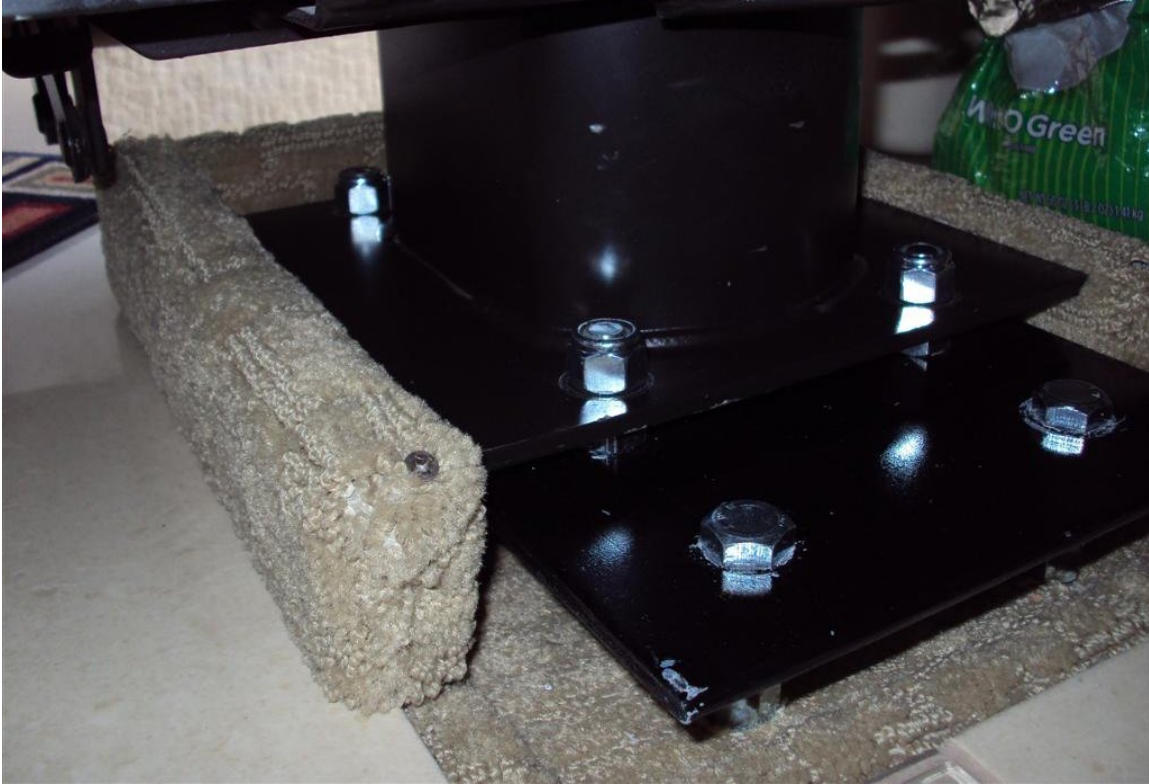
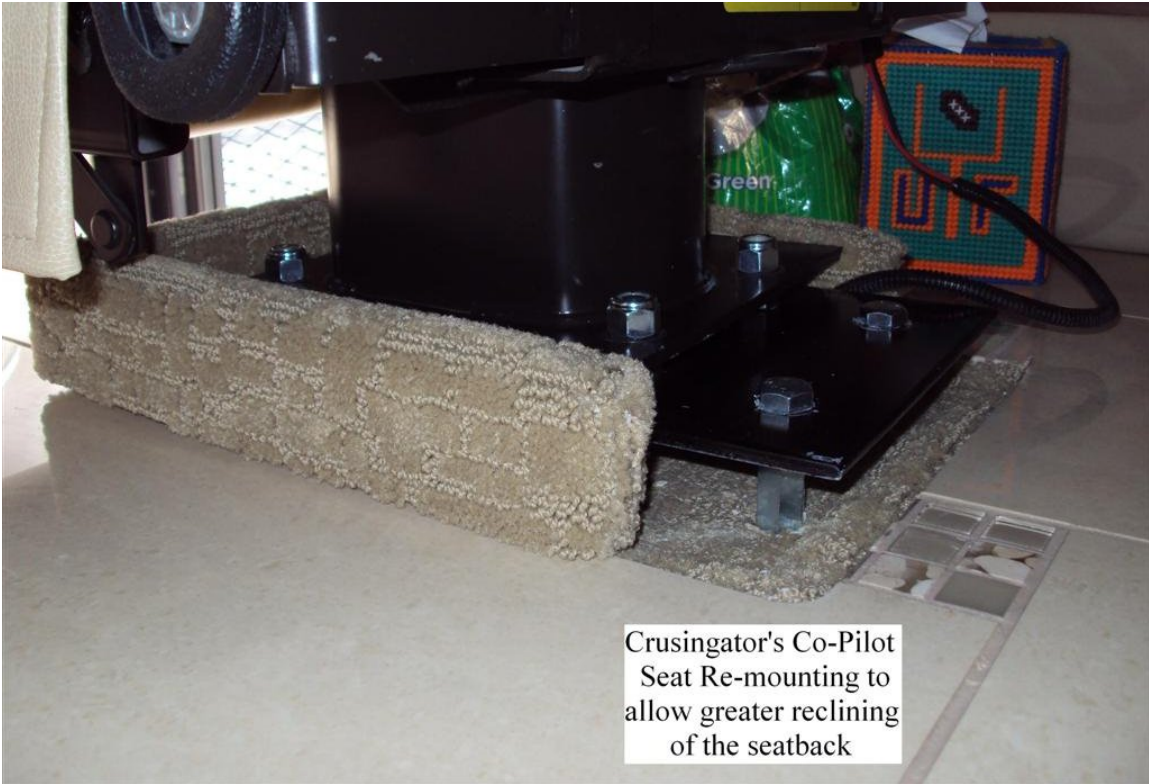
As can be seen in the following photograph a new wood skirt will need to be fabricated then covered with carpet before it is mounted around the new co-pilot chair mount to hide the seat mounting structure.

Crusingator's Co-Pilot  
Seat Re-mounting to  
allow greater reclining  
of the seatback
