## 2010 43QGP Allegro Bus

**FIFTY-SEVENTH** - coach modification – **AC/HP VENT IN REAR CLOSET.** Tiffin installed a return vent in our rear closet however they did not install a supply vent to provide Air Conditioning or Heat from the heat pump into the closet. After our coach was built Tiffin began installing a supply vent in the ceiling of the closet. In an effort to keep up with production changes an OEM supply vent was purchased from the campground store for \$ 1.50 plus tax.

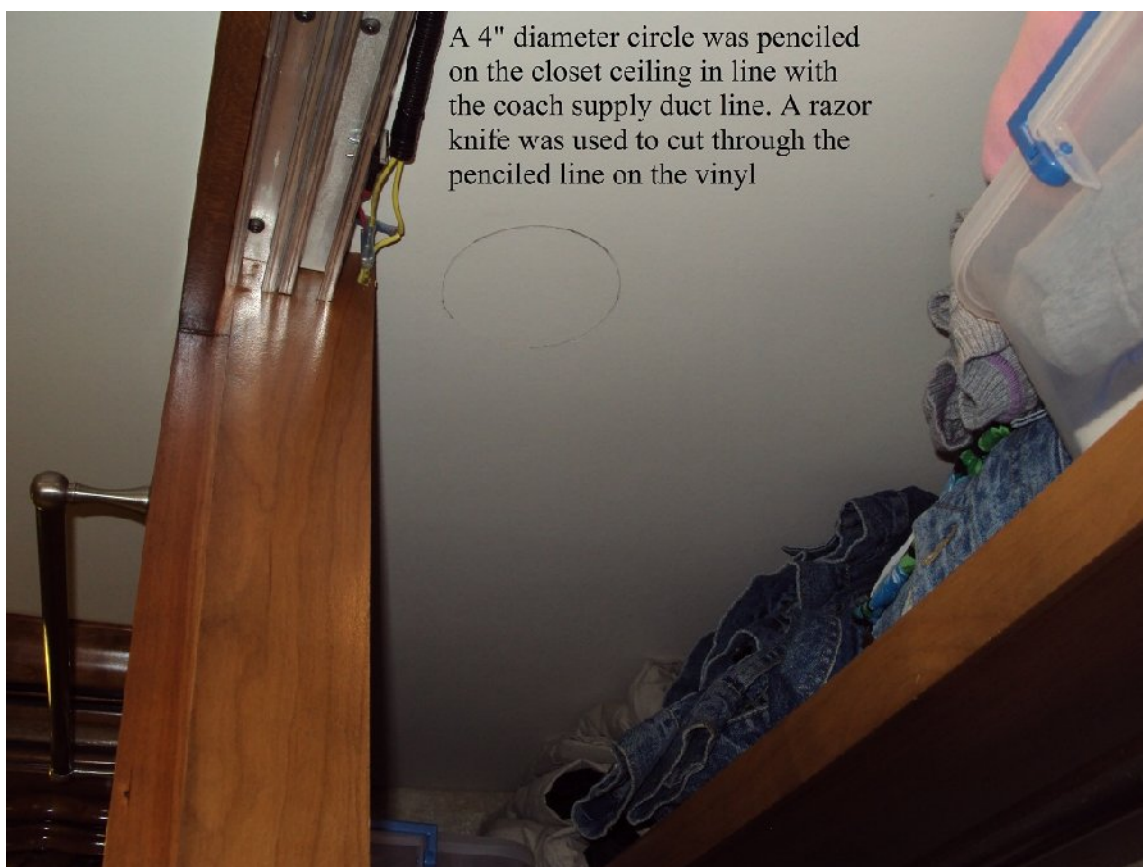
After checking our closet ceiling to make sure nothing was in the way a 4” diameter hole was marked on the ceiling with a pencil. A razor knife was used to cut through the vinyl ceiling cover.

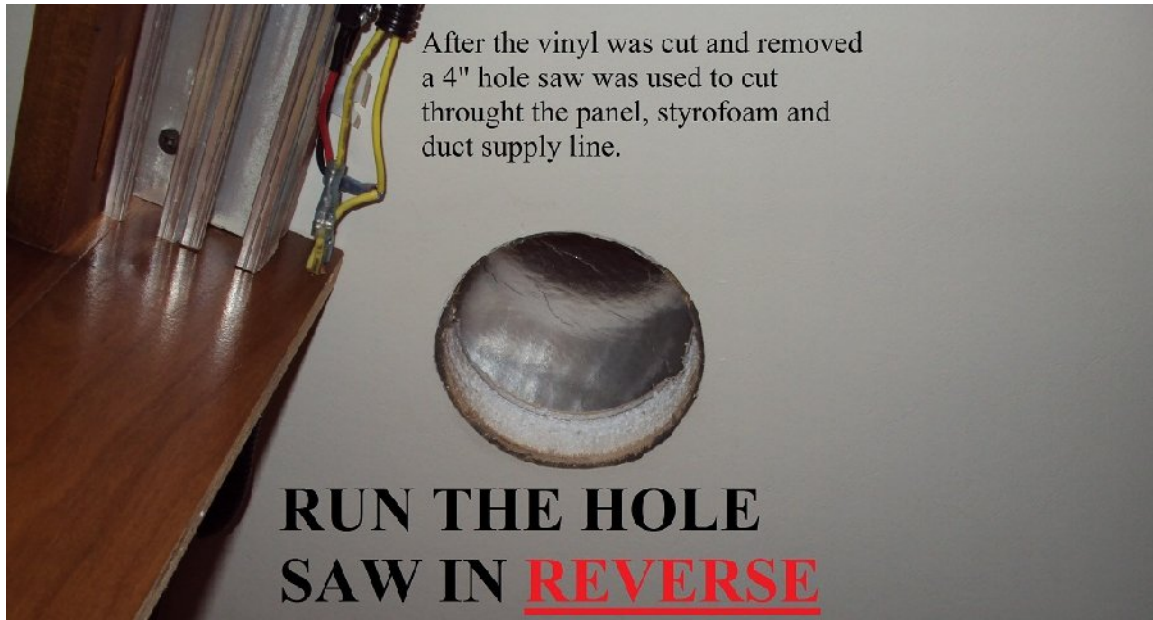
After cutting the vinyl circle the plug was peeled from the ceiling exposing a thin layer of gray foam padding. The next layer in the ceiling is the sheet of

Luan panel then the hard foam insulation and finally the duct board used to make the duct supply line.

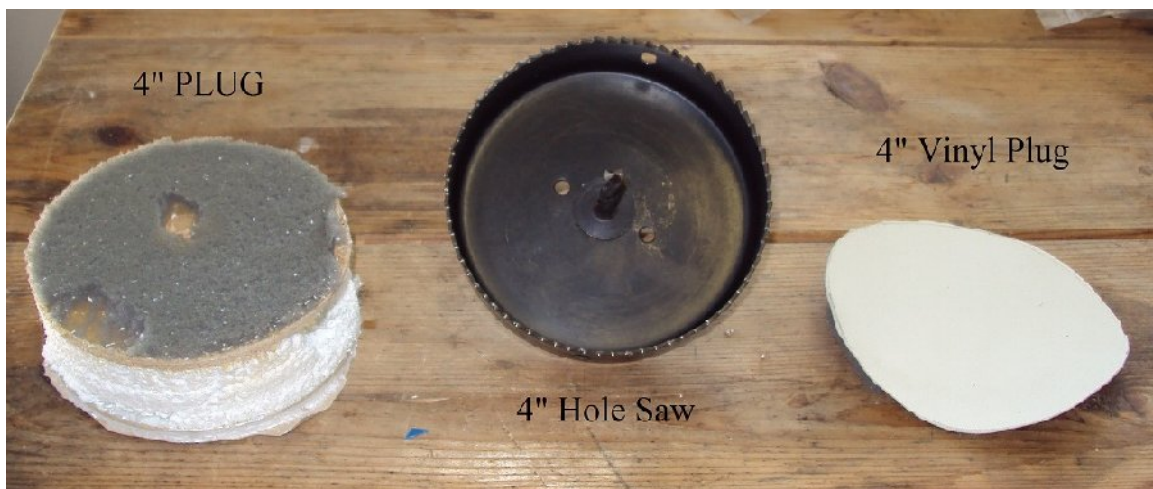
Below is a photo of the ceiling sandwich. As stated it is made up of vinyl, gray foam, hard foam and duct board.

**DO NOT RUN THE HOLE SAW IN FORWARD (RIGHT TURNING) AS YOU NORMALLY WOULD TO CUT OUT THE PLUG, DOING SO WILL DAMAGE THE CEILING. RUN THE CUTTING HEAD IN REVERSE.**

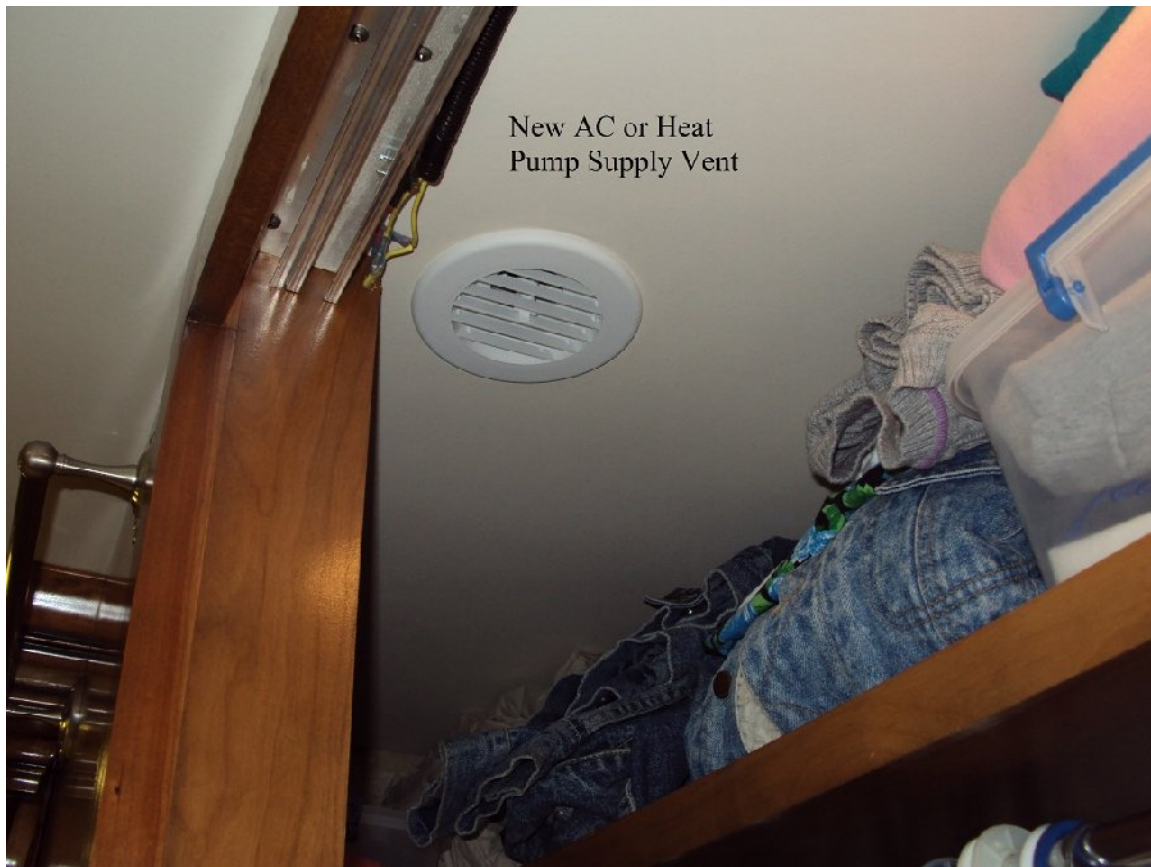
The new supply vent is smaller than the other ceiling vents in the coach.
